# DMPS FACILITY ASSESSMENT | BRUBAKER ELEMENTARY

01.16.2024

# EXECUTIVE BUILDING SUMMARY

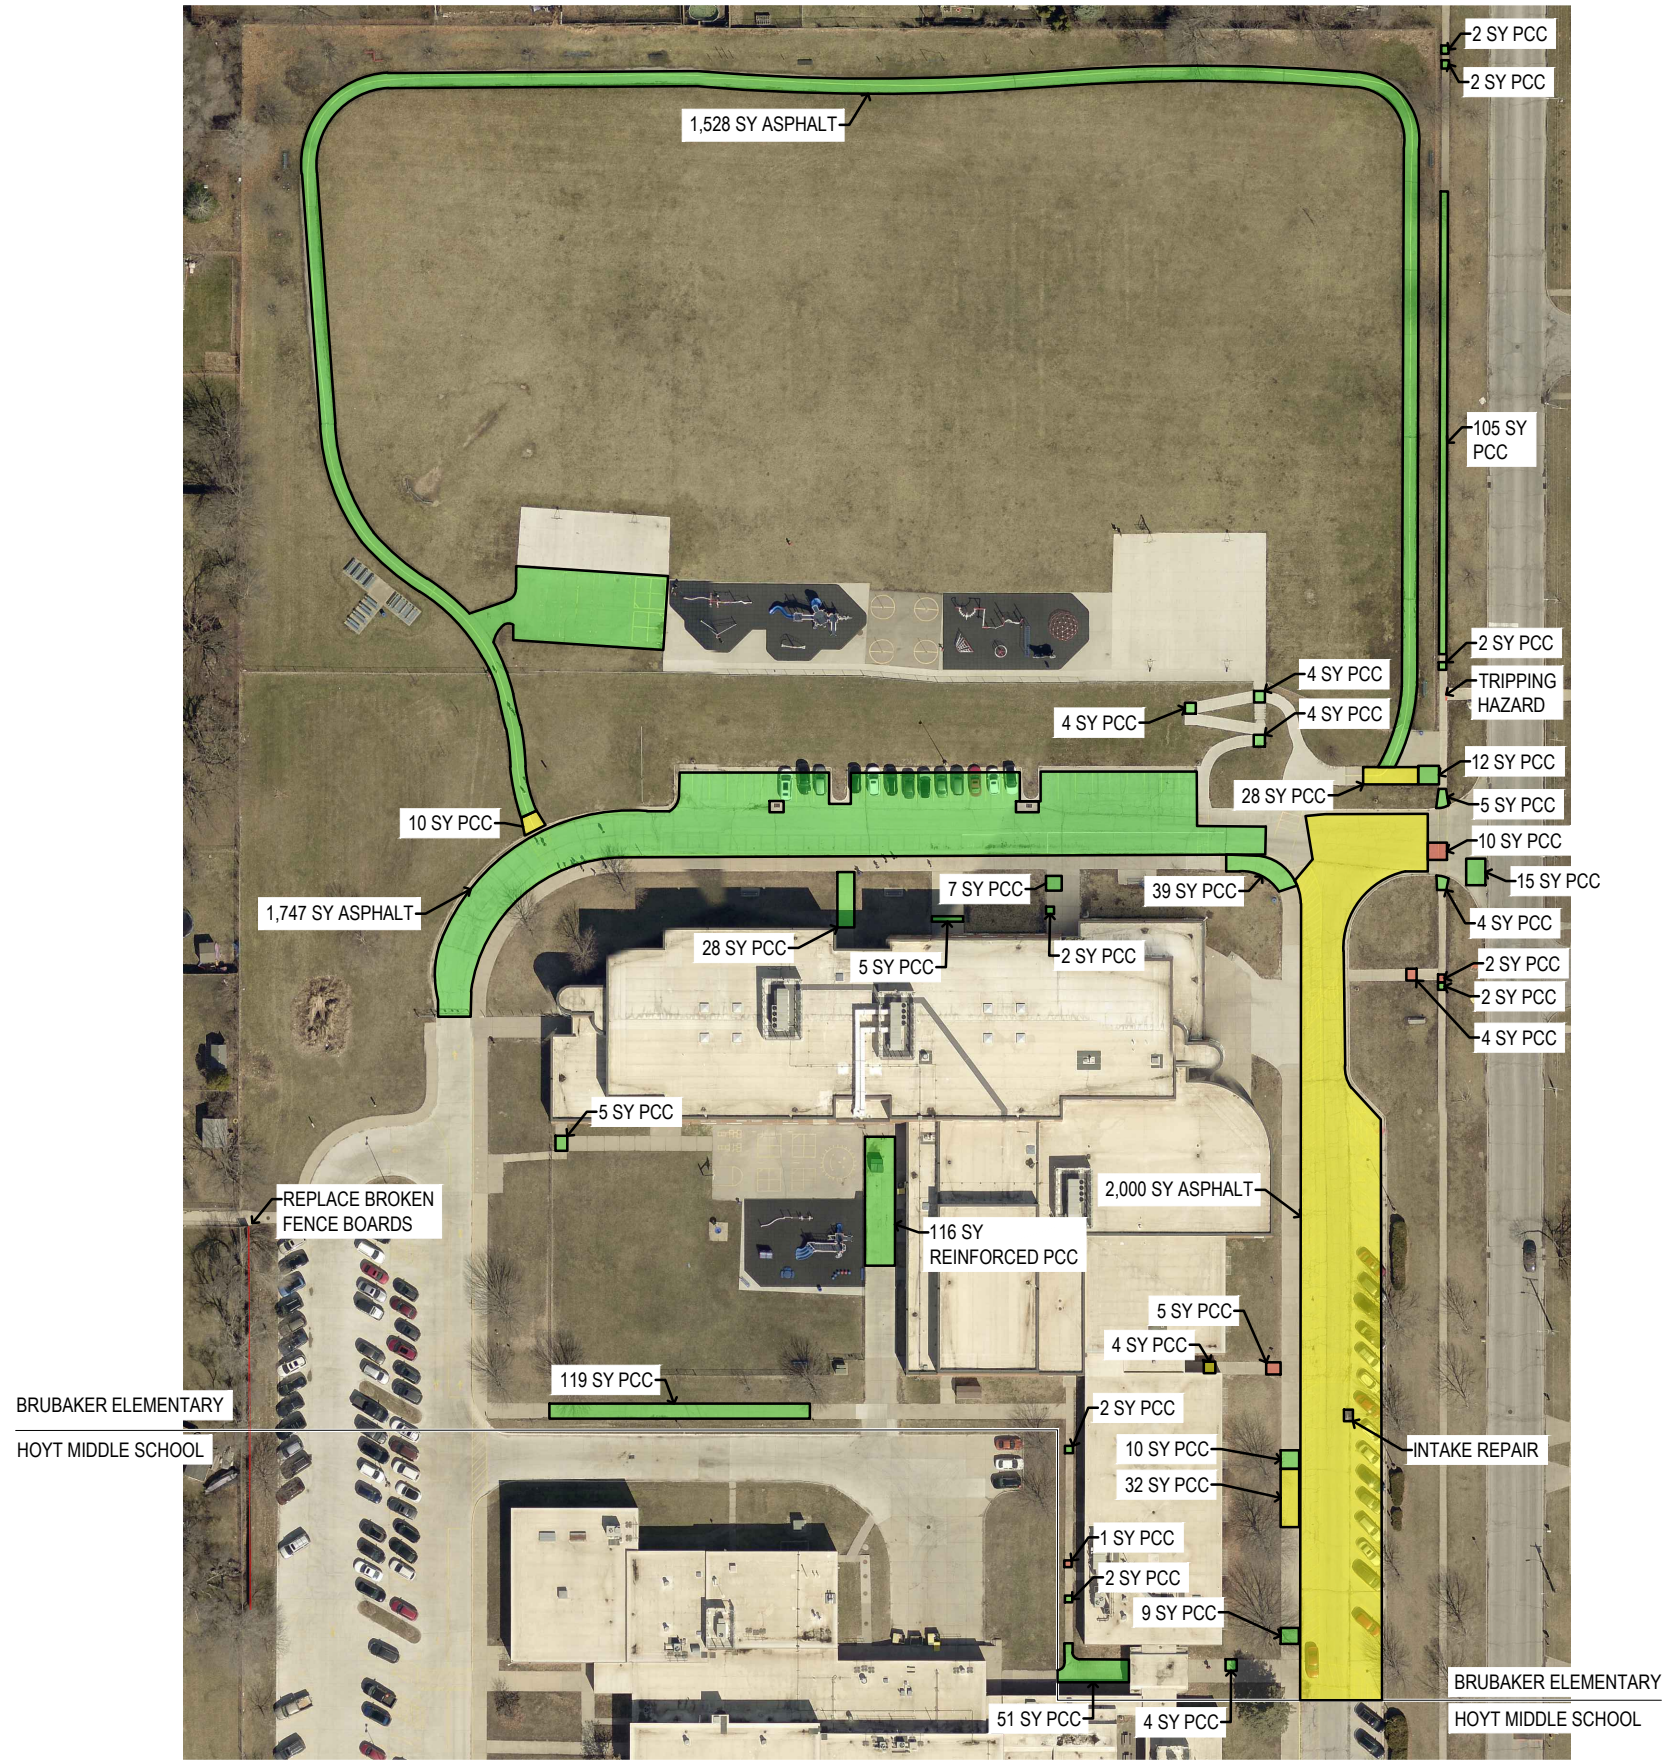
- 5+ YEAR REPLACEMENT
- 3-4 YEAR REPLACEMENT
- 1-2 YEAR REPLACEMENT

Fence Board Replacement	Replace the damaged wooden boards along the fence. For location, refer to civil site plan exhibit found in the appendix of this report.

Sidewalk Repairs	Repair damaged sidewalks across the site. Approximately 12 SY. For locations, refer to civil site plan exhibit found in the appendix of this report.	\$7,000
Pavement Replacement	Remove and replace 10 SY of PCC. For location, refer to civil site plan exhibit found in the appendix of this report.	\$7,000
Heat Pump Replacement	Replace all GSHP throughout the building and consider 2 speed compressor to more closely match load.	\$1,600,000
MDF Cooling Equipment Installation	Install new split unit in MDF room with low ambient cooling capability or consider added exhaust from room.	\$12,000
Flush Valve Upgrades	Install new automatic flush valves in restrooms (~25%)	\$25,000
Exterior Lighting	Add exterior lighting on east side of building (south) along east side facing playground.	\$11,000
Repair Lightning Protection System (See Hoyt Middle School)	Repair broken air terminals and ensure system is in proper working order. System needs to be connected to a new system at Hoyt Middle School.	\$12,000
