DMPS FACILITY ASSESSMENT |

EXECUTIVE BUILDING SUMMARY

Building Name: Callanan Middle

Date: 2.21.2024

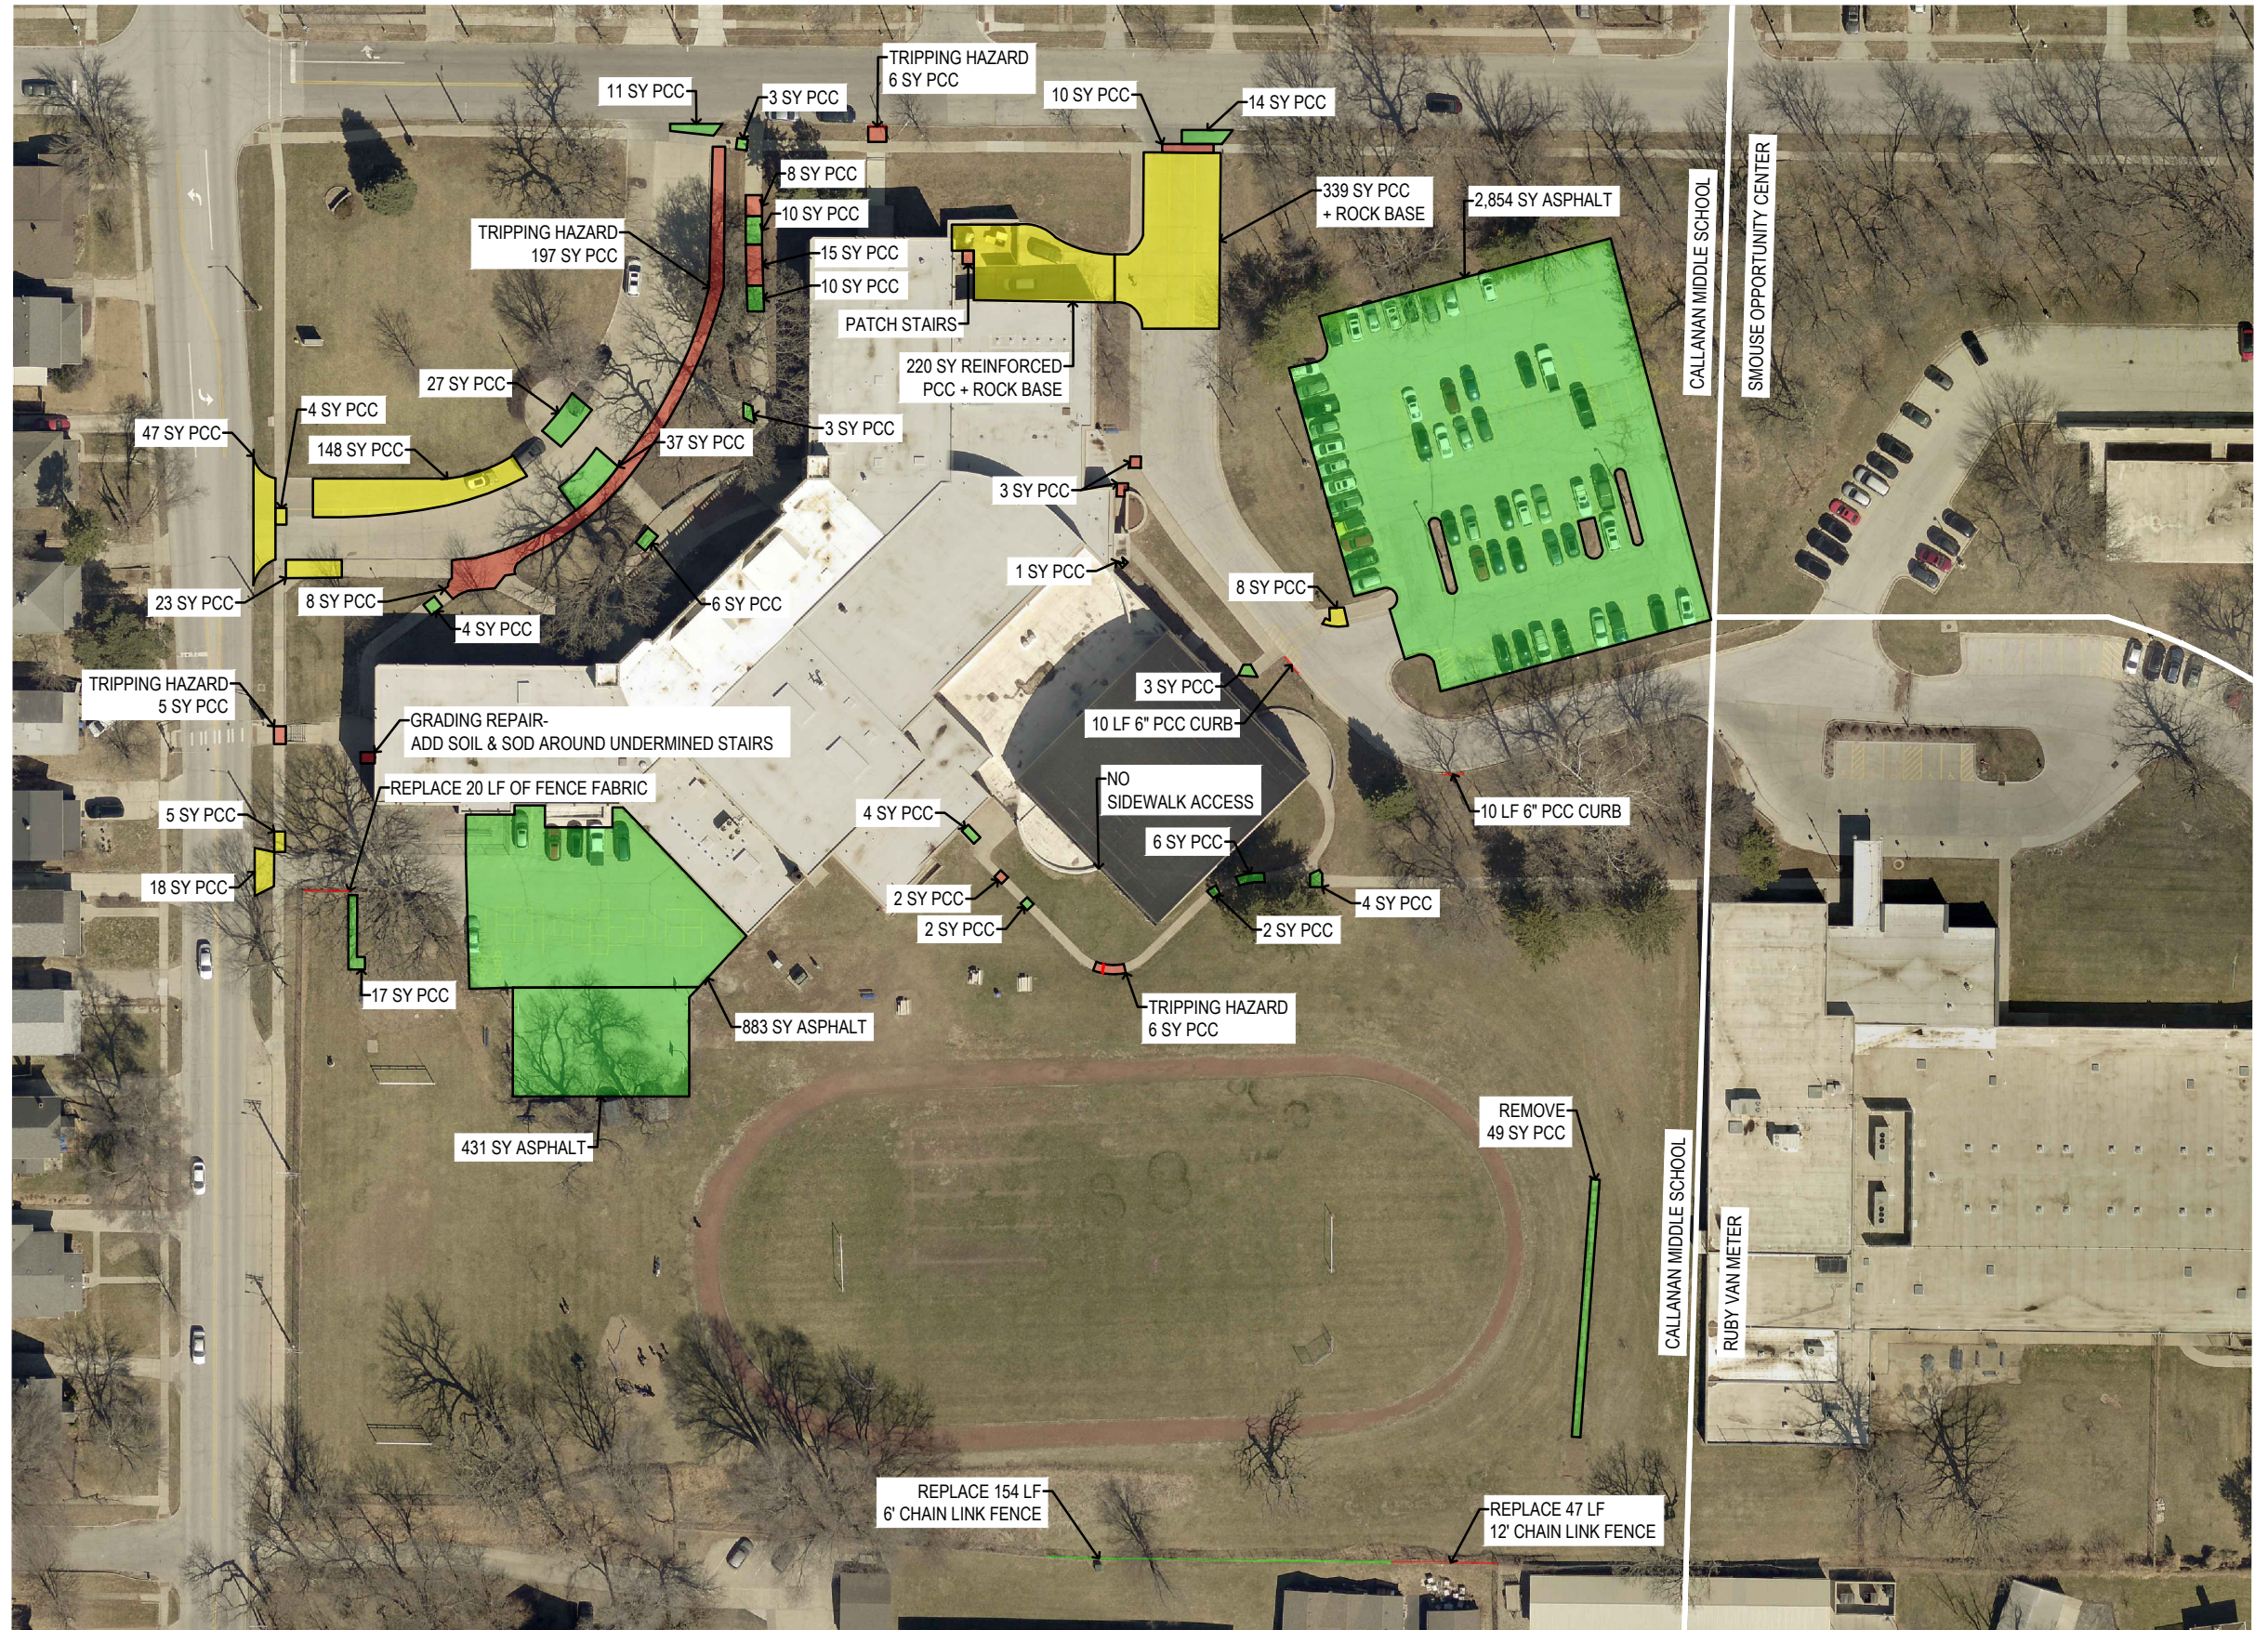
CALLANAN MIDDLE SCHOOL

- 5+ YEAR REPLACEMENT
- 3-4 YEAR REPLACEMENT
- 1-2 YEAR REPLACEMENT

Pavement Replacement	Remove 220 SY of PCC and replace with reinforced PCC. Remove 552 SY of pavement and install a rock base under the 339 SY of pavement experiencing subsurface moisture issues. For locations, refer to civil site plan exhibit found in the appendix of this report.	\$140,000
Sidewalk Repairs	Repair damaged sidewalks across the site. Approximately 40 SY. For locations, refer to civil site plan exhibit found in the appendix of this report.	\$12,000
Replace Water Heaters	Replace (2) gas fired water heaters..	\$85,000

Improve Roof Access/Safety	Provide guards at each of (2) roof access hatches.	\$12,000
Pavement Replacement	Remove and replace 3737 SY of asphalt and 89 SY of PCC. For locations, refer to civil site plan exhibit found in the appendix of this report.	\$680,000
Sidewalk Repairs	Repair damaged sidewalks across the site. Approximately 121 SY. For locations, refer to civil site plan exhibit found in the appendix of this report.	\$30,000
Fence Replacement	Remove and replace 154 LF of 6' chain link fence. For location\,s, refer to civil site plan exhibit found in the appendix of this report.	\$25,000
Playground Pavement Replacement	Take out and restore deteriorated playground asphalt. Approximately 431 SY. For locations, refer to civil site plan exhibit found in the appendix of this report.	\$80,000
