DMPS FACILITY ASSESSMENT |

EXECUTIVE BUILDING SUMMARY

Building Data Record

Building Name: Capitol View Elementary

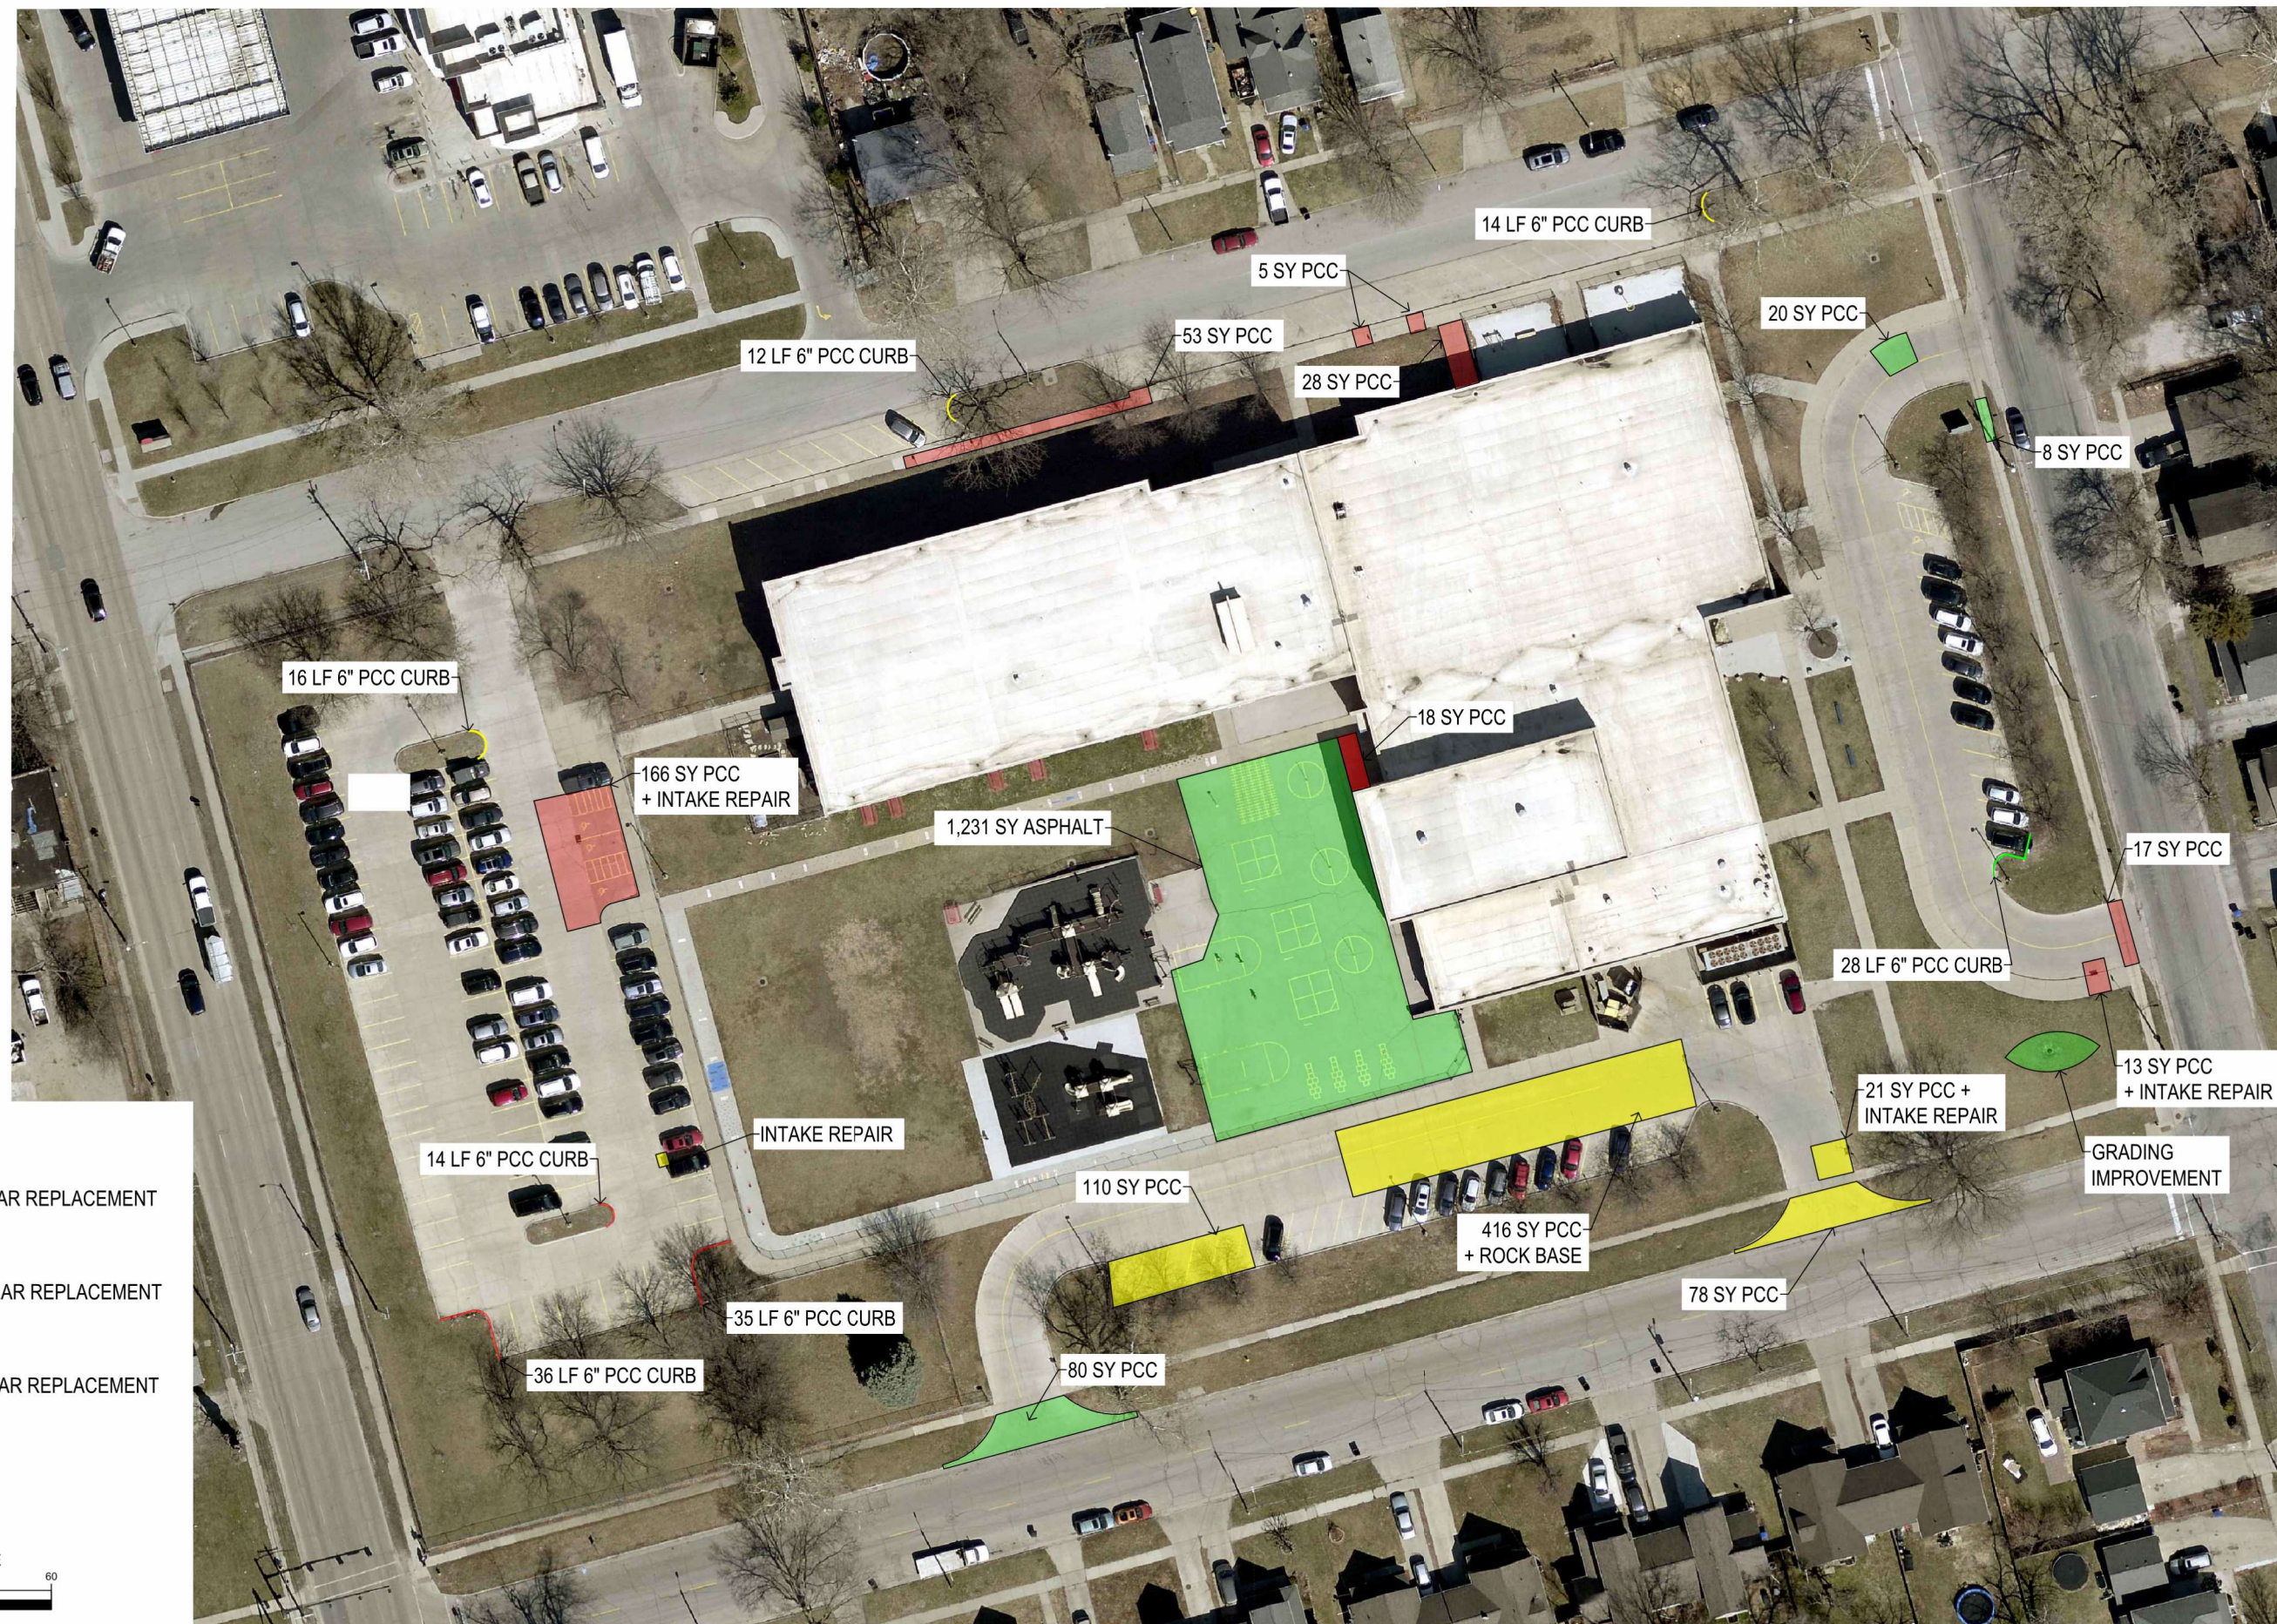
4.2 Parking areas are in good condition.	5	4	20	Majority of parking pavement in east lot in good condition, south lot pavement in fair condition with some subsurface drainage/moisture issues, ADA parking stalls and curbs in W lot in need of immediate replacement. Curbs around the N side islands require maintenance.

4.5 Sidewalks around the facility are in good condition .	1	4	4	Most of sidewalk around playground and school in good condition. Tripping hazards were observed in the northeast corner of playground just outside of building, on sidewalk north of building entrance, and on sidewalk of south entrance of east parking lot.

Curb Repair	Repair 155 LF of 6" PCC curb across site. For locations, refer to civil site plan exhibit found in the appendix of this report.	\$12,000
Exterior Concrete Slab Repairs	Repair cracks and areas where spalling of concrete is occurring in the following locations: 1. Loading dock outside of room 111. Roughly 260 sq. ft. of concrete here. Approx. 20 L.F. of cracks. Approx. 10 SF x 2" deep spalled concrete. 2. Stoop in front of exterior door near room 133. Roughly 40 sq. ft. of concrete here. Approx. 16 L.F. of cracks.	\$6,000.00

Sidewalk Replacement	Replace 8 SY of sidewalk pavement. For locations, refer to civil site plan exhibit found in the appendix of this report.	\$7,000
Sprinkler Installation	Install sprinklers in the 1-story portion of building that is currently not sprinklered.	\$5,000
