DMPS FACILITY ASSESSMENT | CARVER ELEMENTARY

10.31.2023

EXECUTIVE BUILDING SUMMARY

Building Name: Carver Elementary

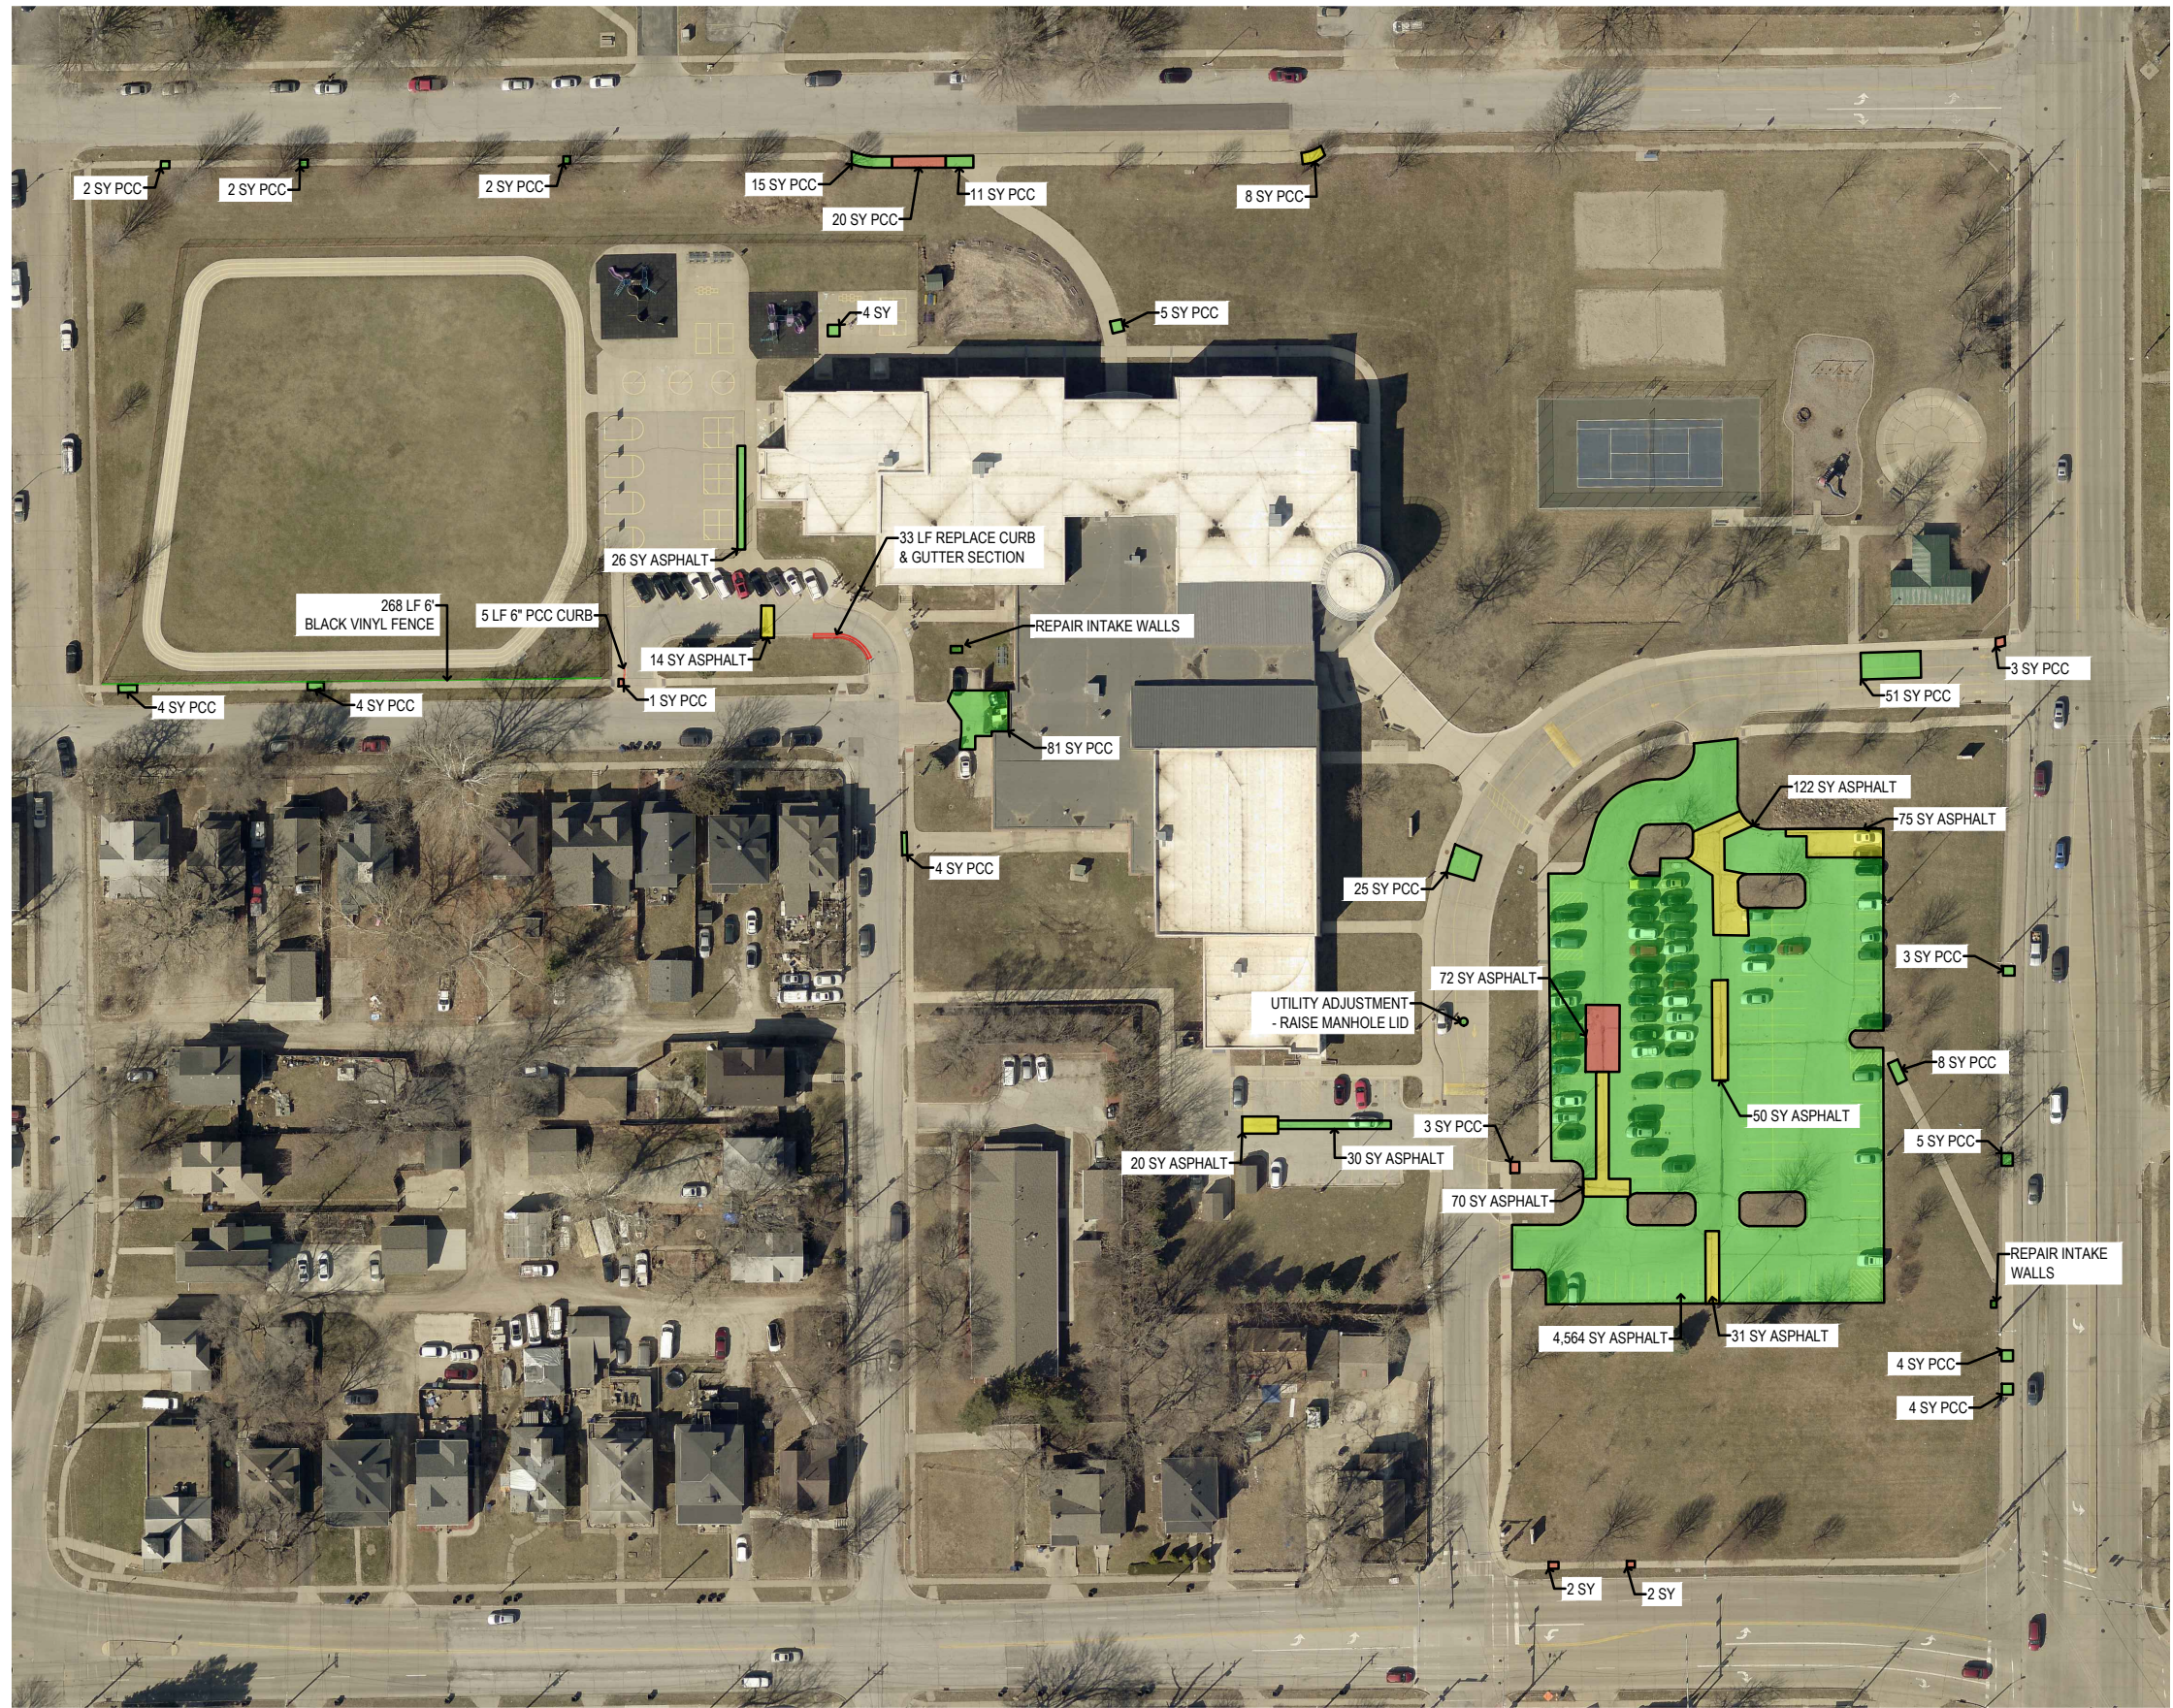
CARVER ELEMENTARY

4.2 Parking areas are in good condition.	5	3	15	The north lot is cracking throughout the lot, but the pavement does not appear to be failing immediately. The south parking lot has sections in need of repair as well, but they are not to the extent of the north parking lot

4.5 Sidewalks around the facility are in good condition .	1	4	4	Sidewalk conditions were adequate on site. The west bus lane sidewalk had a few locations needing repair, as well as the small sections of the perimeter walk along the north, east, and west sides.

Roof Access Installation	Provide 25 LF guardrail at mechanical equipment on roof area F.	\$14,000.00
Parking Pavement Replacement	Remove and replace 72 SY of asphalt around potholes in north parking lot. For location, refer to civil site plan exhibit found in the appendix of this report.	\$13,000.00
Sidewalk Repairs	Repair damaged sidewalks across the site. Approximately 28 SY. For locations, refer to civil site plan exhibit found in the appendix of this report.	\$10,000.00
Curb Repair	Return damaged curbs to new condition. Approximately 38 LF of 6" curbs. For locations, refer to civil site plan exhibit found in the appendix of this report.	\$7,000.00
Exterior Lighting Replacement	Replace high-pressure sodium light fixture near west entry with LED fixture. Add exterior light fixtures at northwest and southeast corners.	\$10,000.00

Parking Pavement Replacement	Replace asphalt pavement sections with new pavement. See attached civil exhibit.	\$55,000.00
Sidewalk Repairs	Repair damaged sidewalks across the site. Approximately 8 SY. For locations, refer to civil site plan exhibit found in the appendix of this report.	\$7,000.00
Energy Recovery Ventilators Replacement	Replace ERVs. Consider consolidating units due to roof screening requirements. Modify system to provide transfer from classrooms to restrooms without using corridor as pathway. Confirm scope of B9075-Carver-2024 HVAC Upgrades project to make sure replacement of ERV did not occur in this project.	\$2,000,000.00

Repair Intake	Repair walls of two intakes - one on the north side of the site and the other south of the building. For locations, refer to civil site plan exhibit found in the appendix of this report.	\$12,000.00
Manhole Adjustment	Raise manhole lid to match the grade of the road. For location, refer to civil site plan exhibit found in the appendix of this report.	\$7,000
