# DMPS FACILITY ASSESSMENT | COWLES MONTESSORI

11.28.2023

# EXECUTIVE BUILDING SUMMARY

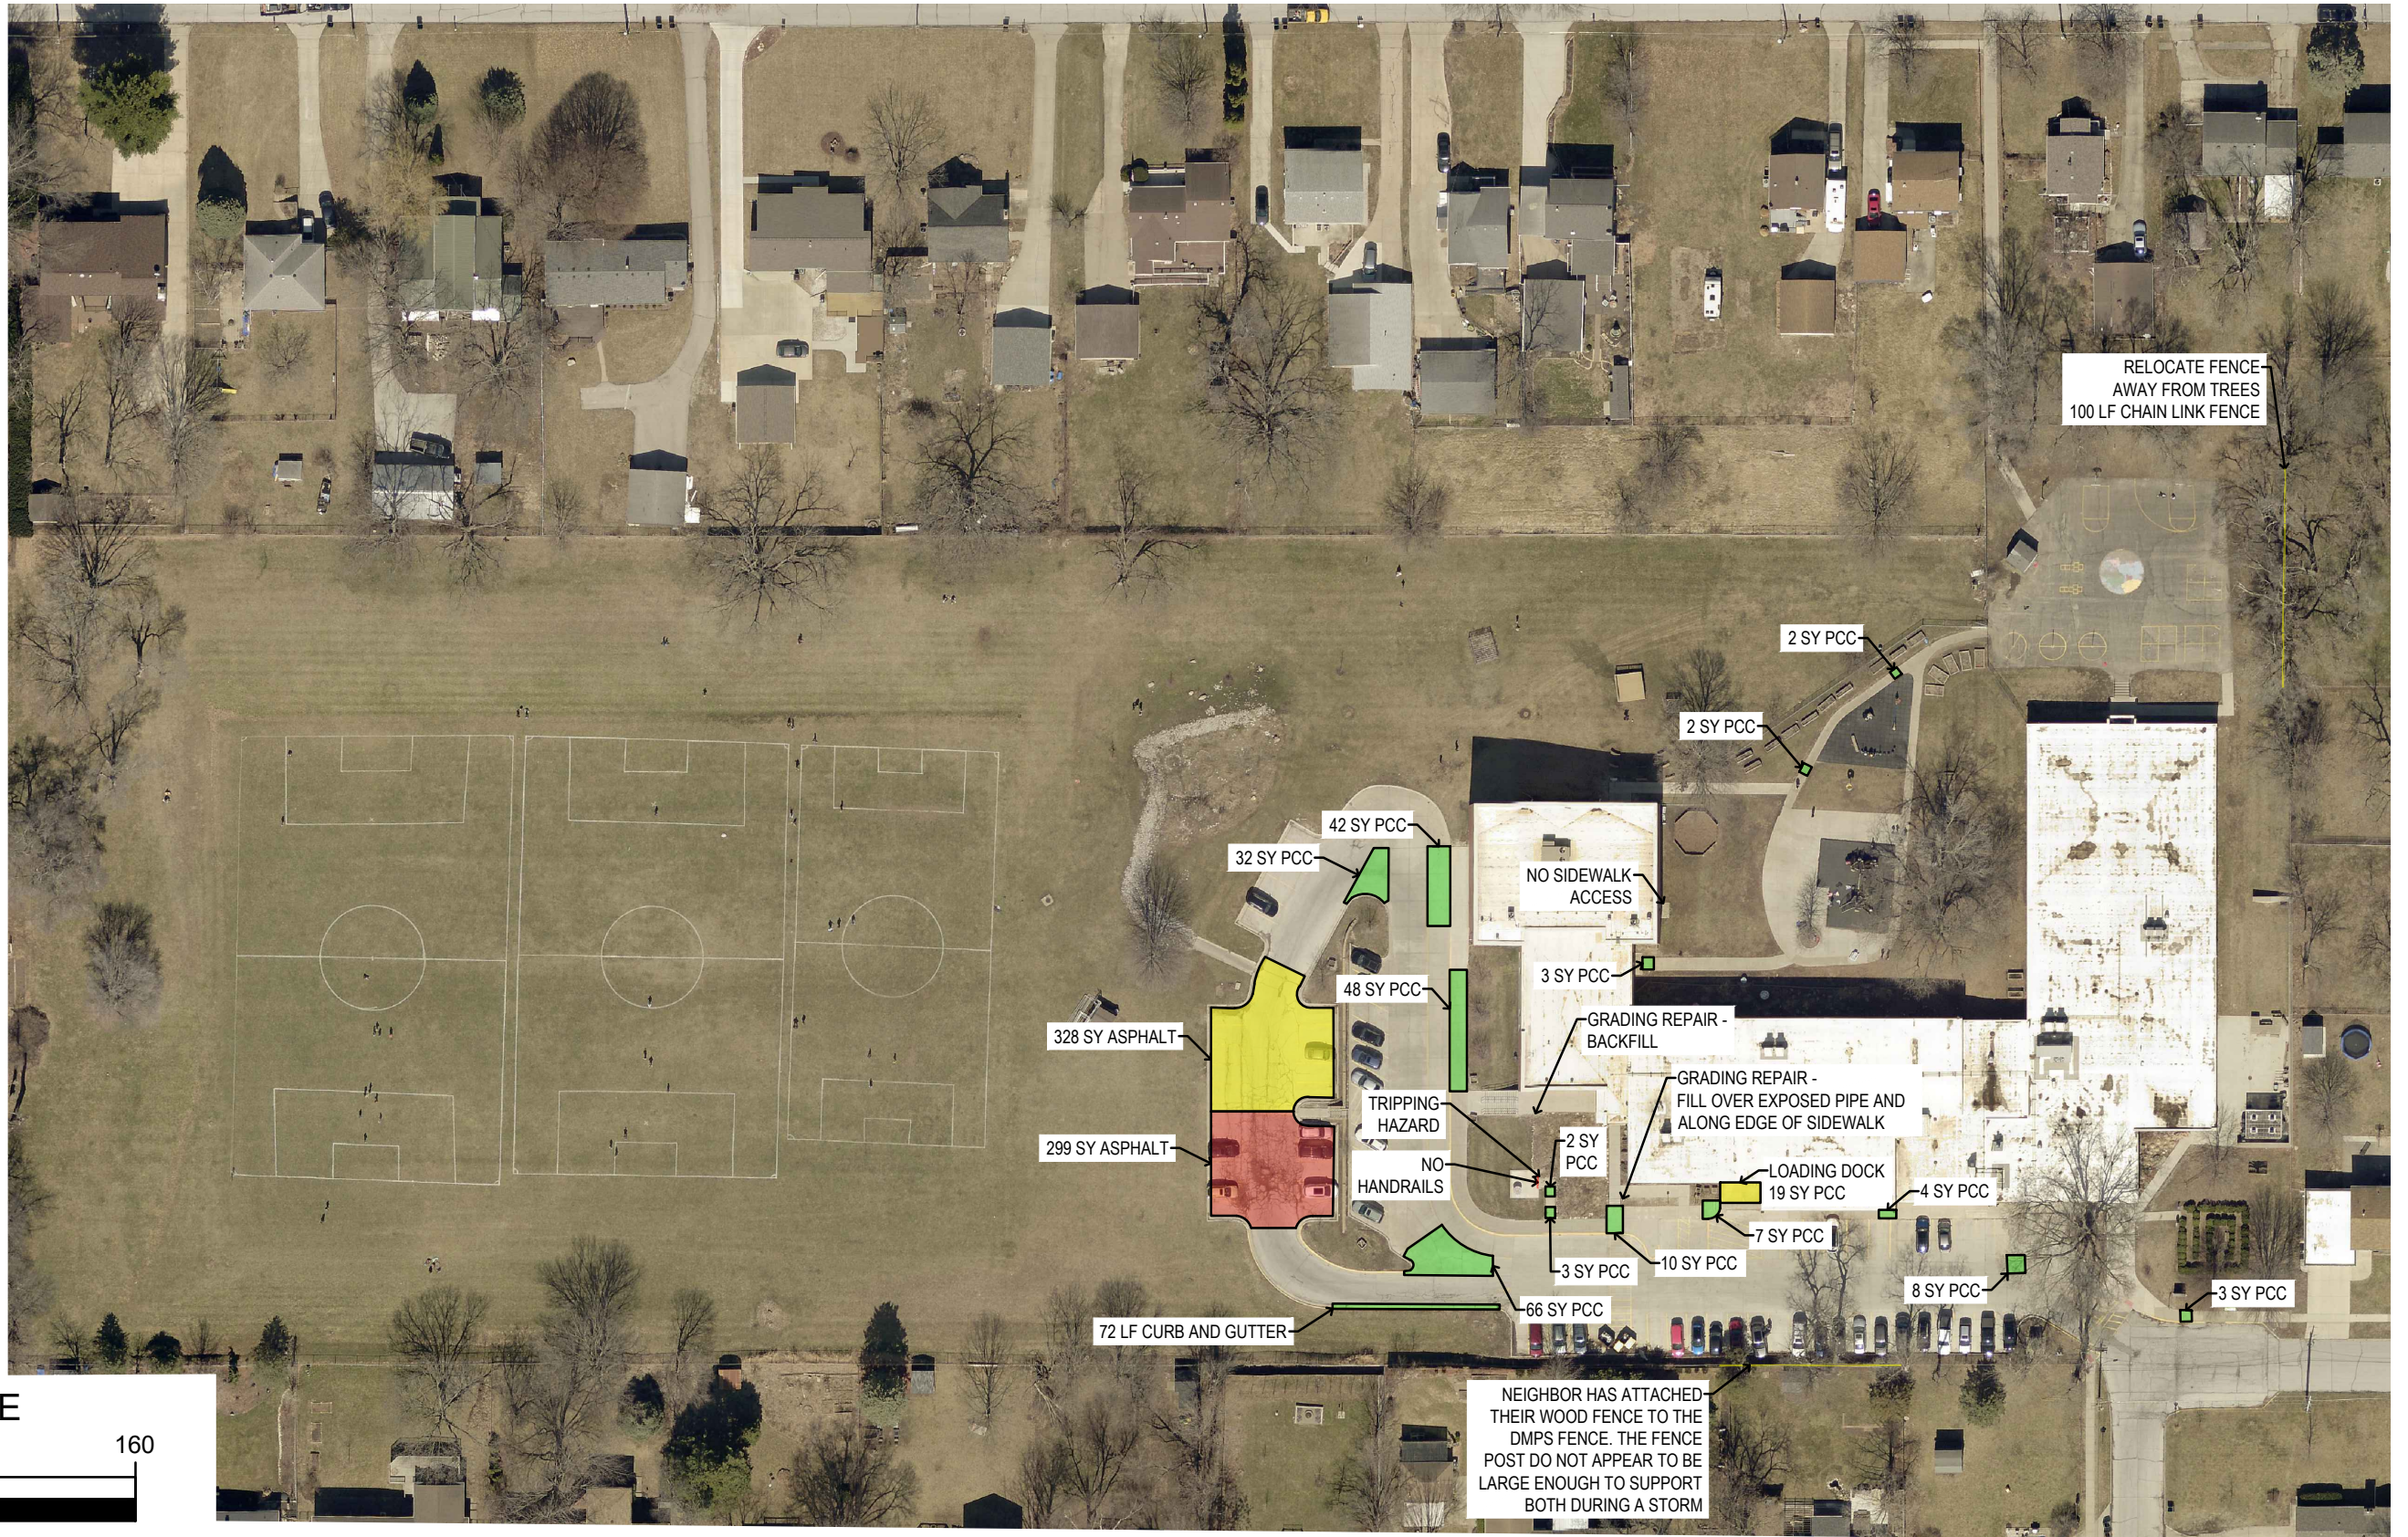
Playground Pavement Replacement	Remove and replace 299 SY of asphalt. For location, refer to civil site plan exhibit found in the appendix of this report.	\$40,000

Repair Curb and Gutter	Return damaged curb and gutters to new condition. Approximately 72 LF of 6" curbs. For locations, refer to civil site plan exhibit found in the appendix of this report.	\$12,000
Parking Pavement Replacement	Remove and replace 140 SY of PCC. For location, refer to civil site plan exhibit found in the appendix of this report.	\$25,000
Sidewalk Repair	Repair damaged sidewalks across the site. Approximately 84 SY. For locations, refer to civil site plan exhibit found in the appendix of this report.	\$20,000

- 5+ YEAR REPLACEMENT
- 3-4 YEAR REPLACEMENT
- 1-2 YEAR REPLACEMENT
