DMPS FACILITY ASSESSMENT |

EXECUTIVE BUILDING SUMMARY

Building Name: **Downtown School**

Date: **4.2.2024**

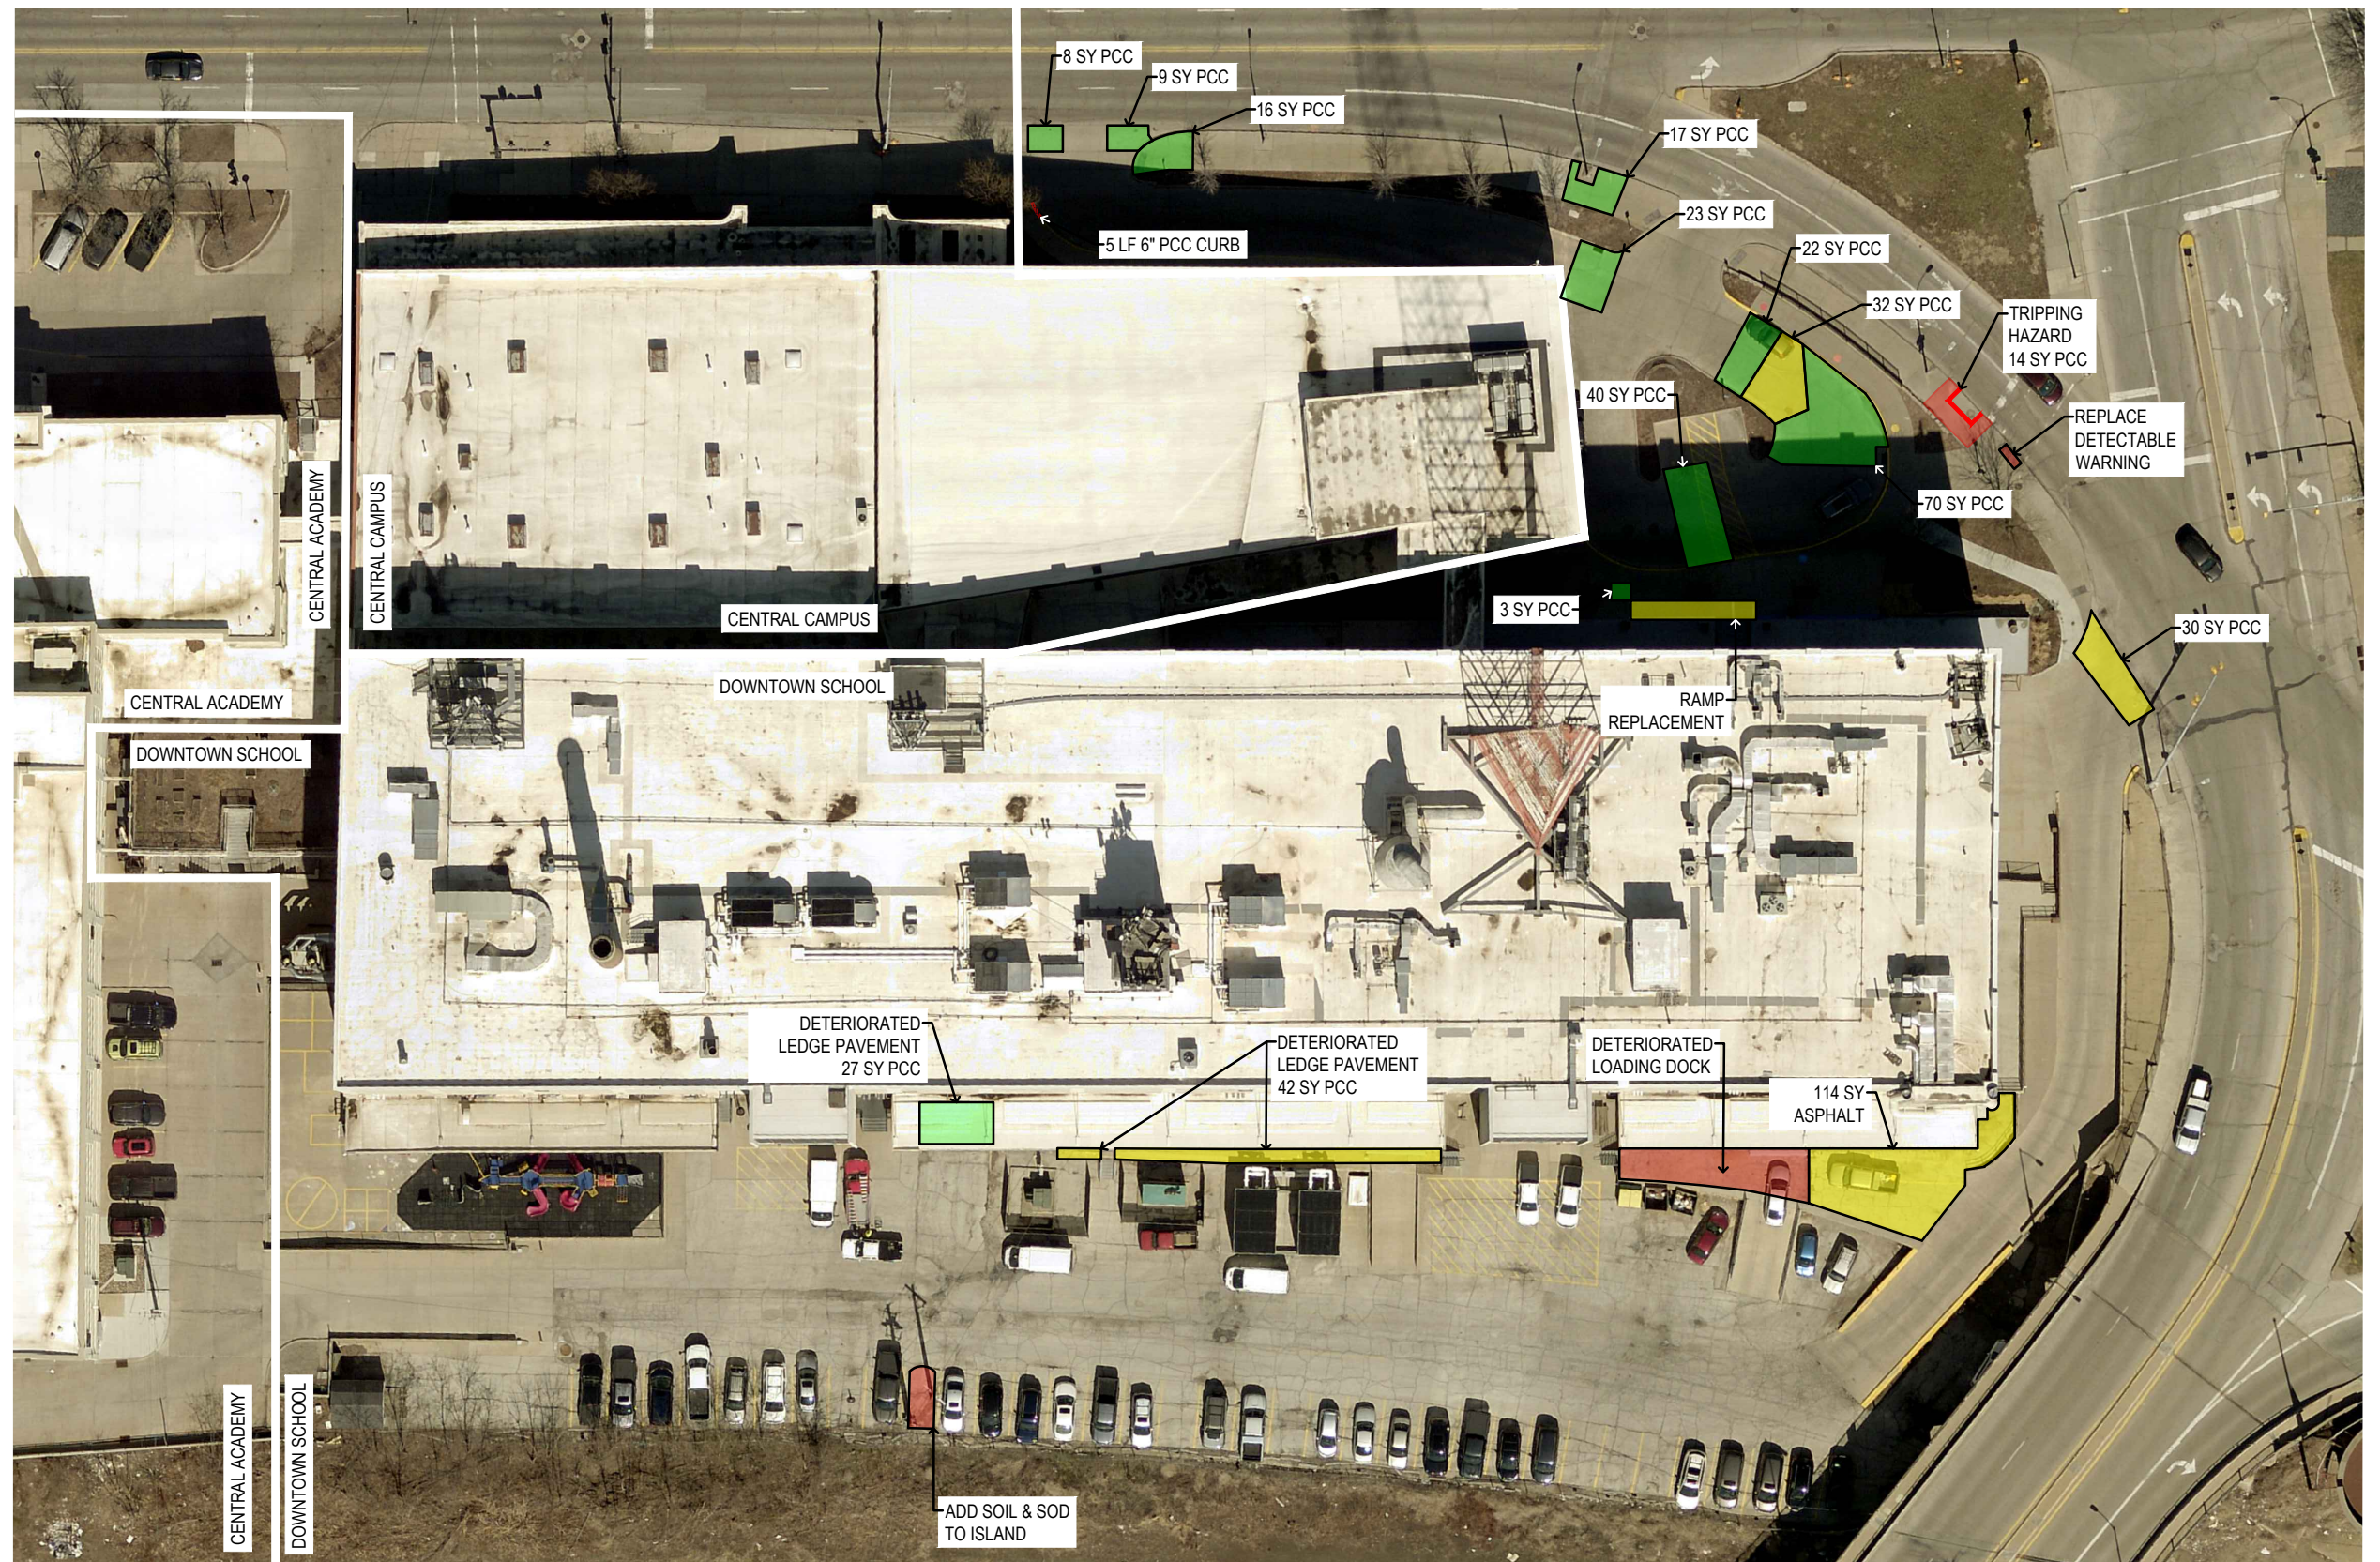
- 5+ YEAR REPLACEMENT
- 3-4 YEAR REPLACEMENT
- 1-2 YEAR REPLACEMENT

Pavement Replacement	Remove and replace 62 SY of PCC and 114 SY of asphalt. For locations, refer to civil site plan exhibit found in the appendix of this report.	\$25,000
Ledge Pavement Repairs	Repair damaged ledge pavement on site. Approximately 42 SY. For locations, refer to civil site plan exhibit found in the appendix of this report.	\$12,000
Ramp Replacement	Replace the deteriorated ADA ramp. For location, refer to civil site plan exhibit found in the appendix of this report.	\$30,000

Pavement Replacement	Remove and replace 164 SY of PCC. For locations, refer to civil site plan exhibit found in the appendix of this report.	\$30,000
Ledge Pavement Repairs	Repair damaged ledge pavement on site. Approximately 27 SY. For locations, refer to civil site plan exhibit found in the appendix of this report.	\$11,000
Sidewalk Repairs	Repair damaged sidewalks across the site. Approximately 44 SY. For locations, refer to civil site plan exhibit found in the appendix of this report.	\$13,000
