DMPS FACILITY ASSESSMENT |

EXECUTIVE BUILDING SUMMARY

Building Name: East High

Date: 2.27.2024

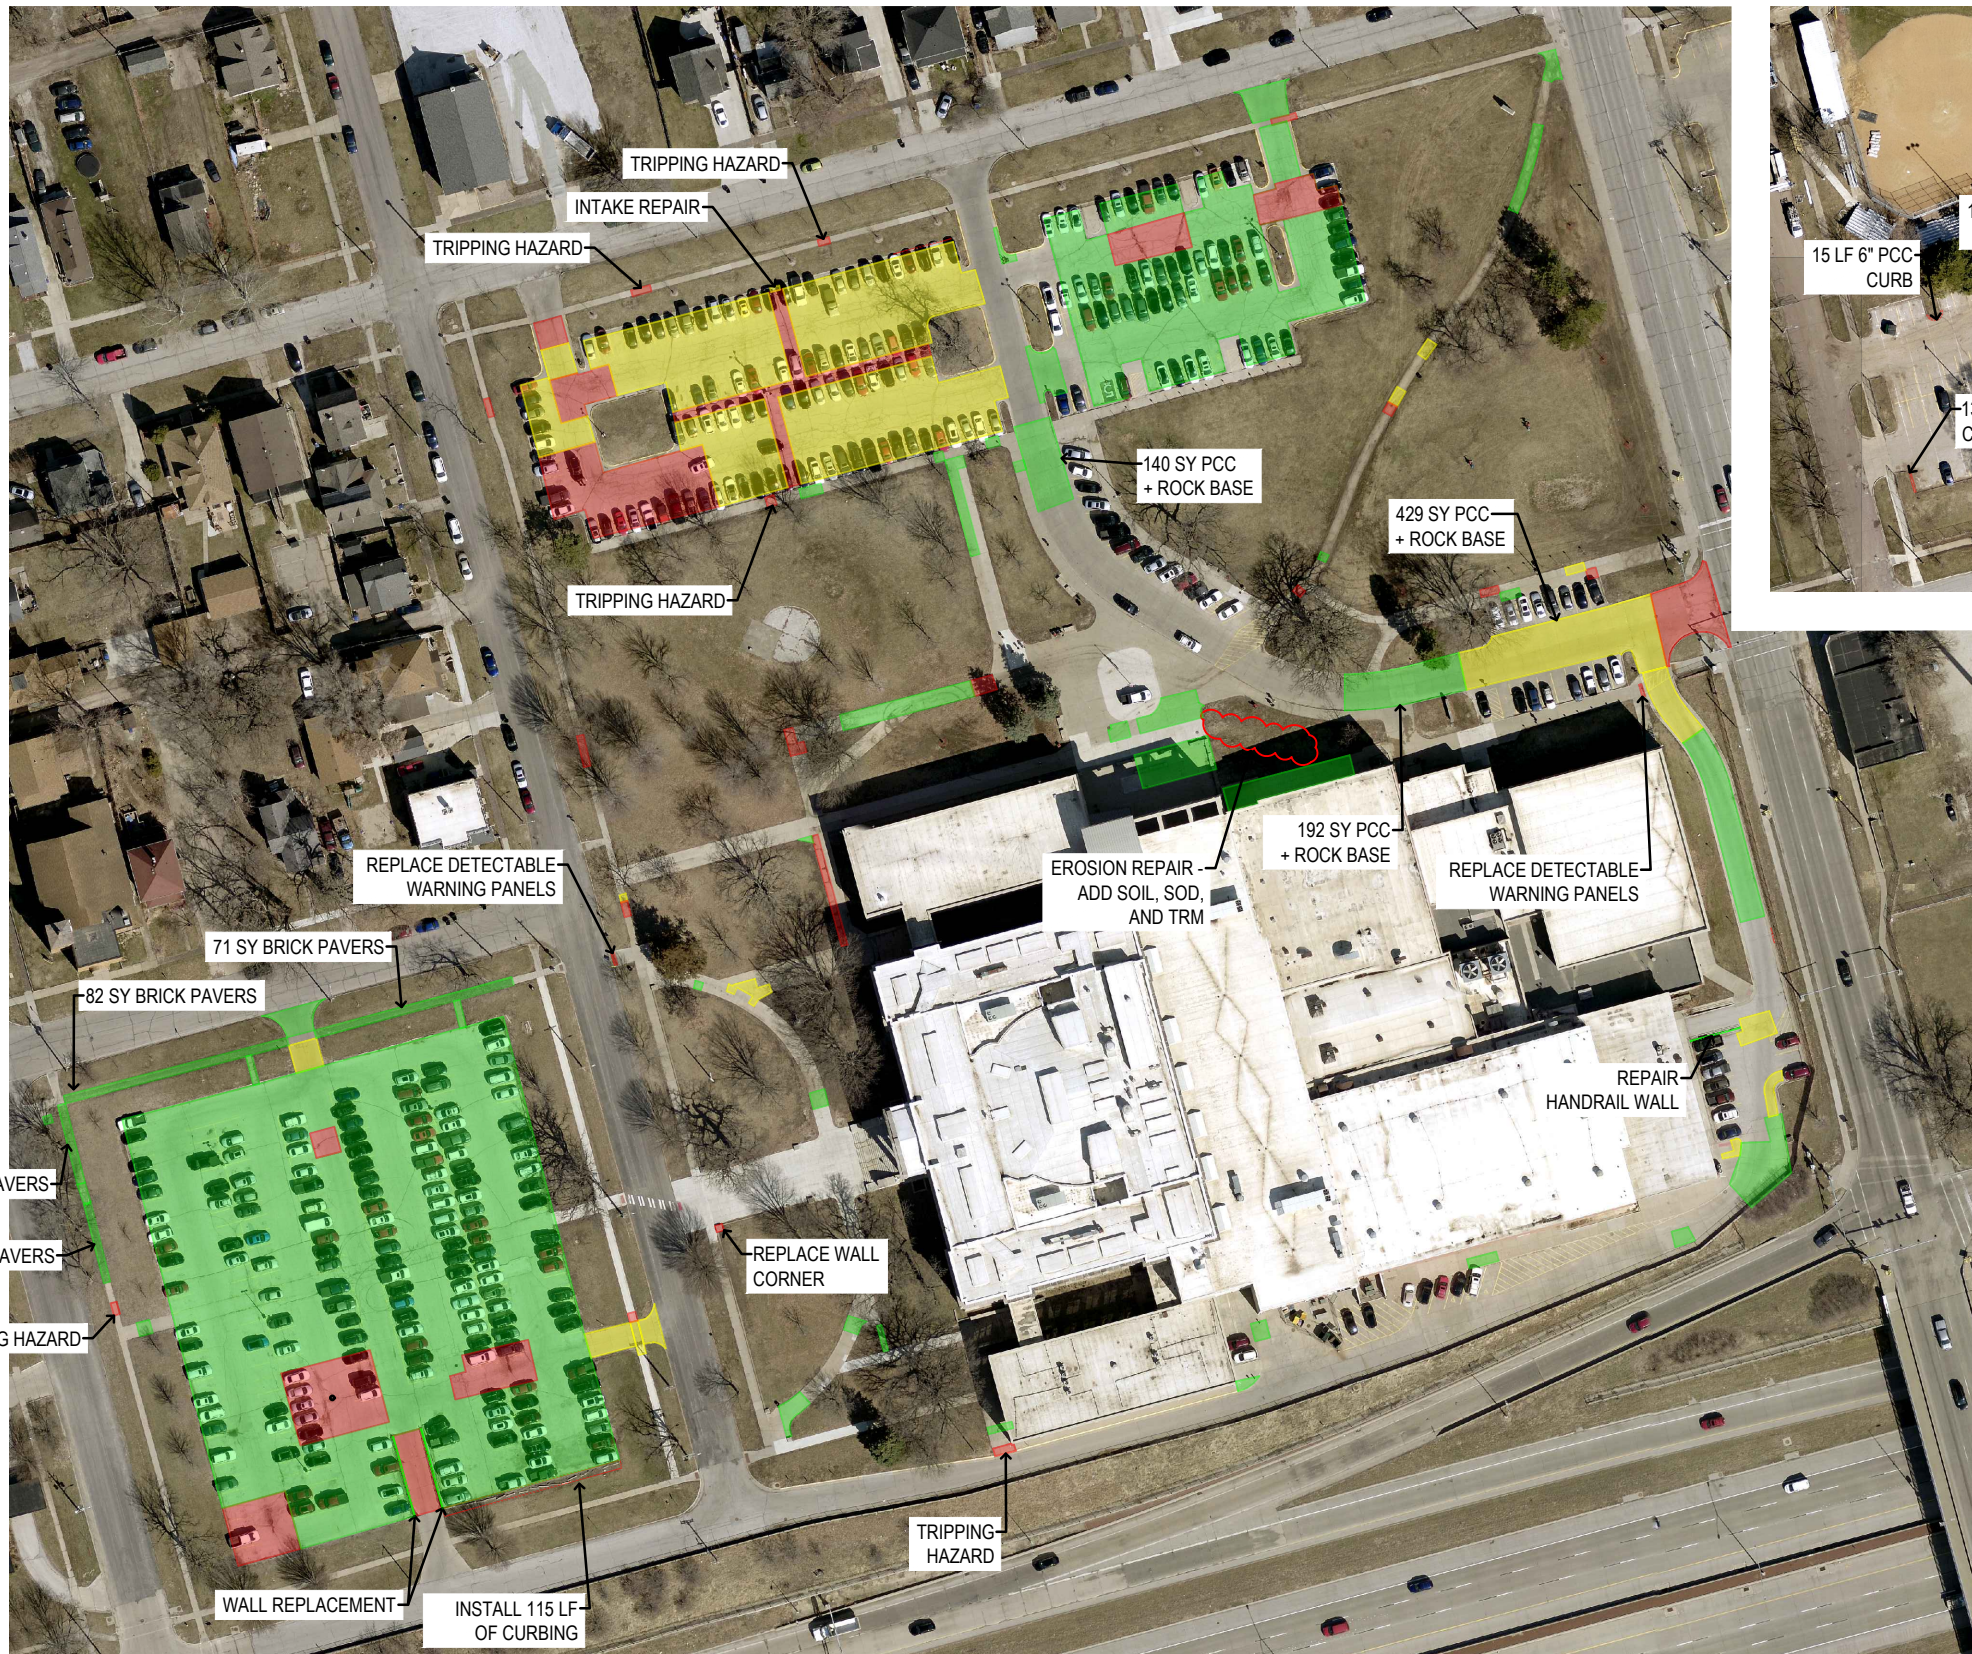
PAVEMENT QUANTITIES (SY)			
	SIDEWALK	PCC	ASPHALT
■	646	850	9177
■	60	578	2624
■	115	166	1869

- 5+ YEAR REPLACEMENT
- 3-4 YEAR REPLACEMENT
- 1-2 YEAR REPLACEMENT

Pavement Replacement	Remove and replace 166 SY of PCC and 1,869 SY of asphalt. For locations, refer to the civil site plan exhibit found in the appendix of this report.	\$270,000
Curb Repairs	Return damaged curbs to new condition. Approximately 79 LF of 6" curbs. For locations, refer to civil site plan exhibit found in the appendix of this report.	\$9,000
Sidewalk Repairs	Repair damaged sidewalks across the site. Approximately 115 SY. For locations, refer to civil site plan exhibit found in the appendix of this report.	\$20,000
Install Curbing	Install 115 LF of curbing to prolong life of pavement and reduce maintenance of parking blocks. For location, refer to the civil site plan exhibit found in the appendix of this report.	\$13,000
Replace Wall Corner	Replace the corner cap of the landscaping wall. For location, refer to the civil site plan exhibit found in the appendix of this report.	\$10,000
