DMPS FACILITY ASSESSMENT |

EXECUTIVE BUILDING SUMMARY

Building Name: **Garton Elementary**

Address: **2820 East 24th Street
Des Moines, IA 50317**

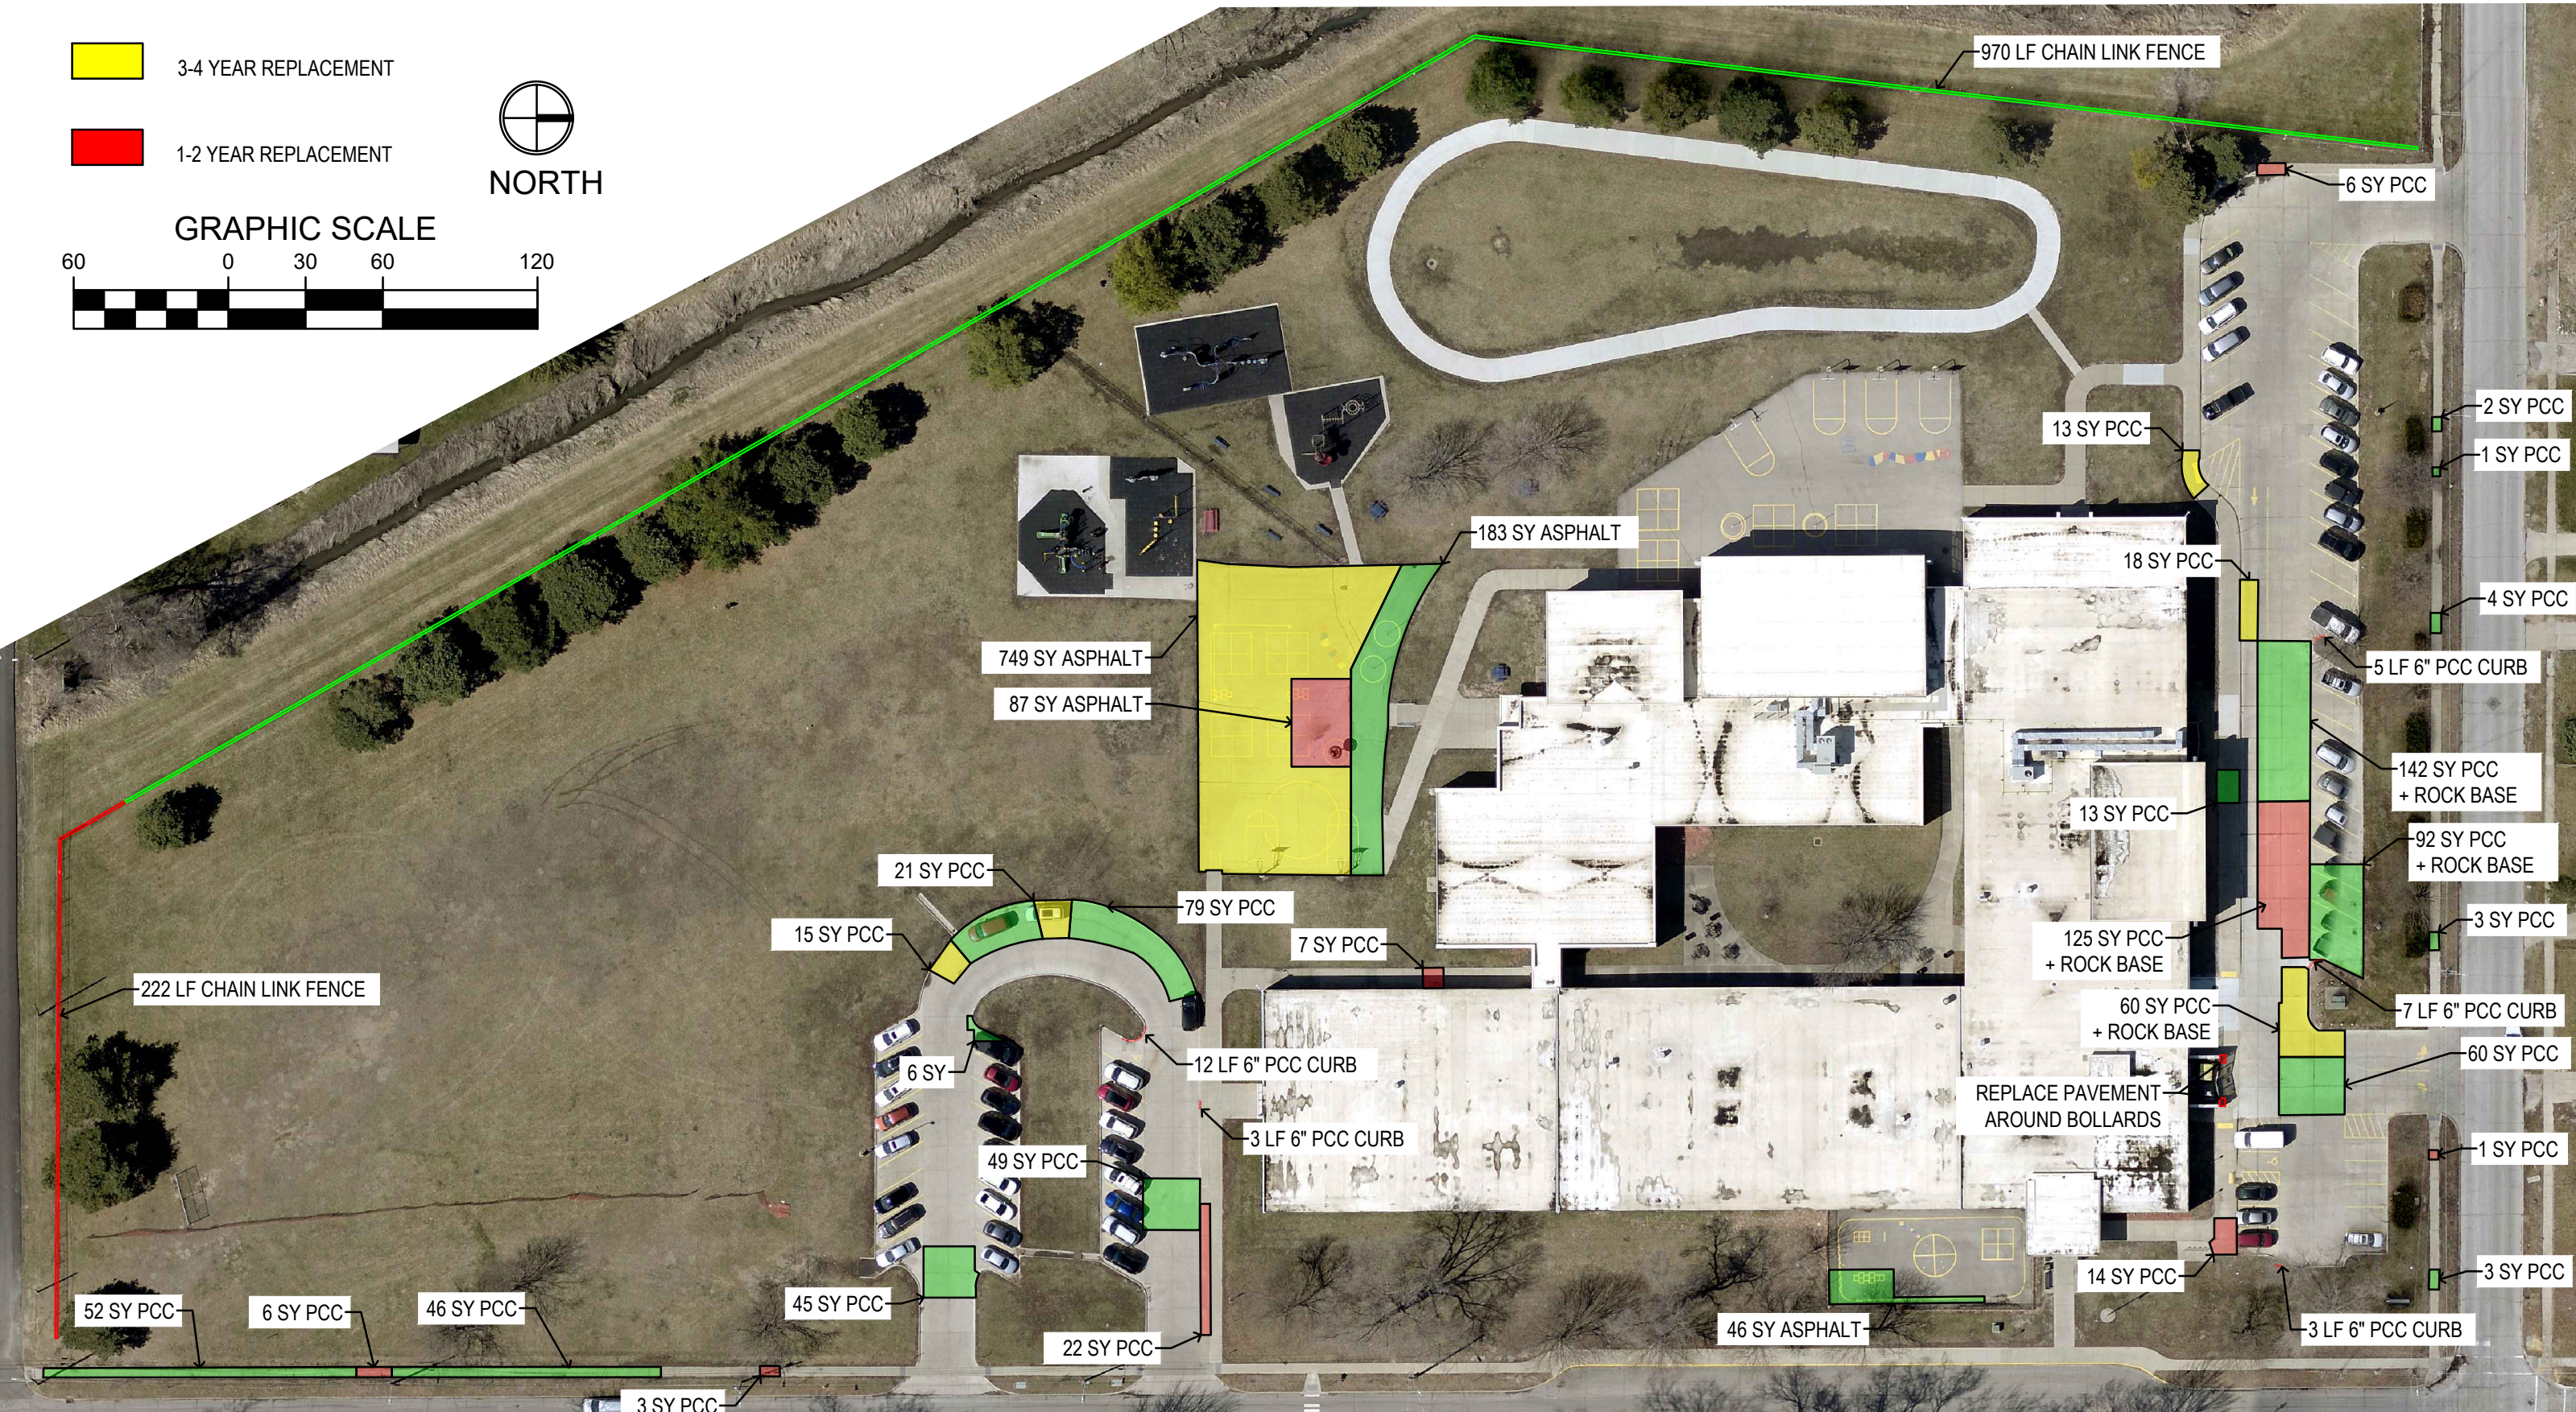
- 5+ YEAR REPLACEMENT
- 3-4 YEAR REPLACEMENT
- 1-2 YEAR REPLACEMENT

Sidewalk Repair	Repair damaged sidewalks across the site. Approximately 124 SY. For locations, refer to civil site plan exhibit found in the appendix of this report.	\$30,000.00
Circulator Pumps for Geoexchange Replacement	Install new circulation pumps and motors, including circulation pump on backup boiler.	\$140,000.00
