# DMPS FACILITY ASSESSMENT | GOODRELL MIDDLE SCHOOL

02.06.2024

# EXECUTIVE BUILDING SUMMARY

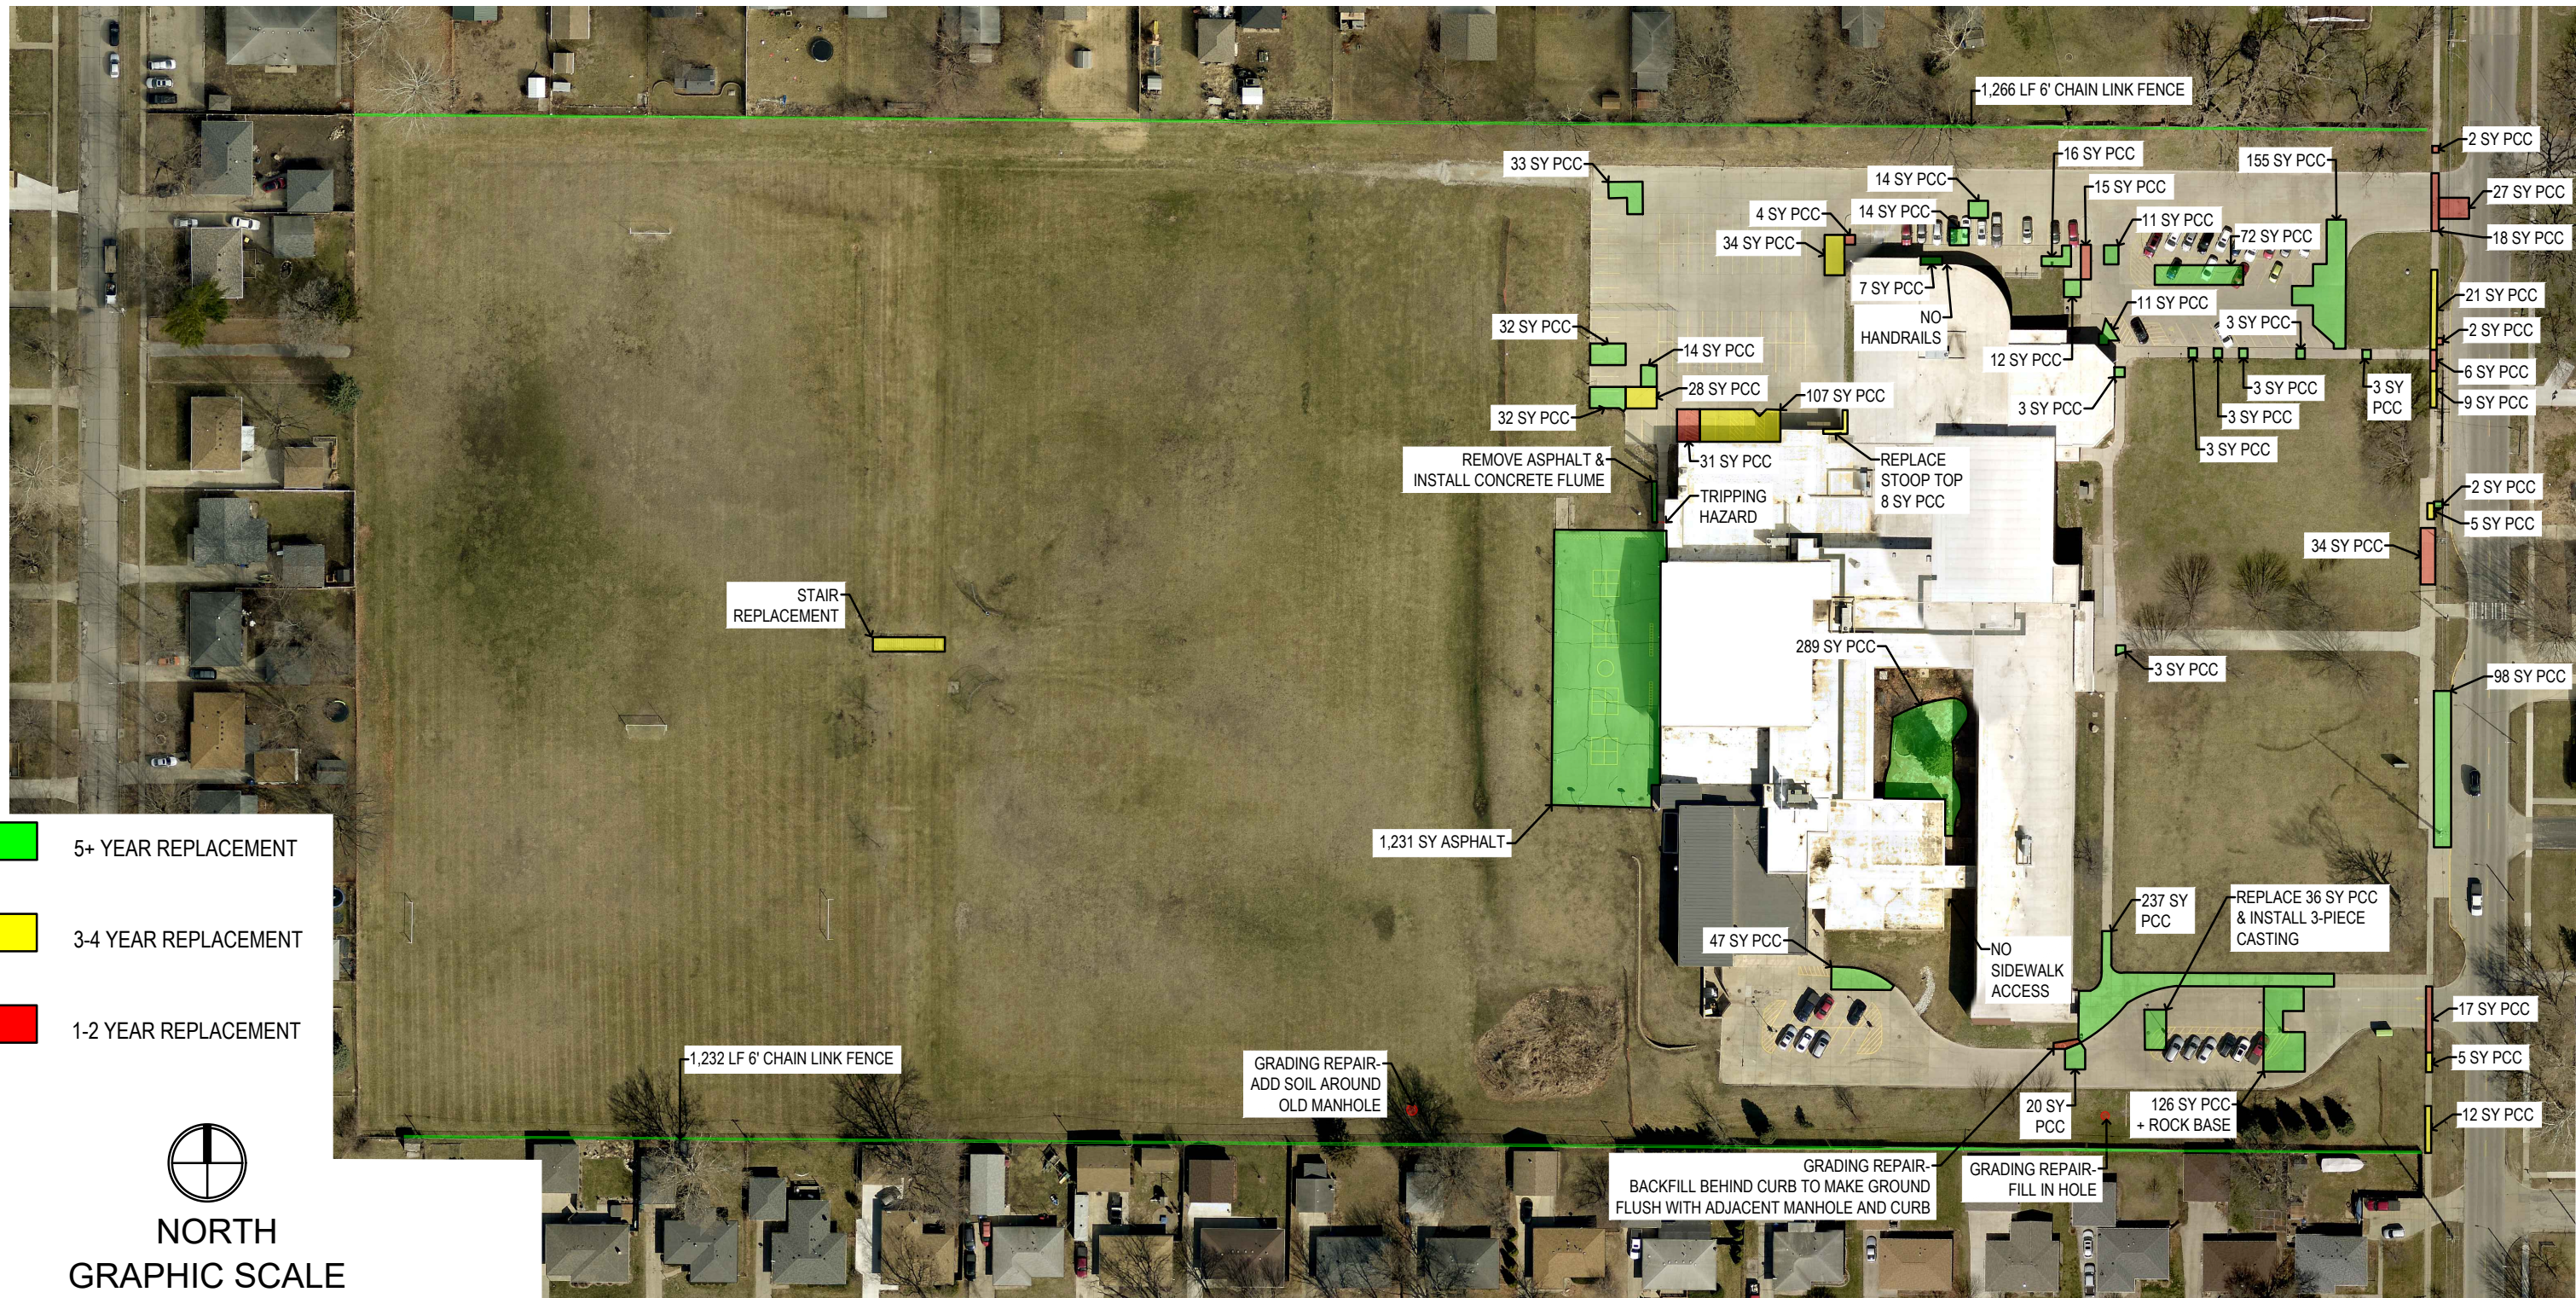
4.2 <b>Parking areas</b> are in good condition.	5	4	20	ADA pavement in the north parking lot needs replacement, a couple of other sections in the north lot need replacement as well. The south parking lot has an area experiencing subsurface moisture issues and would benefit from a rock base.

4.3 <b>Drive areas</b> are in good condition.	3	4	12	The middle section of the drive access to the north parking lot needs replacement, a few panels to replace elsewhere.

4.5 <b>Sidewalks</b> around the facility are in good <b>condition</b> .	1	3	3	The sidewalk along the east side of the school has multiple areas needing replacement and the stairs to the west of the school connecting the upper and lower levels of the open space will also need replacement.

4.7 <b>Hard surface</b> playground surfaces are in good condition.	3	3	9	The asphalt to the west of the building was cracking, and some of the concrete by the basketball hoops will need replacement.

4.8 <b>Fencing</b> around the site is in good condition.	1	2	2	The fence around the open space area appeared old but was still holding up well. The fencing on the north and south sides of the site was getting older and will eventually need replacement. The slats in the fence were also needing replaced in several areas.

EIFS Repair	Widespread deterioration of the EIFS system above the roof requires repair. Full scrape and refinish approx. 2,700 SF around roof areas M, O, and R.	\$60,000
Pavement Replacement	Remove and replace 58 SY of PCC. For location, refer to the civil site plan exhibit found in the appendix of this report.	\$12,000
Sidewalk Repairs	Repair damaged sidewalks across the site. Approximately 98 SY. For locations, refer to civil site plan exhibit found in the appendix of this report.	\$20,000

Pavement Replacement	Remove and replace 169 SY of PCC. For location, refer to the civil site plan exhibit found in the appendix of this report.	\$25,000

Sidewalk Repairs	Repair damaged sidewalks across the site. Approximately 55 SY. For locations, refer to civil site plan exhibit found in the appendix of this report.	\$13,000
Stair Replacement	Remove and replace deteriorated staircase. For location, refer to the civil site plan exhibit found in the appendix of this report.	\$45,000
Heat Pump Replacement	Replace heat pump that are original and consider using two speed heat pump to better match load.	\$3,200,000
Bring Natural Gas to Building	Extend natural gas utility service to the building. This is required to support the project related to ERV replacement and boiler replacement. (Note that the majority of this cost is borne by Mid-American with the intention being that they will re-coup this cost as with gas bills.)	\$20,000
ERV Replacement	Replace all existing DOAS/ERV units with gas heat and DX cooling. Will require gas service to be added to the building site.	\$3,100,000

Roof Replacement	Remove approx. 87,500 SF of PVC roofing and insulation over entire roof. Install code compliant insulation and TPO roofing. Approx. 2031 or 2032.	\$2,800,000
Pavement Replacement	Remove and replace 595 SY of PCC and install a rock base under the 126 SY experiencing subsurface moisture issues. For location, refer to the civil site plan exhibit found in the appendix of this report.	\$100,000
Sidewalk Repairs	Repair damaged sidewalks across the site. Approximately 693 SY. For locations, refer to civil site plan exhibit found in the appendix of this report.	\$160,000

Playground Pavement Replacement	Take out and restore deteriorated playground asphalt. Approximately 1,2313 SY. For locations, refer to civil site plan exhibit found in the appendix of this report.	\$220,000
Fence Replacement	Remove and replace 2,498 LF of 6' chain link fence. For locations, refer to civil site plan exhibit found in the appendix of this report.	\$330,000
Manhole Casting Replacement	Replace the existing manhole casting with a 3-piece casting to prevent future pavement damage. For location, refer to civil site plan exhibit found in the appendix of this report.	\$11,000
