# DMPS FACILITY ASSESSMENT | GREENWOOD ELEMENTARY

12.6.2023

# EXECUTIVE BUILDING SUMMARY

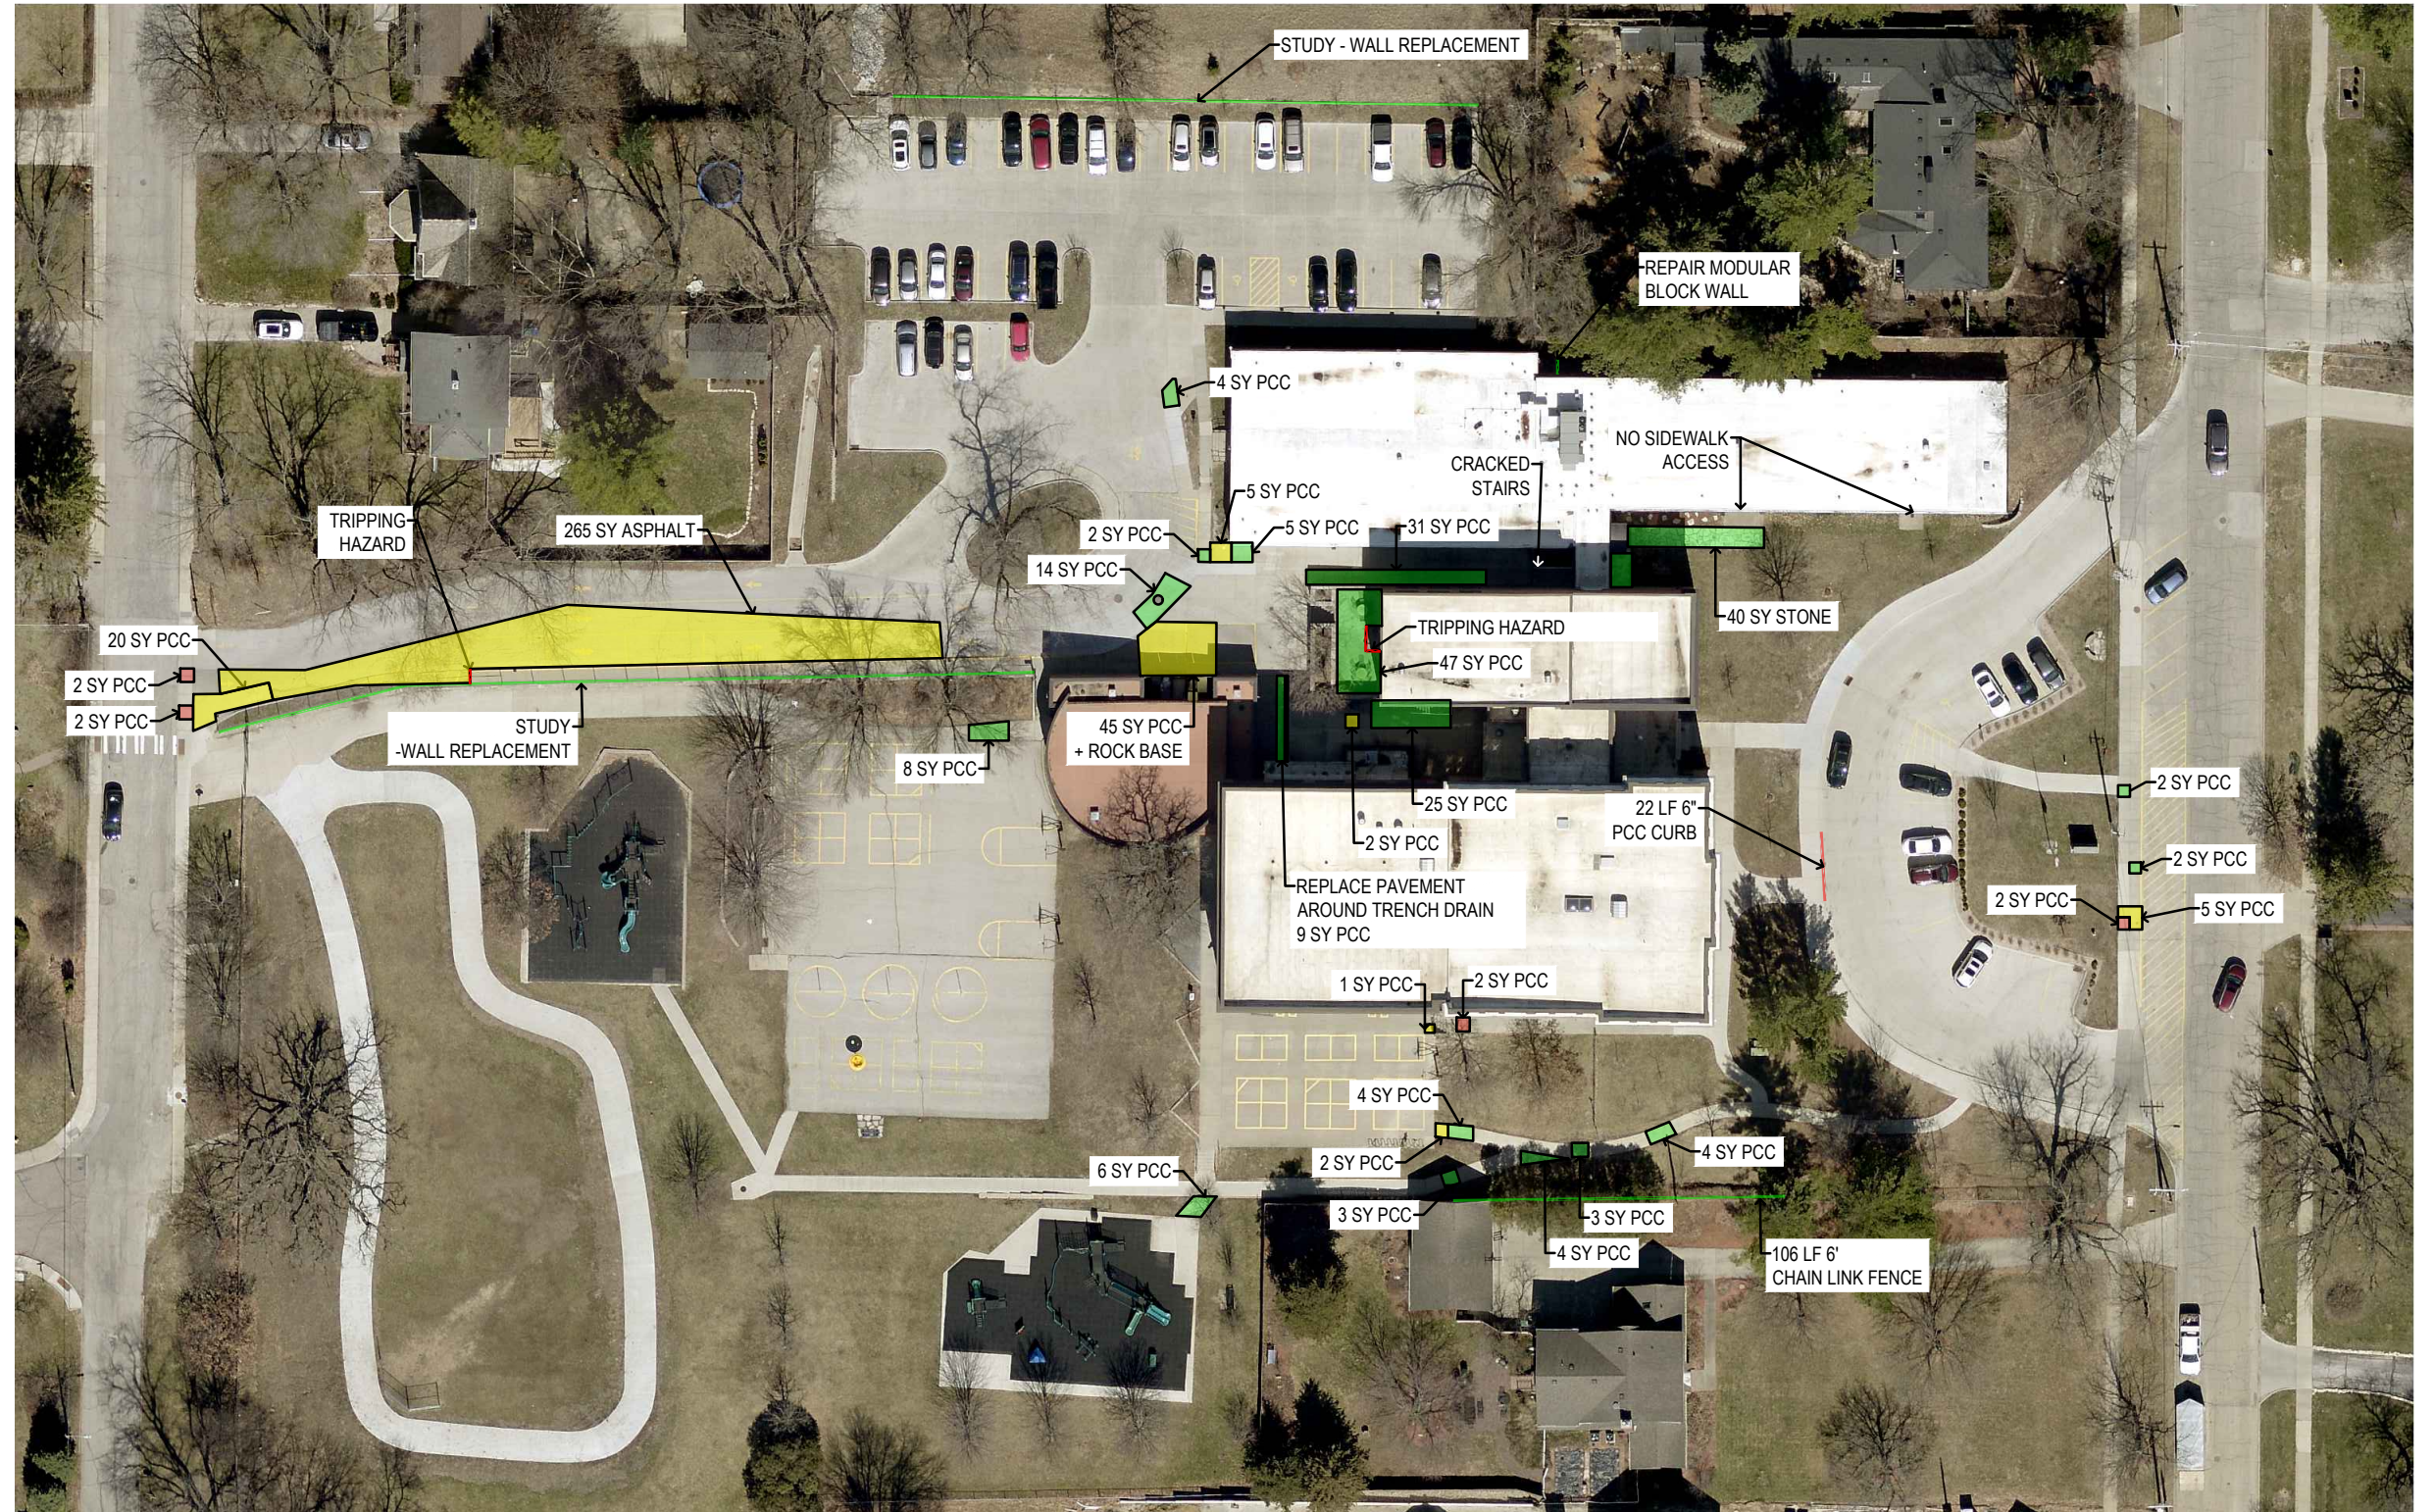
- 5+ YEAR REPLACEMENT
- 3-4 YEAR REPLACEMENT
- 1-2 YEAR REPLACEMENT

Parking Pavement Replacement	Remove and replace 265 SY of asphalt. Remove, replace, and reinforce 45 SY of pavement in front of trash enclosure and install a rock base. For locations, refer to civil site plan exhibit found in the appendix of this report.	\$50,000
Sidewalk Repair	Repair damaged sidewalks across the site. Approximately 37 SY. For locations, refer to civil site plan exhibit found in the appendix of this report.	\$11,000
Concrete Column Repairs	Concrete patch repairs are recommended for exposed exterior concrete columns of the NE classroom wing. Removal of de-laminated concrete is required down to sound concrete, in addition, rust removal cleaning of exposed rebar will be necessary prior to concrete patch application. Columns are 12" x 12" x 10' tall and a total of 5 columns will need repairs. Concrete patch repair is assumed to be for the full exterior face of the columns at a depth of 3". Patch stucco finish at upper walls of this wing (25 SF) and repaint concrete/stucco on entire wing. (1800 SF paint.)	\$35,000

Parking Pavement Replacement	Remove and replace 14 SY of PCC. For location, refer to civil site plan exhibit found in the appendix of this report.	\$8,000
Sidewalk Repair	Repair damaged sidewalks and stone path on site. Approximately 159 SY of sidewalk and 40 SY of stone. For locations, refer to civil site plan exhibit found in the appendix of this report.	\$45,000
Fencing Replacement	Remove and replace 106 LF of chain link fence. For location, refer to civil site plan exhibit found in the appendix of this report.	\$15,000
