# DMPS FACILITY ASSESSMENT | HANAWALT ELEMENTARY

12.6.2023

# EXECUTIVE BUILDING SUMMARY

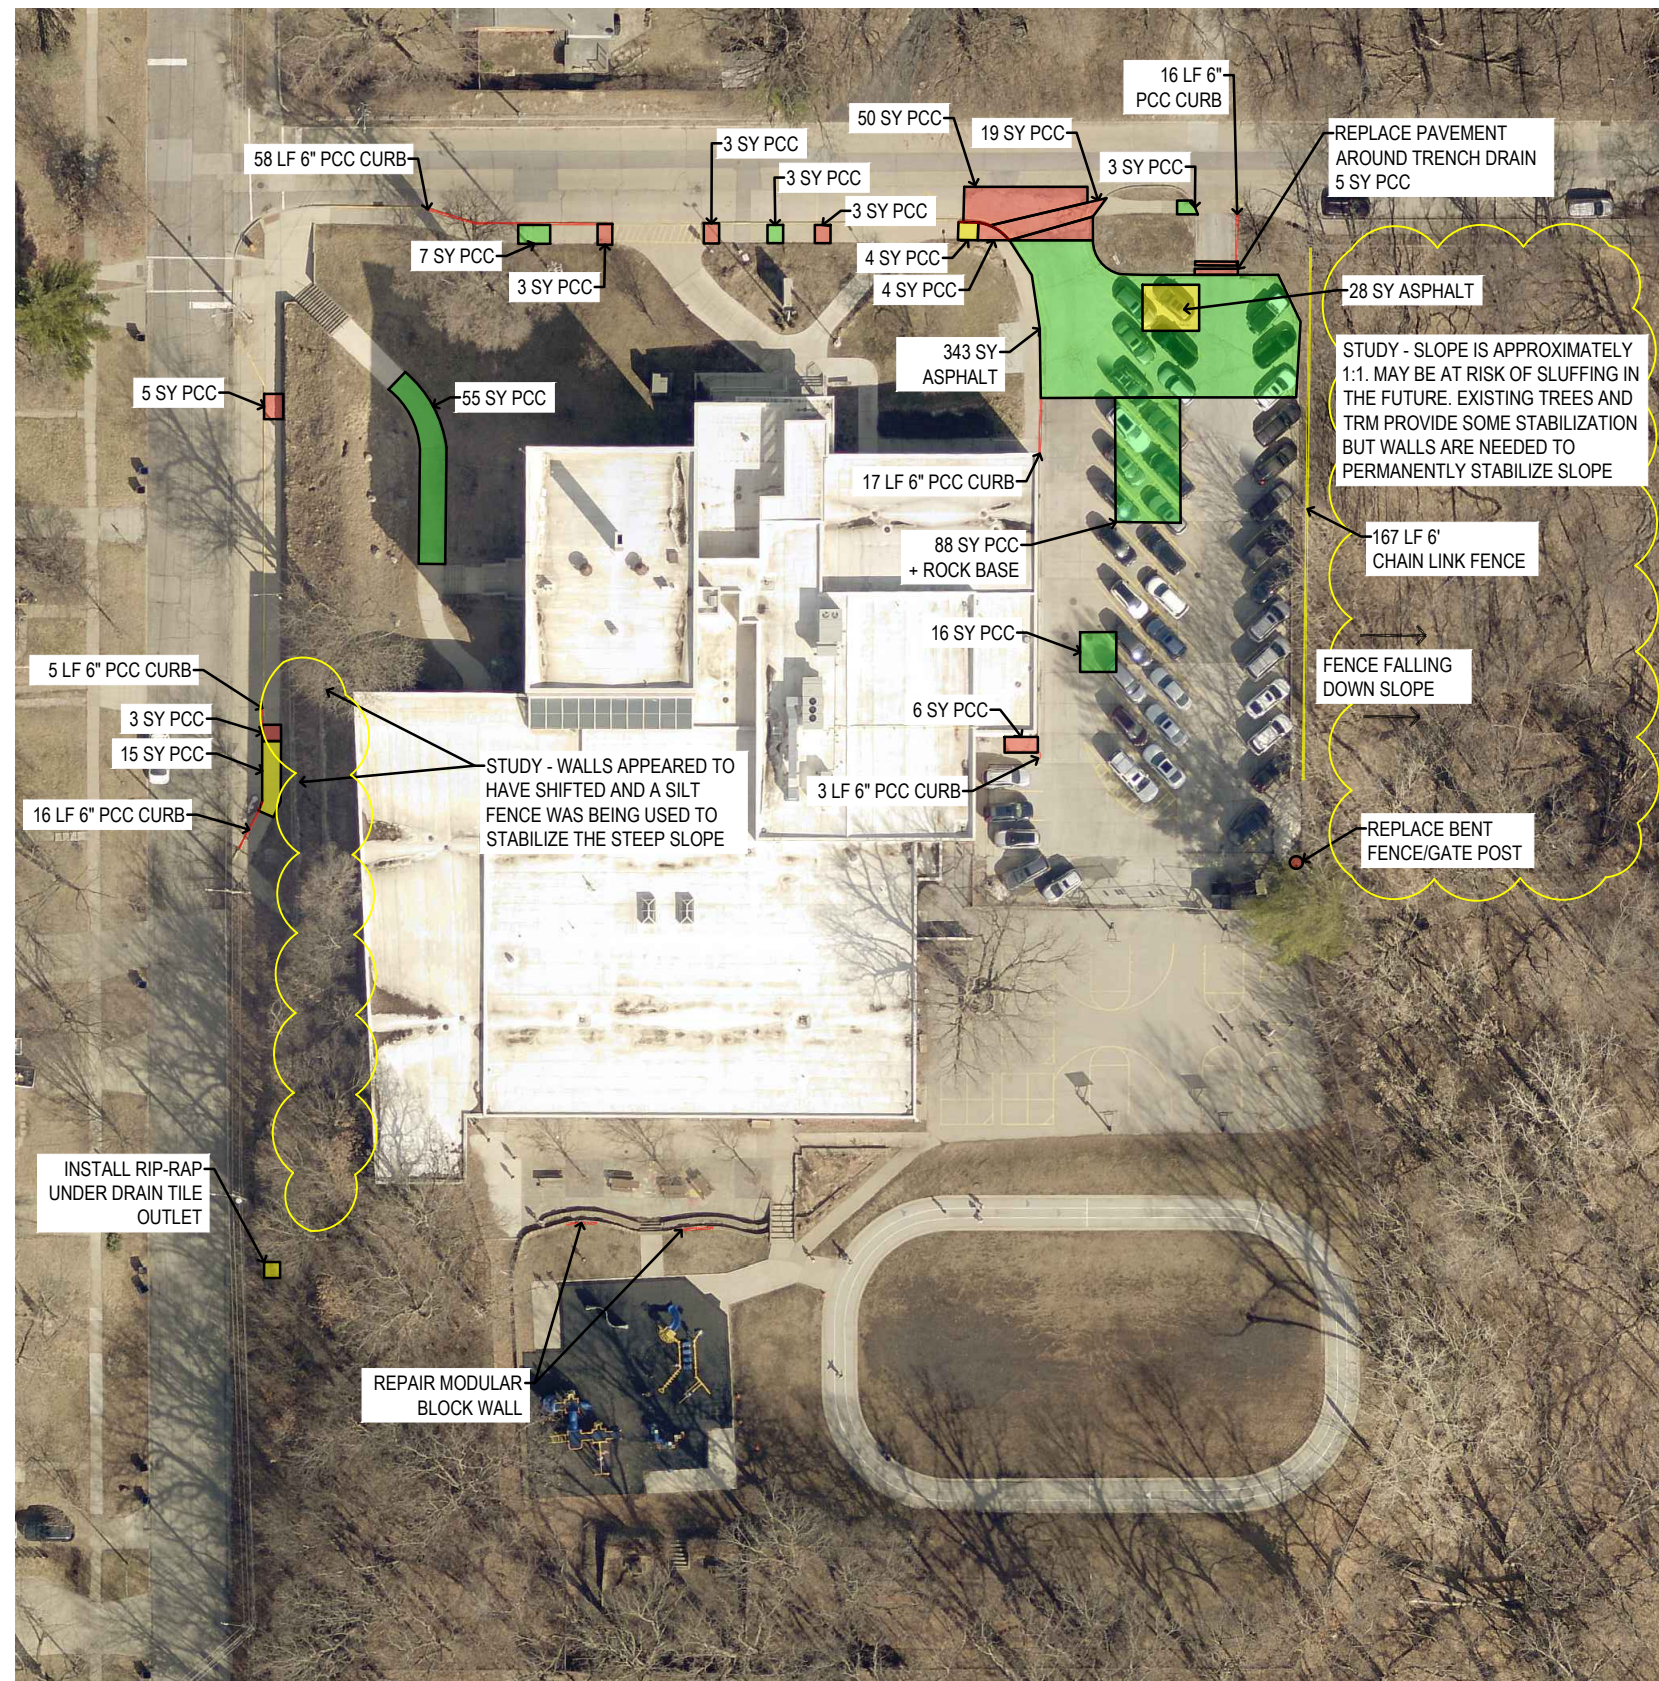
- 5+ YEAR REPLACEMENT
- 3-4 YEAR REPLACEMENT
- 1-2 YEAR REPLACEMENT

Modular Block Wall Repair	Disassemble and repair sections of modular block wall. For location, refer to civil site plan exhibit found in the appendix of this report.
Fence Post Replacement	Remove and replace the bent and unconnected fence/gate post. For location, refer to civil site plan exhibit found in the appendix of this report.
Filter Replacement	Replace filters throughout the building with properly sized filters. Multiple locations observed where 1" filter installed in 2" rack at heat pumps leaving openings around filter.

Parking Pavement Replacement	Remove and replace 55 SY of PCC. For locations, refer to civil site plan exhibit found in the appendix of this report.	\$12,000
Sidewalk Repair	Repair damaged sidewalks across the site. Approximately 42 SY. For locations, refer to civil site plan exhibit found in the appendix of this report.	\$11,000
Curb Repair	Return damaged curbs to new condition. Approximately 115 LF of 6" curbs. For locations, refer to civil site plan exhibit found in the appendix of this report.	\$11,000
Stoop Installation	Add a stoop at the exterior door between rooms 110 & 111. Stoop is 4ft x 8ft. 8" thick stoop walls, 42" deep. Reinforce w/ #4 bars @ 12" o.c. each way. 5" thick slab w/ #4 @ 9" o.c. each way.	\$8,000
Stair Railing Replacement.	The stair railings going from the 2nd to 3rd floor are wobbly. They might be able to be re-attached, or may need to be replaced. 48 total feet of railing. Estimated project cost is for replacement.	\$30,000

Exterior Sealant Replacement	Reseal flashing joint at head of large skylight Roof K. Approximately 52 LF of sealant.	\$6,000
Ventilator Replacement	Replace (2) ventilators on Roof I. Existing units are significantly rusted.	\$20,000
Masonry Repointing	Repoint masonry chimney on original building, or remove entirely if no longer in use. Approximately 480 SF of repointing.	\$13,000
Pavement Replacement	Remove and replace 28 SY of asphalt. For locations, refer to civil site plan exhibit found in the appendix of this report.	\$9,000
Sidewalk Repair	Repair damaged sidewalks across the site. Approximately 19 SY. For locations, refer to civil site plan exhibit found in the appendix of this report.	\$9,000
Fencing Replacement	Remove and replace 167 LF of chain link fence. For locations, refer to civil site plan exhibit found in the appendix of this report.	\$20,000

Drainage Repair	Install rip-rap under the drain tile outlet to prevent further erosion. For location, refer to civil site plan exhibit found in the appendix of this report.	\$7,000
Concrete Retaining Wall Replacement	Replace retaining walls at the northwest corner of the property around the stairs. There is about 15ft of 6" thick x 4ft tall wall. Reinforce w/ #5 bars @ 18" o.c. both ways. There is about 35ft of 8" thick wall x 4ft tall. Reinforce w/ #5 bars @ 12" o.c. both ways. The walls will have a footing underneath them that is 3ft wide, 12" thick. Footing reinforced with #5 @ 12" o.c. each way. The stairs will need to be replaced when the walls are torn out. The stairs are 6ft wide, 15 ft. long, with 15 risers.	\$30,000
Replace Heat Pumps	Replace heat pumps that were installed in 2005 and have not yet been replaced.	\$990,000
