DMPS FACILITY ASSESSMENT | HARDING MIDDLE SCHOOL

02.13.2024

EXECUTIVE BUILDING SUMMARY

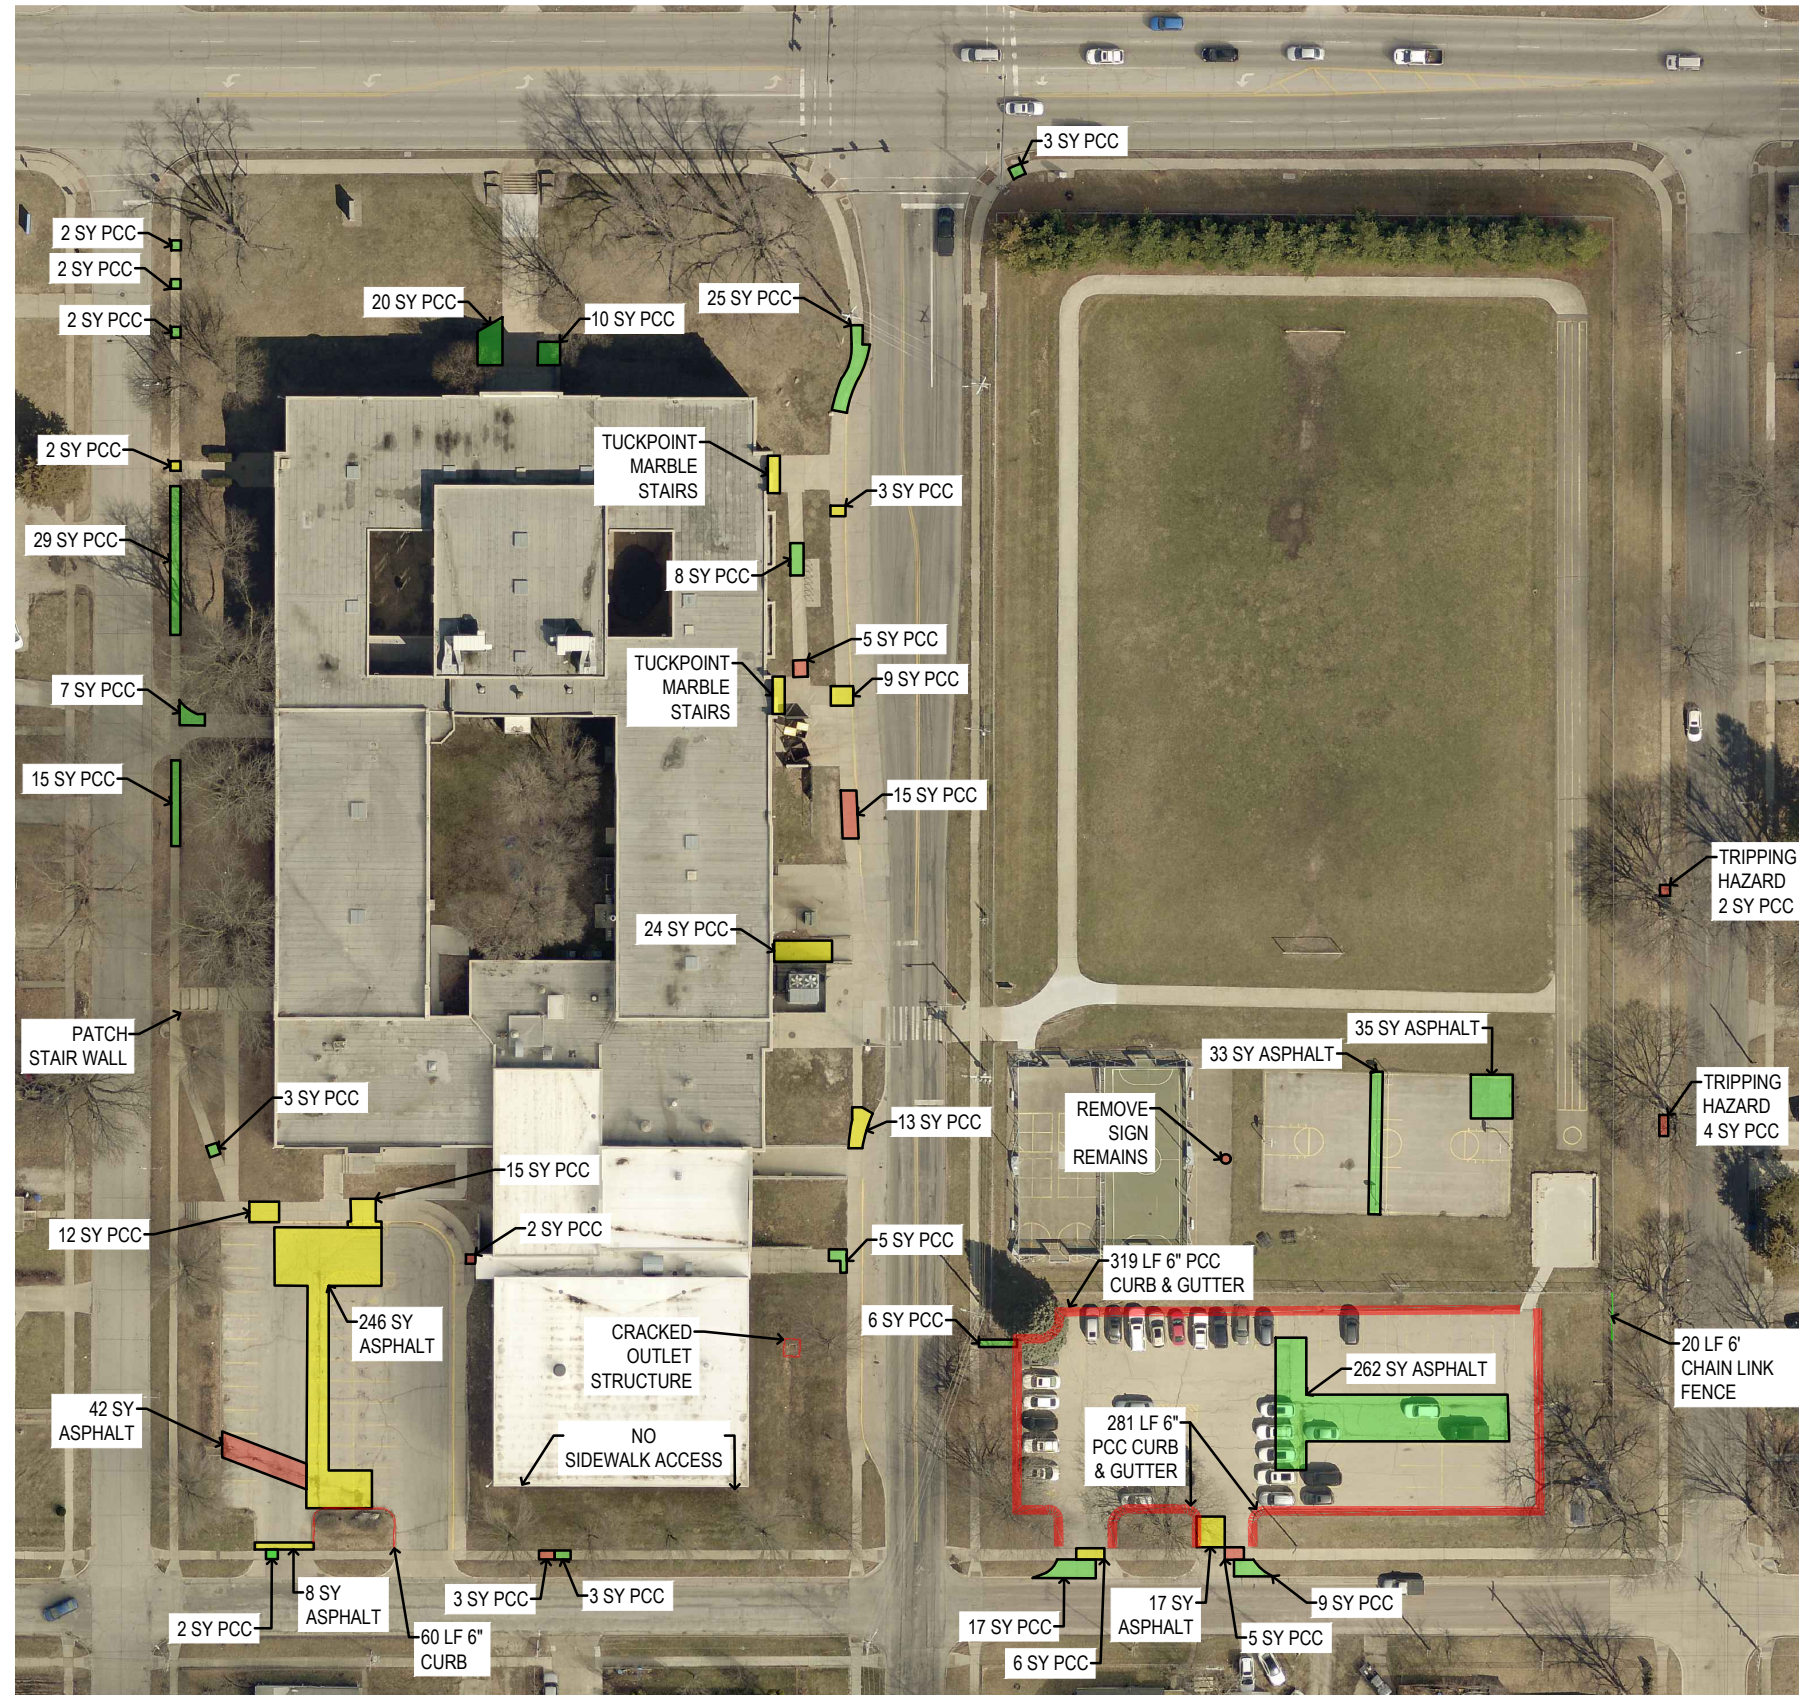
4.2 Parking areas are in good condition.	5	4	20	Some areas of asphalt are cracking in both the west and east lots but the majority of parking pavement appeared to be in good condition. The asphalt curbs in the east parking lot have deteriorated and need replacement, we recommend replacement with PCC curb and gutter section.

4.5 Sidewalks around the facility are in good condition .	1	4	4	Isolated sections across site need replacement, the ADA ramp into the parking lot on the south side of the building is wearing away at the joints and needs replacement. The tree roots on the east side of Earl Rodine park have moved the sidewalk and created tripping hazards.

4.7 Hard surface playground surfaces are in good condition.	3	4	12	Some of the basketball asphalt is sagging/cracking and will need replacement, the PCC walk track had a few cracked panels but appeared mostly in good condition. There are remains of what appears to be an old sign to the west of the basketball court that create a tripping hazard & should be removed.

4.8 Fencing around the site is in good condition.	1	4	4	An area of fence by the east parking lot was warped and did not have the fabric extend all the way to the ground, fencing across site appeared to be in good condition otherwise.

Pavement Replacement	Remove and replace 42 SY of asphalt. For location, refer to the civil site plan exhibit found in the appendix of this report.	\$11,000
PCC Curb and Gutter Replacement	Remove 600 LF of asphalt curbs, 2' of adjacent asphalt pavement, and install PCC curb and gutter sections. For location, refer to the civil site plan exhibit found in the appendix of this report.	\$50,000
Curb Repairs	Return damaged curbs to new condition. Approximately 60 LF of 6" curbs. For locations, refer to civil site plan exhibit found in the appendix of this report.	\$8,000
Sidewalk Repairs	Repair damaged sidewalks across the site. Approximately 31 SY. For locations, refer to civil site plan exhibit found in the appendix of this report.	\$10,000
Masonry Partition Wall Removal	The masonry partition wall within room 49 is heavily deteriorated and should be removed. Wall is approximately 10' tall and 24 L.F. long	\$30,000

Fence Replacement	Remove and replace 20 LF of 6' chain link fence. For location, refer to the civil site plan exhibit found in the appendix of this report.	\$8,000
