DMPS FACILITY ASSESSMENT |

EXECUTIVE BUILDING SUMMARY

Building Data Record

Building Name: **Hiatt Middle**

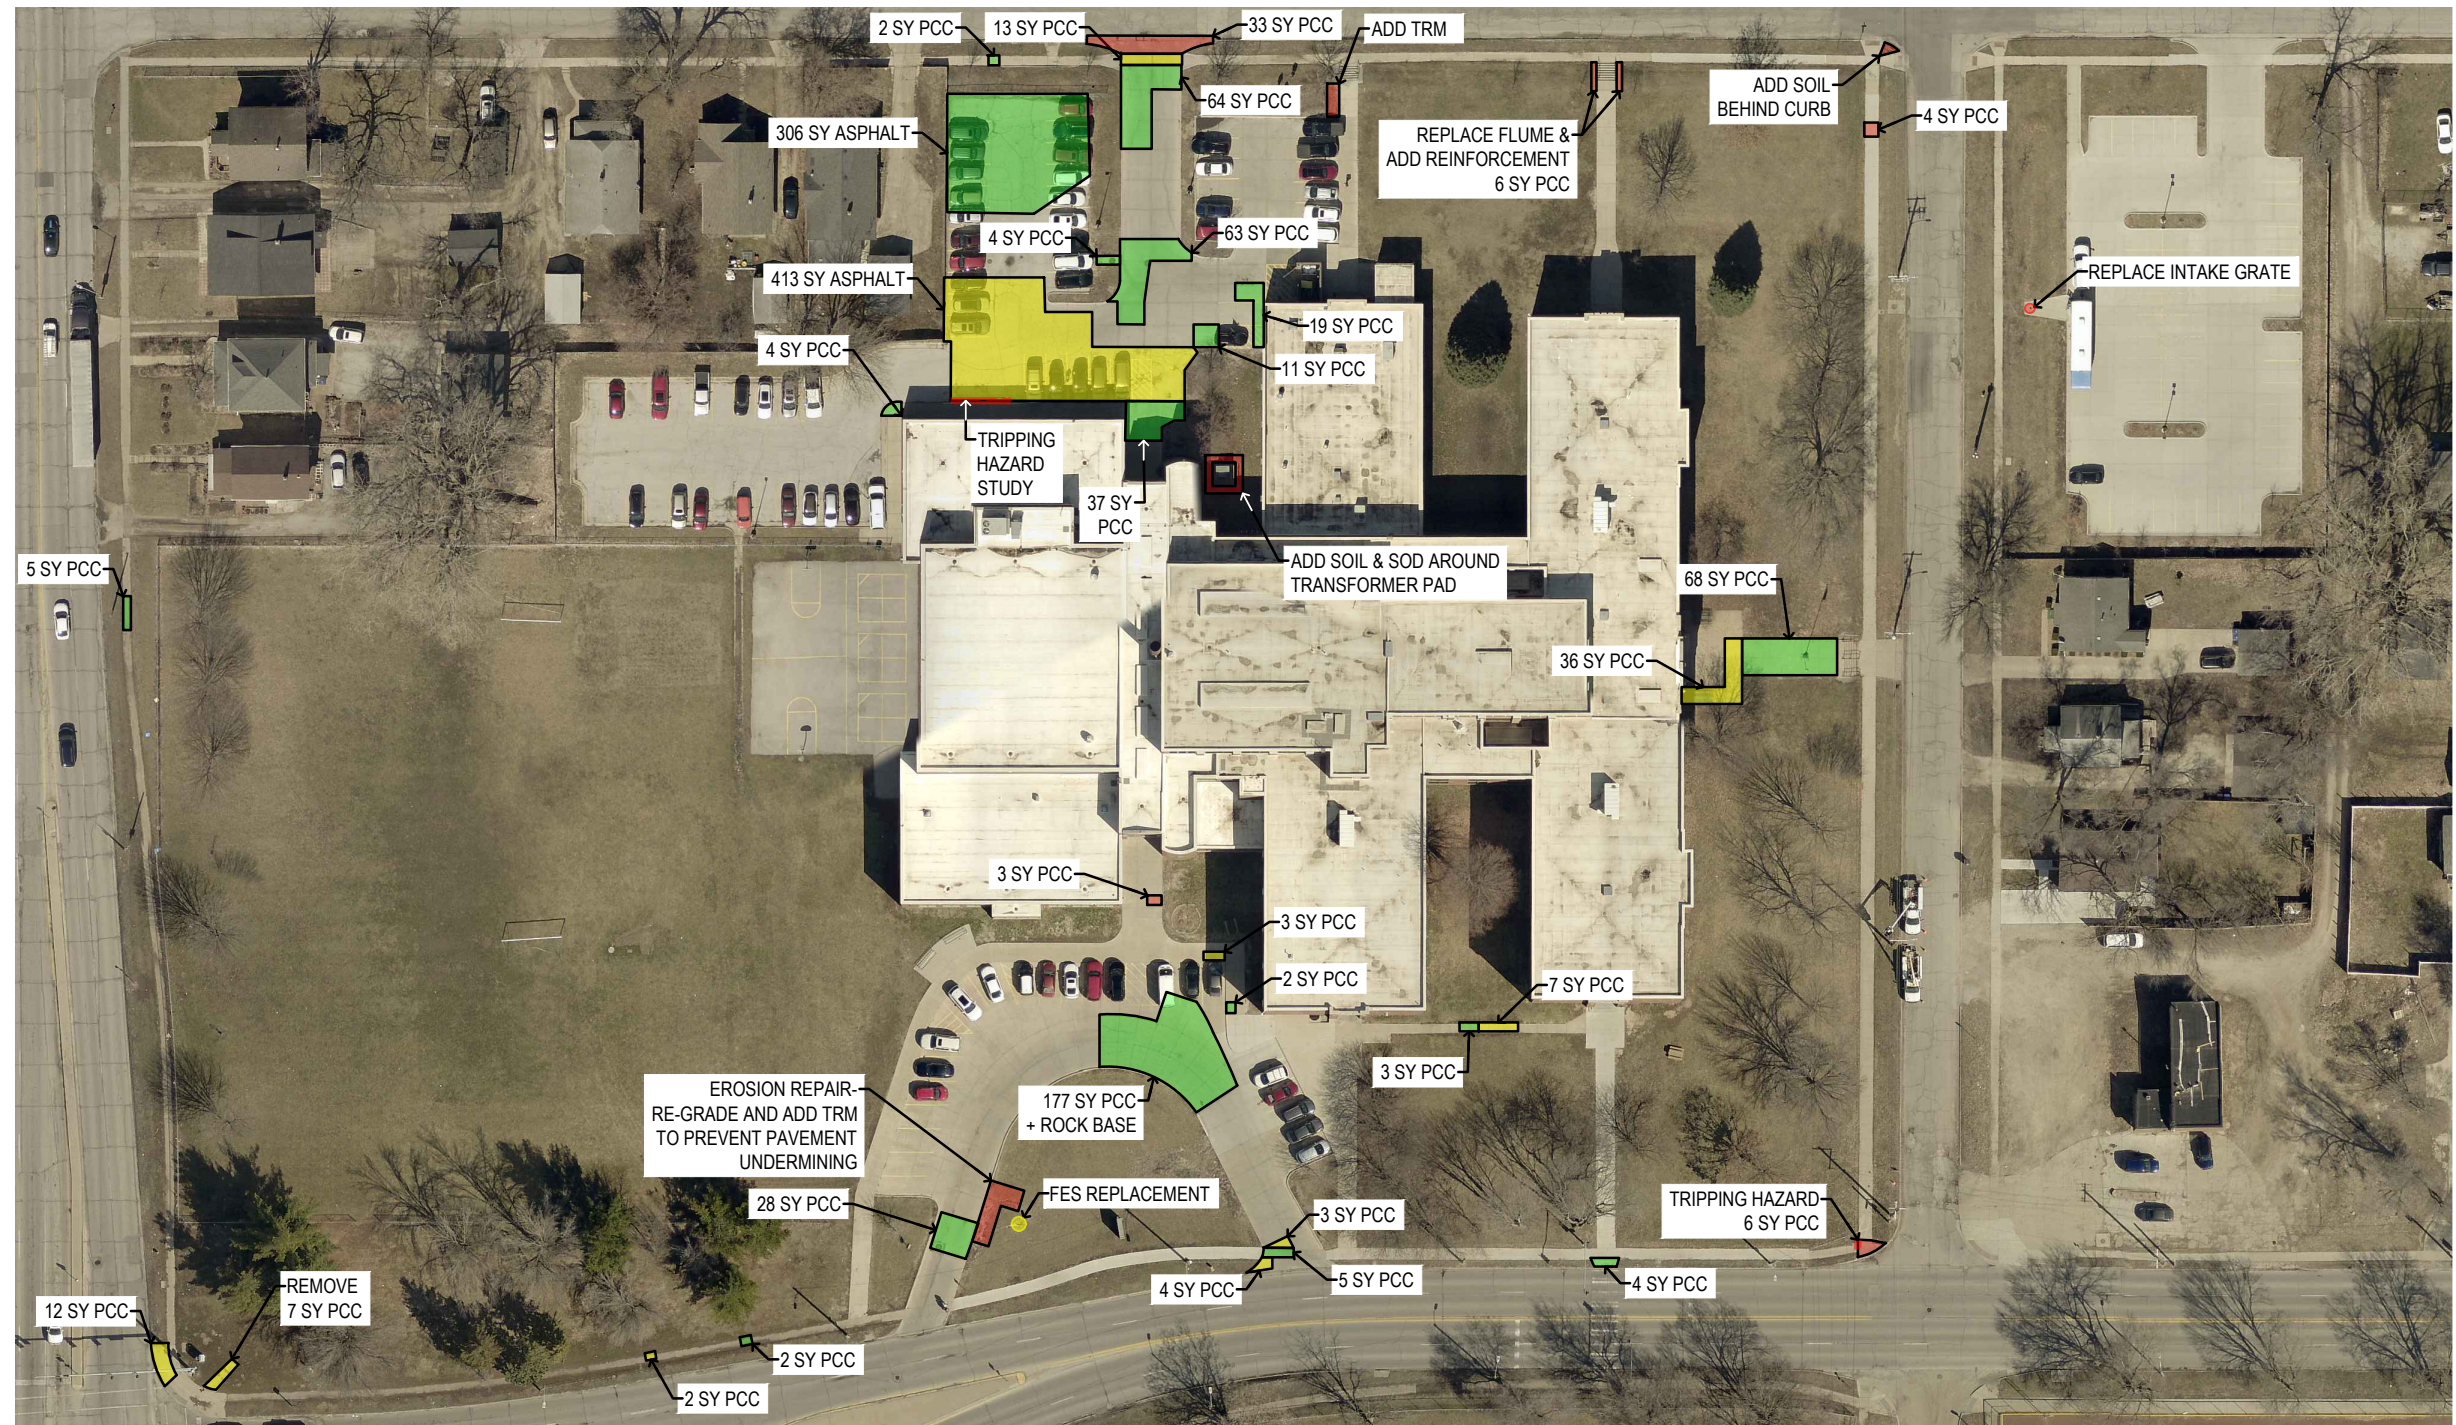
EXHIBIT
 PROJECT # 230286-43
 DATE 2/16/2024

- 5+ YEAR REPLACEMENT
- 3-4 YEAR REPLACEMENT
- 1-2 YEAR REPLACEMENT

Replace the missing parking lot intake grate. For location, refer to the civil site plan exhibit found in the appendix of this report.

Add TRM Around Flume	Install TRM around the flume experiencing washout from erosion. For location, refer to the civil site plan exhibit found in the appendix of this report.
Add Soil and Sod	Add soil behind the curb, and add soil and sod around the transformer pad being undermined. For locations, refer to the civil site plan exhibit found in the appendix of this report.
Erosion Repair	Re-grade and add TRM around area experiencing erosion wash out to prevent pavement undermining. For location, refer to the civil site plan exhibit found in the appendix of this report.
Service Mixing Valve	Confirm function of thermostatic mixing valve and service or replace unit if not functional.
Secure Filters	Multiple heat pumps were observed with loose filters in racks - confirm proper sizing and secure filters to achieve intended function.
Gymnasium Sign Repair	Identify circuit for gymnasium scoreboard and repair.

Replace Roofing	Remove approximately 46,500 SF of PVC roofing and insulation over roof areas H-P. Install code compliant insulation and TPO roofing. This project should follow or be done alongside the water infiltration study and roof infill study listed below.	\$1,500,000
Pavement Replacement	Remove and replace 334 SY of asphalt. Remove and replace 334 SY of PCC and add a rock base under the 177 SY experiencing subsurface moisture issues. For locations, refer to civil site plan exhibit found in the appendix of this report.	\$140,000
Sidewalk Repairs	Repair damaged sidewalks across the site. Approximately 131 SY. For locations, refer to civil site plan exhibit found in the appendix of this report.	\$30,000
