DMPS FACILITY ASSESSMENT | HILLIS ELEMENTARY

12.12.2023

EXECUTIVE BUILDING SUMMARY

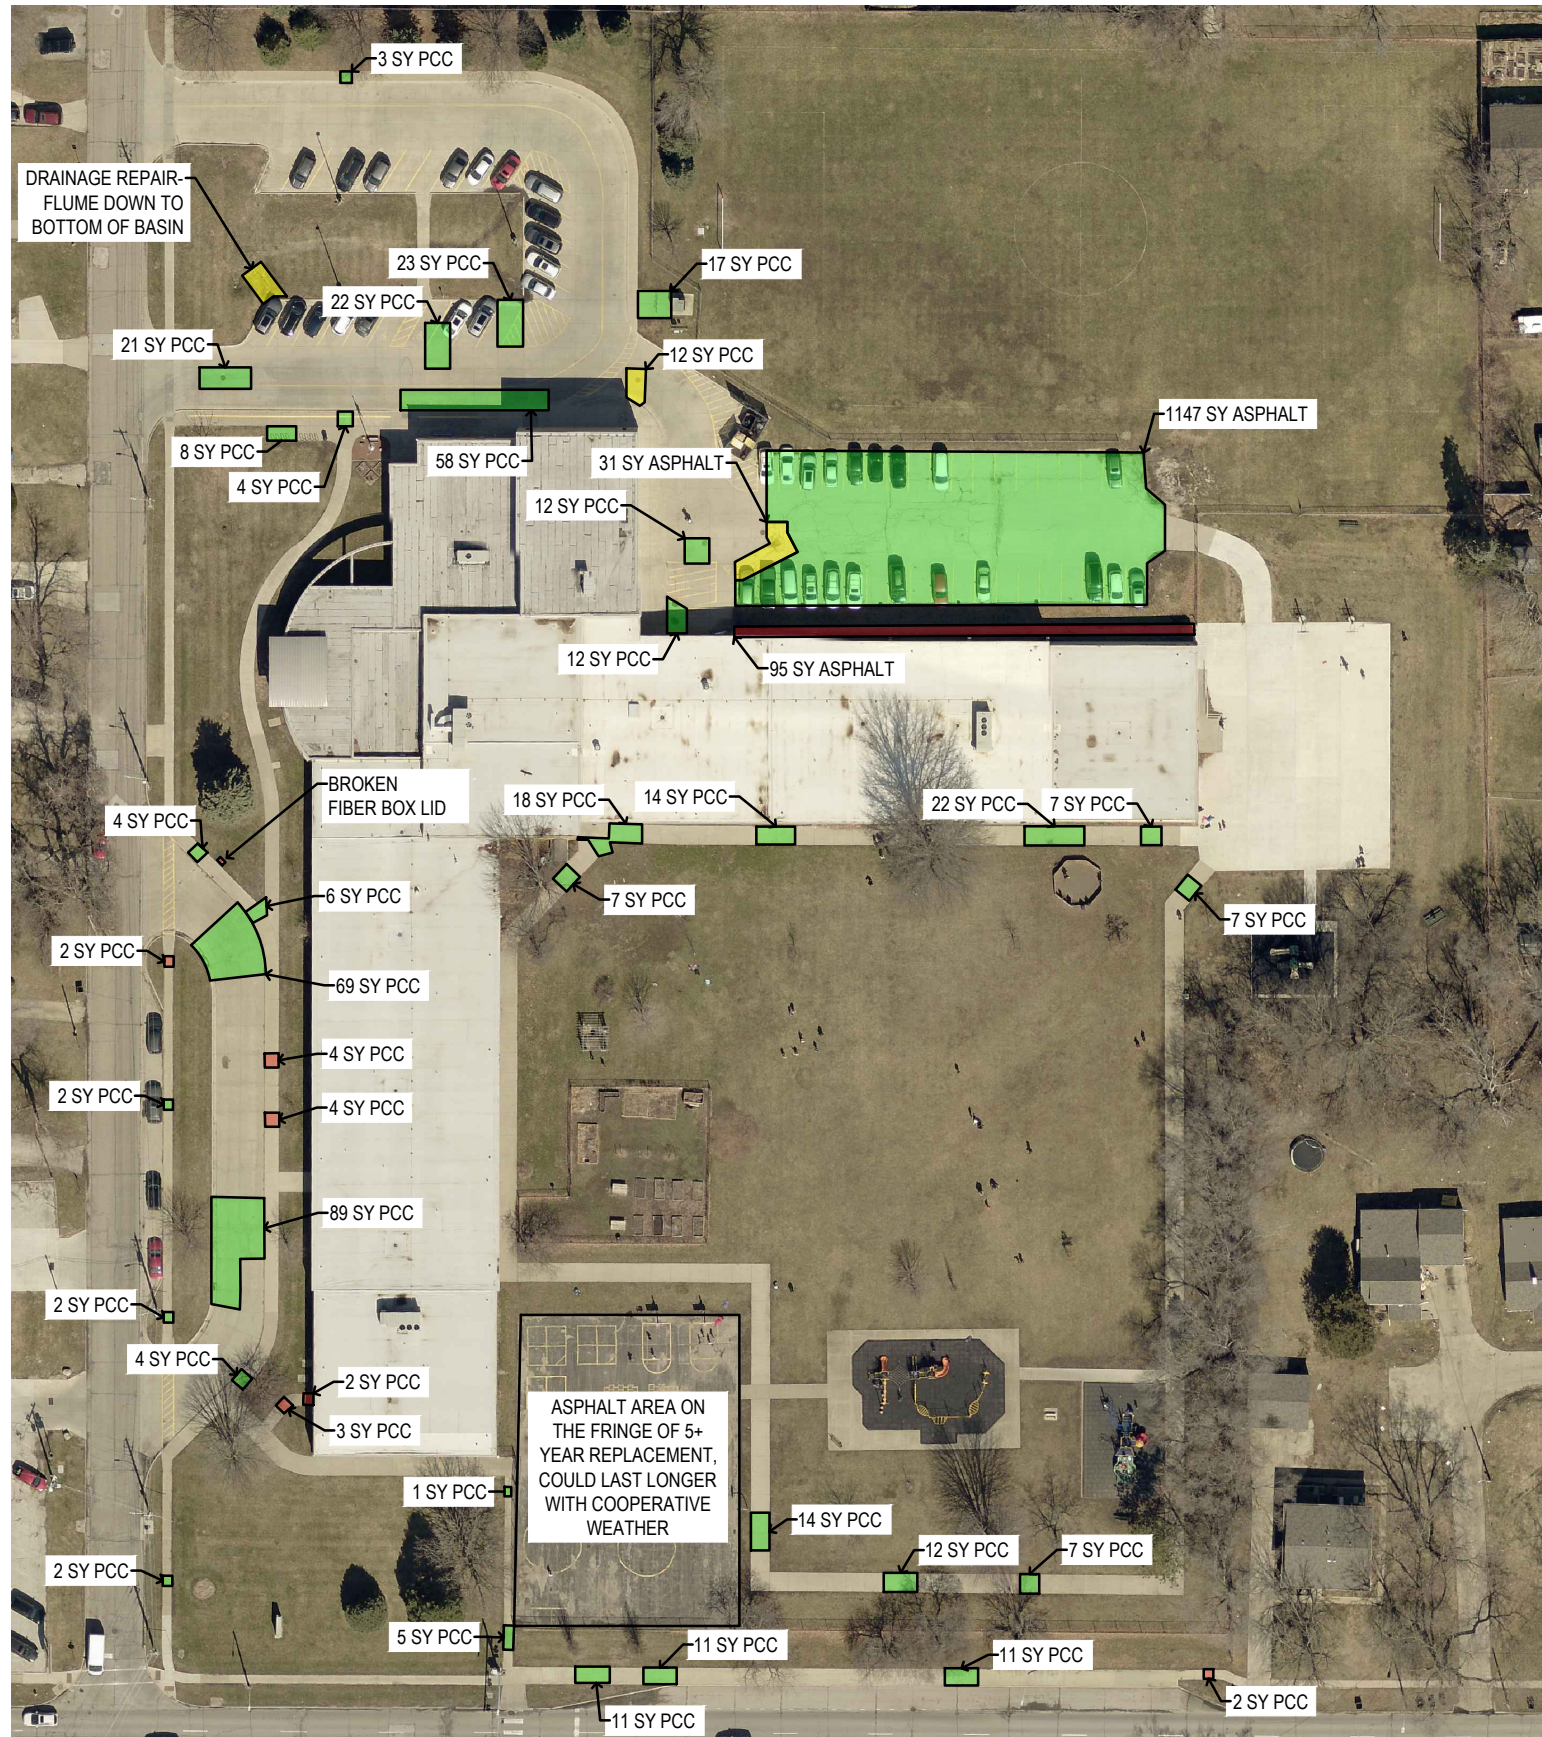
- 5+ YEAR REPLACEMENT
- 3-4 YEAR REPLACEMENT
- 1-2 YEAR REPLACEMENT

Pavement Replacement	Remove and replace 1147 SY of asphalt and 309 SY of PCC. For locations, refer to civil site plan exhibit found in the appendix of this report.	\$260,000
Sidewalk Repair	Repair damaged sidewalks across the site. Approximately 199 SY. For locations, refer to civil site plan exhibit found in the appendix of this report.	\$45,000
Central Thermostatic Mixing Valve Replacement	Replace central thermostatic mixing valve with digital style.	\$15,000
