DMPS FACILITY ASSESSMENT |

EXECUTIVE BUILDING SUMMARY

Building Name: Hoover High School

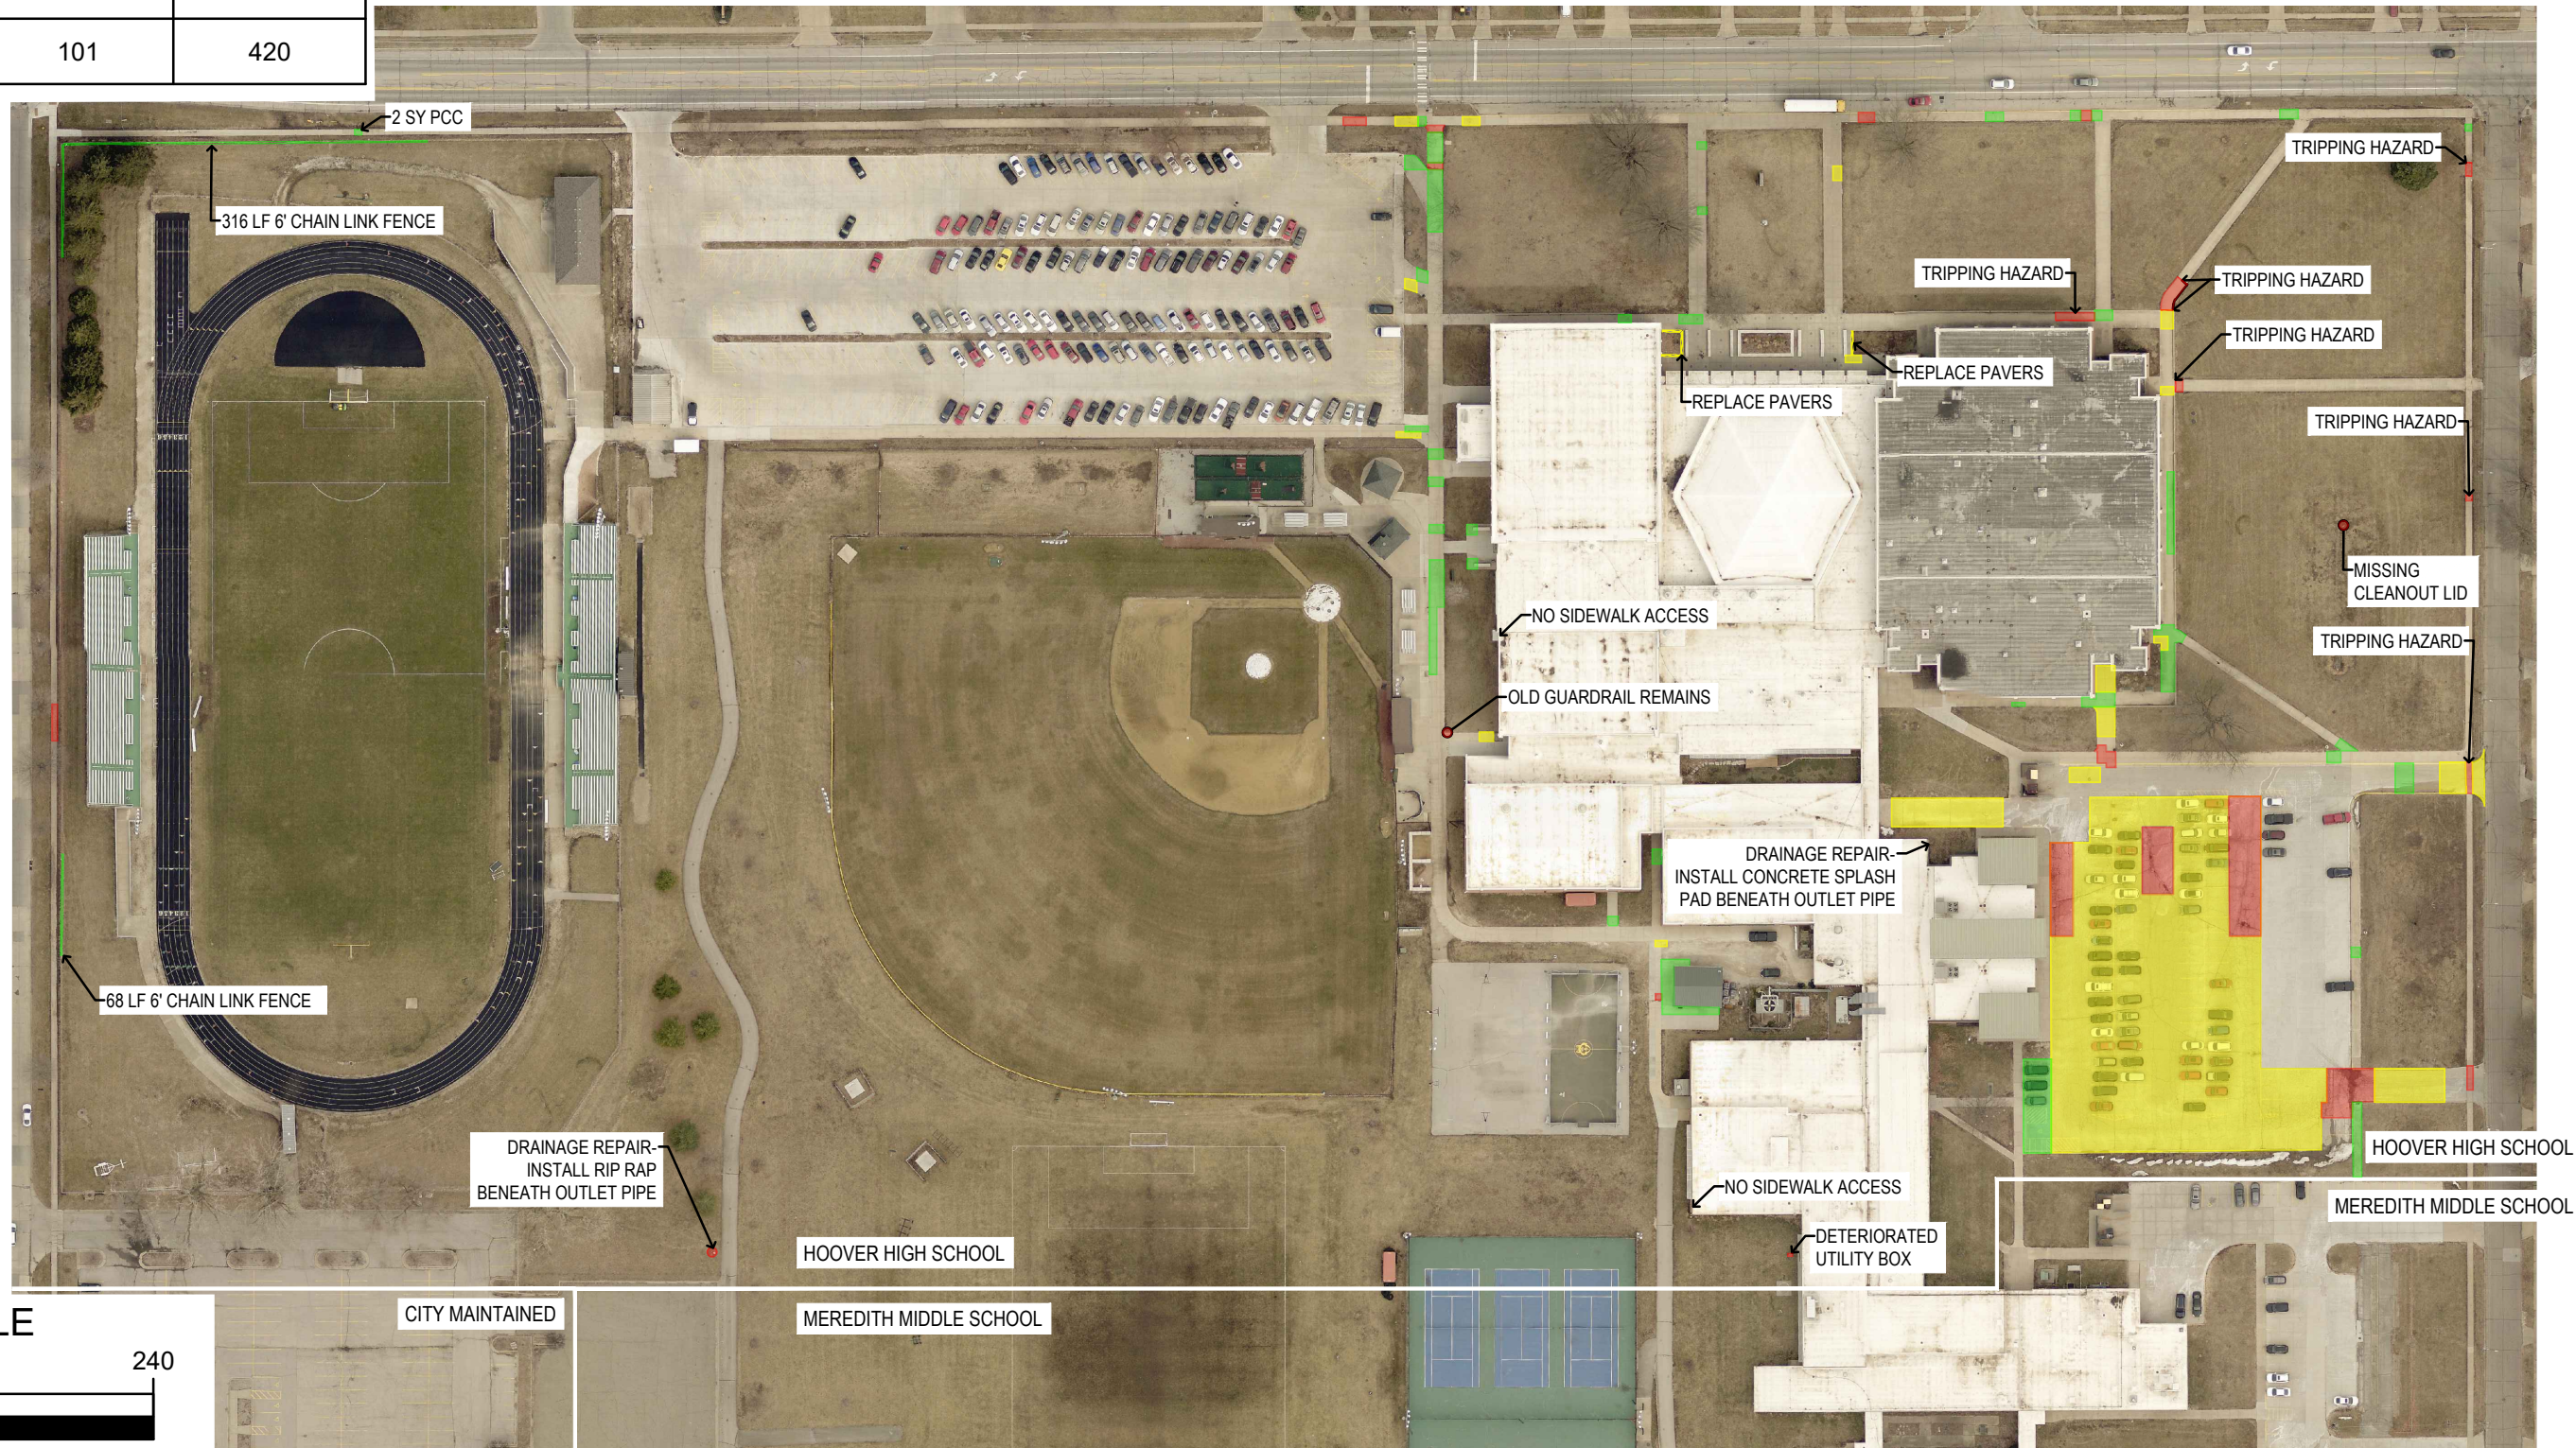
EXHIBIT
PROJECT # 230286-50
DATE 3/15/2024

4.2 Parking areas are in good condition.	5	3	15	The northwest lot appeared new and in good condition. The east lot asphalt is in poor condition, the whole lot should be replaced within 4 years and some areas may require immediate patching

4.3 Drive areas are in good condition.	3	4	12	One panel of the northwest lot drive access is cracking and will need to be replaced in the future. Some of the concrete of the north access into the east parking lot is cracking and the drive up to the building entrance is also cracking.

4.5 Sidewalks around the facility are in good condition .	2	4	8	Some of the concrete outside the SE building exit appears to be experiencing subsurface moisture issues, and the pavement along the north and east sides of the school has heaved and created tripping hazards.

- 5+ YEAR REPLACEMENT
- 3-4 YEAR REPLACEMENT
- 1-2 YEAR REPLACEMENT
