DMPS FACILITY ASSESSMENT | HOWE ELEMENTARY

11.14.2023

EXECUTIVE BUILDING SUMMARY

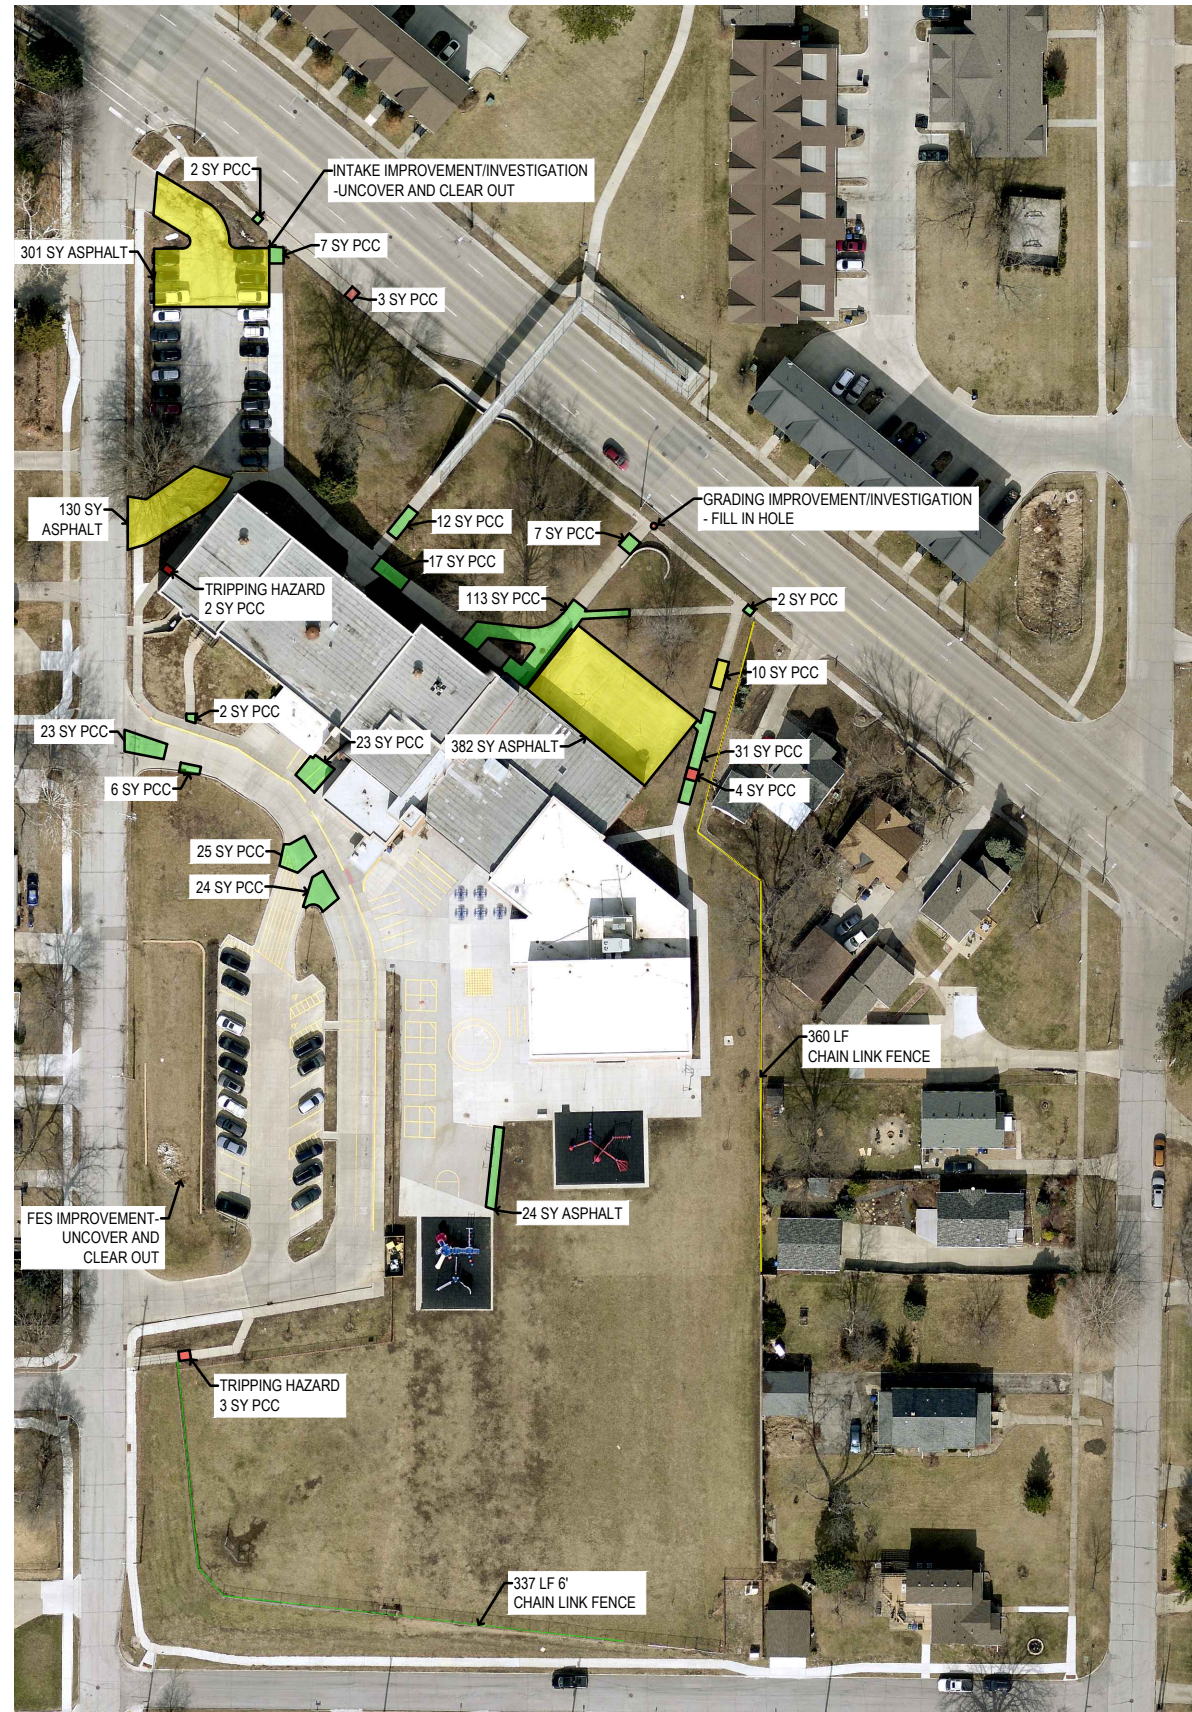
EXHIBIT
PROJECT # 230286-13
DATE 10/27/2023

Weight Factor	Rating	Points	Comments
4.1 Site topography and grading drains water away from the building and retaining walls.	1	4	4	Good drainage away from the building and the retaining walls to the north were in good condition. There was a hole the north of the north side walk that was quite deep and creates a tripping hazard.

4.2 Parking areas are in good condition.	5	4	20	There was some cracking in the north parking area asphalt but the pavement was not failing. The south lot was new concrete and in good condition.

4.3 Drive areas are in good condition.	3	3	9	The north asphalt section of the north lot was in poor condition in areas. The south lot drive areas were holding up well.

4.5 Sidewalks around the facility are in good condition .	1	4	4	Some sections of the north side sidewalk need repair but all other sidewalk areas were in good condition.

4.10 Utilities are in newly constructed conditions and placed in suitable locations.	1	3	3	The detention basin outlet was in good condition, the FES in the basin was covered with dirt and needs to be cleared out and rip-rap elevation adjusted lower. It appears that there is an intake in the NE corner of the north parking lot that is covered and filled with sediment.

Investigate Storm Intake Clog	Use a vac truck to clean out the storm intake at the north parking lot and determine the cause of the clog. See attached civil exhibit.

Parking Pavement Replacement	Remove and replace 431 SY of asphalt paving in the north parking lot. See attached civil exhibit.	\$75,000
Landscaping Wall Replacement	If owned by the school, demolish the multi-wythe brick landscaping wall in its entirety due to degradation. (150 LF).	\$140,000
Lintel Refinish	Clean and protect rusting lintels with high performance coating. Noticeable rusting in lintels in rooms 115, 116, 101, 102, 103, 104, 210, 220, 212, 202, 204, 205, and 206. Total Linear Feet = Approximately 300'. Assume 4" width = 100 sq. ft.	\$10,000
Heat Pumps Replacement	Replace heat pumps in original building for all classrooms and include dehumidification capability. Consider 2 speed compressor to reduce load in well-field and match load.	\$870,000
Grease Interceptor Installation	Install exterior grease interceptor to meet current City of DSM requirements.	\$530,000
