DMPS FACILITY ASSESSMENT | HOYT MIDDLE SCHOOL

02.06.2024

EXECUTIVE BUILDING SUMMARY

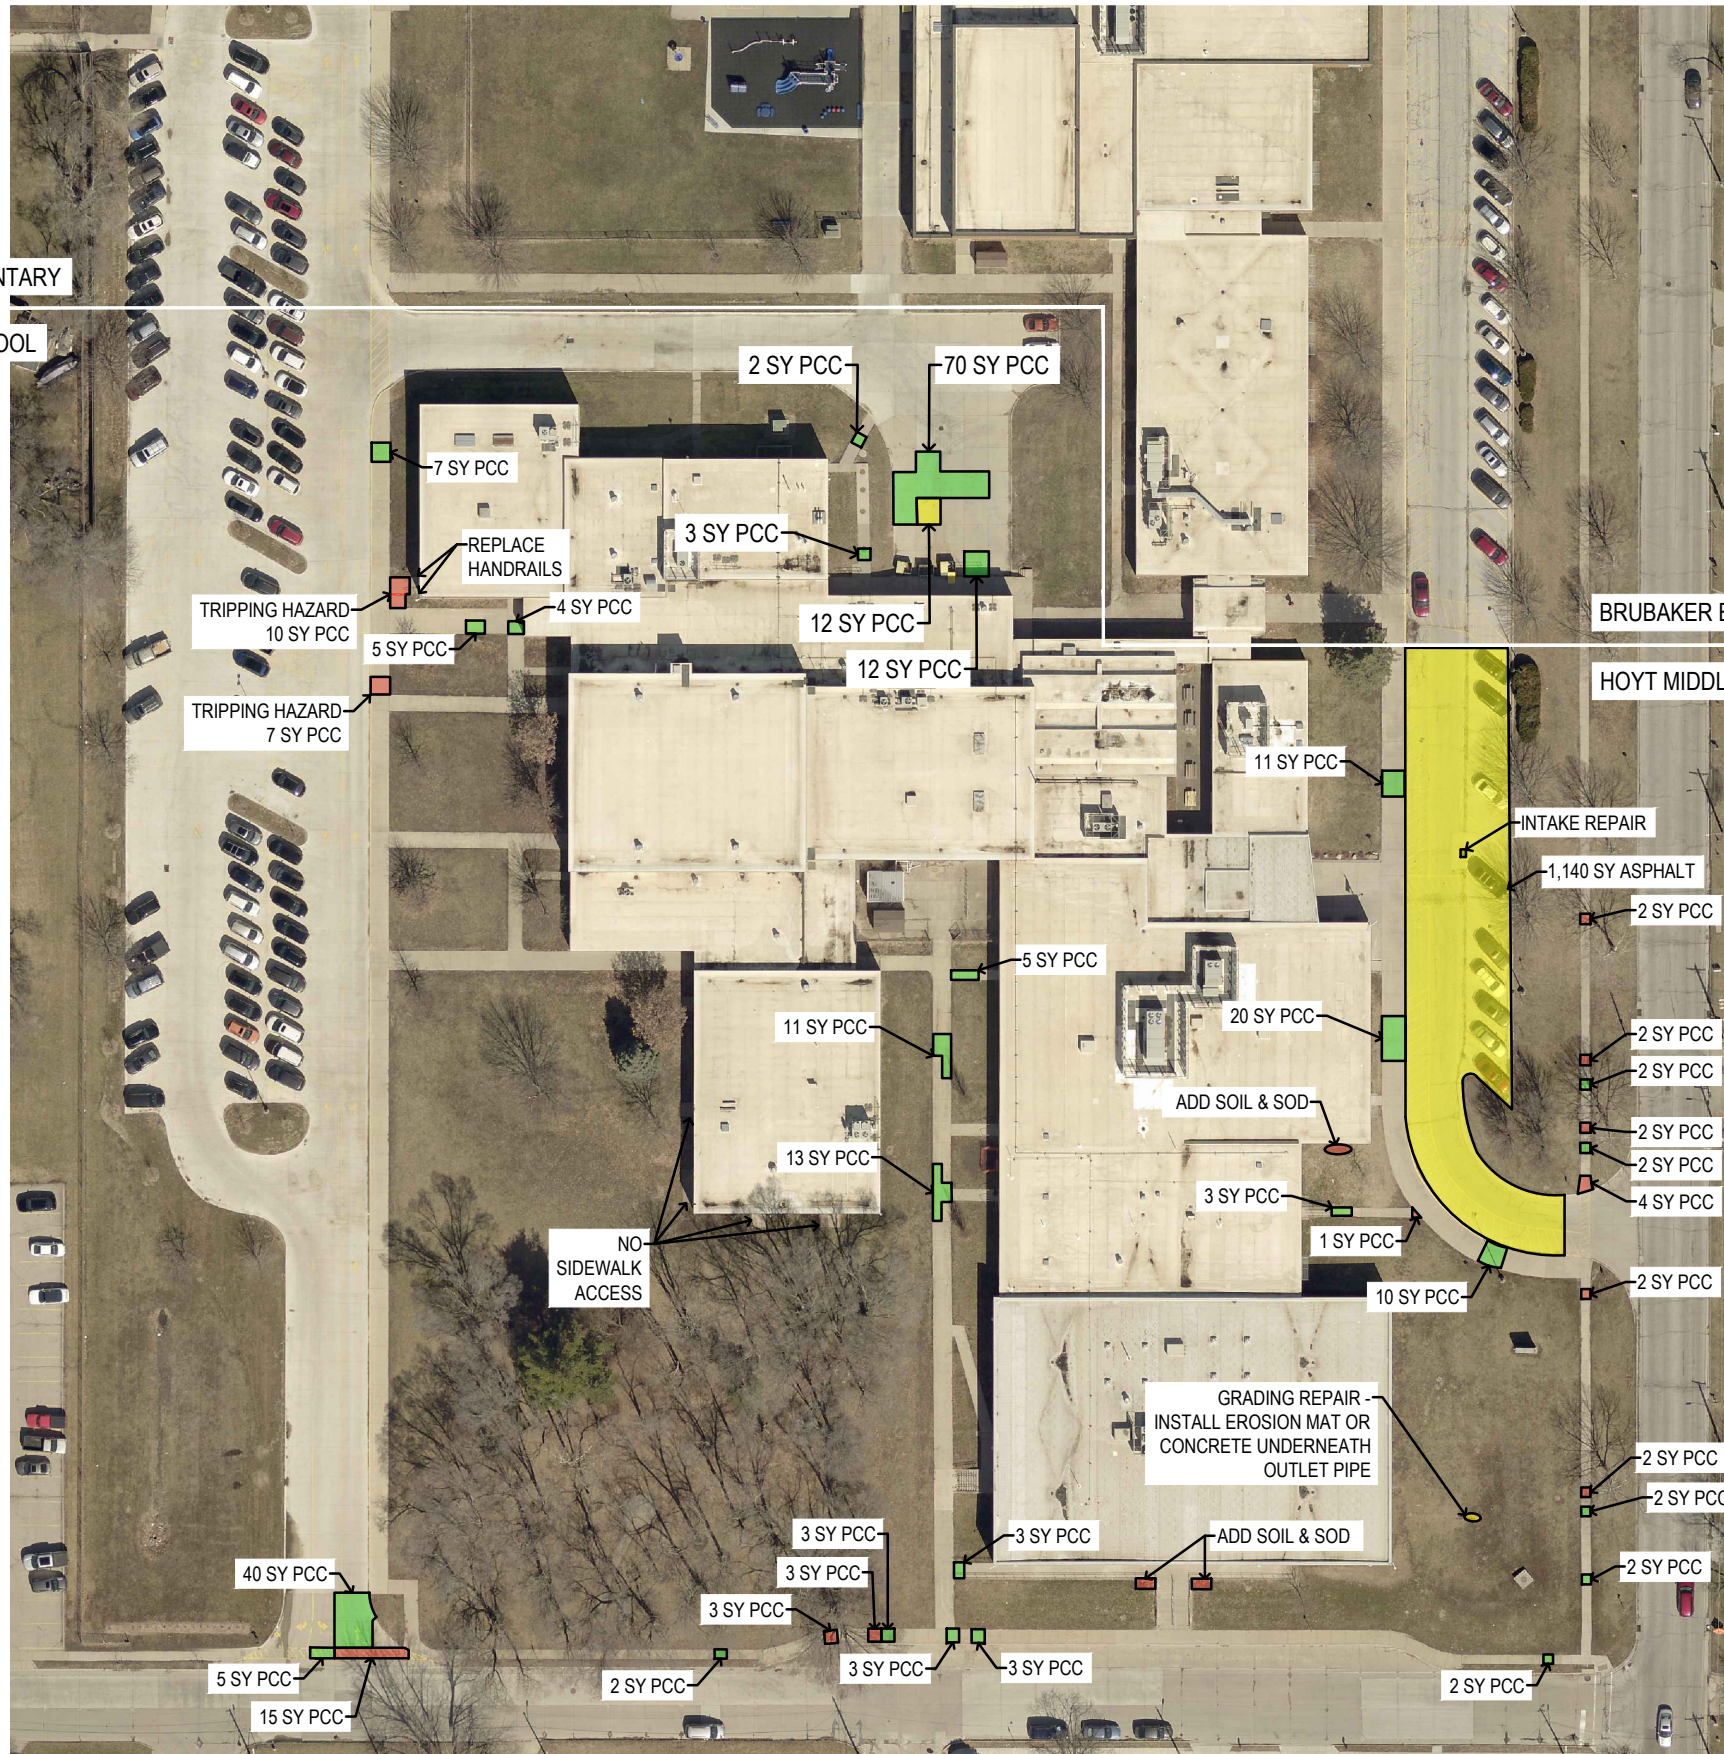
Weight Factor	Rating	Points	Comments
4.1 Site topography and grading drains water away from the building and retaining walls.	1	4	4	One erosion issue under outlet pipe in southeastern detention pond, a few locations where erosion has washed away soil and exposed the stoop/building foundation. Recommend to add soil and sod over these areas as a maintenance project

4.5 Sidewalks around the facility are in good condition .	1	4	4	Patches along the eastern side and the sidewalk through the west lot drive access need replacement, but most of the sidewalk on site was in good condition.

Sidewalk Repair	Repair damaged sidewalks across the site. Approximately 52 SY. For locations, refer to civil site plan exhibit found in the appendix of this report.	\$12,000

Handrail Replacement	Replace the damaged handrails to improve access into the building. For location, refer to civil site plan exhibit found in the appendix of this report.	\$8,000
Exterior Lighting	Add perimeter exterior light at Inset on East side, south end.	\$7,000
Lightning Protection System	Install new lightning protection system and interface with existing lightning protection on Brubaker Elementary.	\$50,000
Piping Insulation Replacement	Replace closed-cell insulation on roof mounted refrigeration piping. Use UV resistant type insulation.	\$25,000

Pavement Replacement	Remove and replace 122 SY of PCC. For locations, refer to civil site plan exhibit found in the appendix of this report.	\$25,000
Sidewalk Repair	Repair damaged sidewalks across the site. Approximately 128 SY. For locations, refer to civil site plan exhibit found in the appendix of this report.	\$30,000

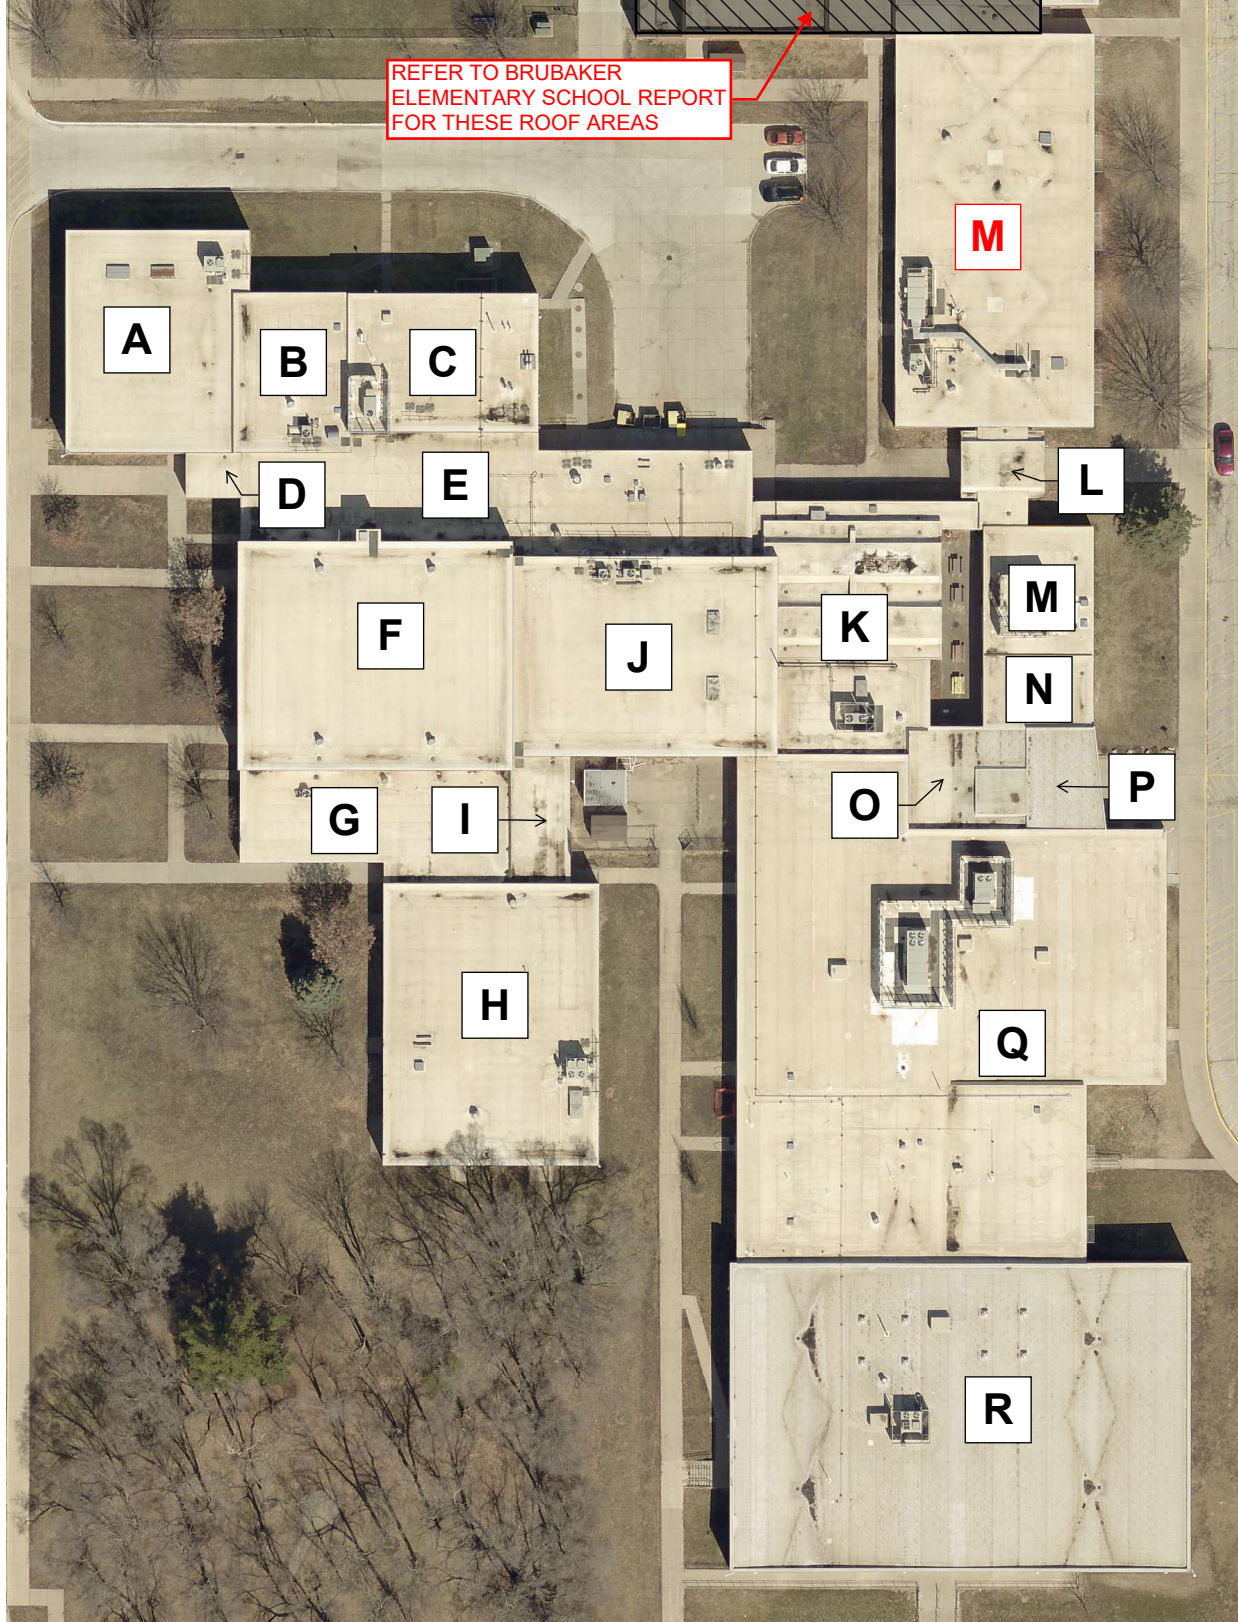
Reroofing required in 5-10 years.

Replace 11 missing or mismatched roof drain covers: 5 at roof area K; 4 at roof area F; and 2 at roof area H.

Roof Replacement	Remove approx. 60,000 SF of PVC roofing and insulation over roof areas A through O and Q (not P or R), as well as M from Brubaker. Install code compliant insulation and TPO roofing. Approx. 2030.	\$2,000,000
Roof Access Installation	Provide 6 VLF ladder from roof area B to E. Provide 18 VLF ladder from roof area E to F. Provide 18 VLF ladder from roof area F to I. Provide 4 VLF ladder from roof area G to H. Provide 4 VLF ladder from roof area Q to R.	\$30,000
Exterior Duct Painting	Remove rust and paint goose neck roof exhaust duct. Duct approx. 30" x 40" and 60" tall.	\$6,000
