DMPS FACILITY ASSESSMENT |

EXECUTIVE BUILDING SUMMARY

Building Name: **Hubbell Elementary**

EXHIBIT
PROJECT # 230286-14
DATE 12/26/2023

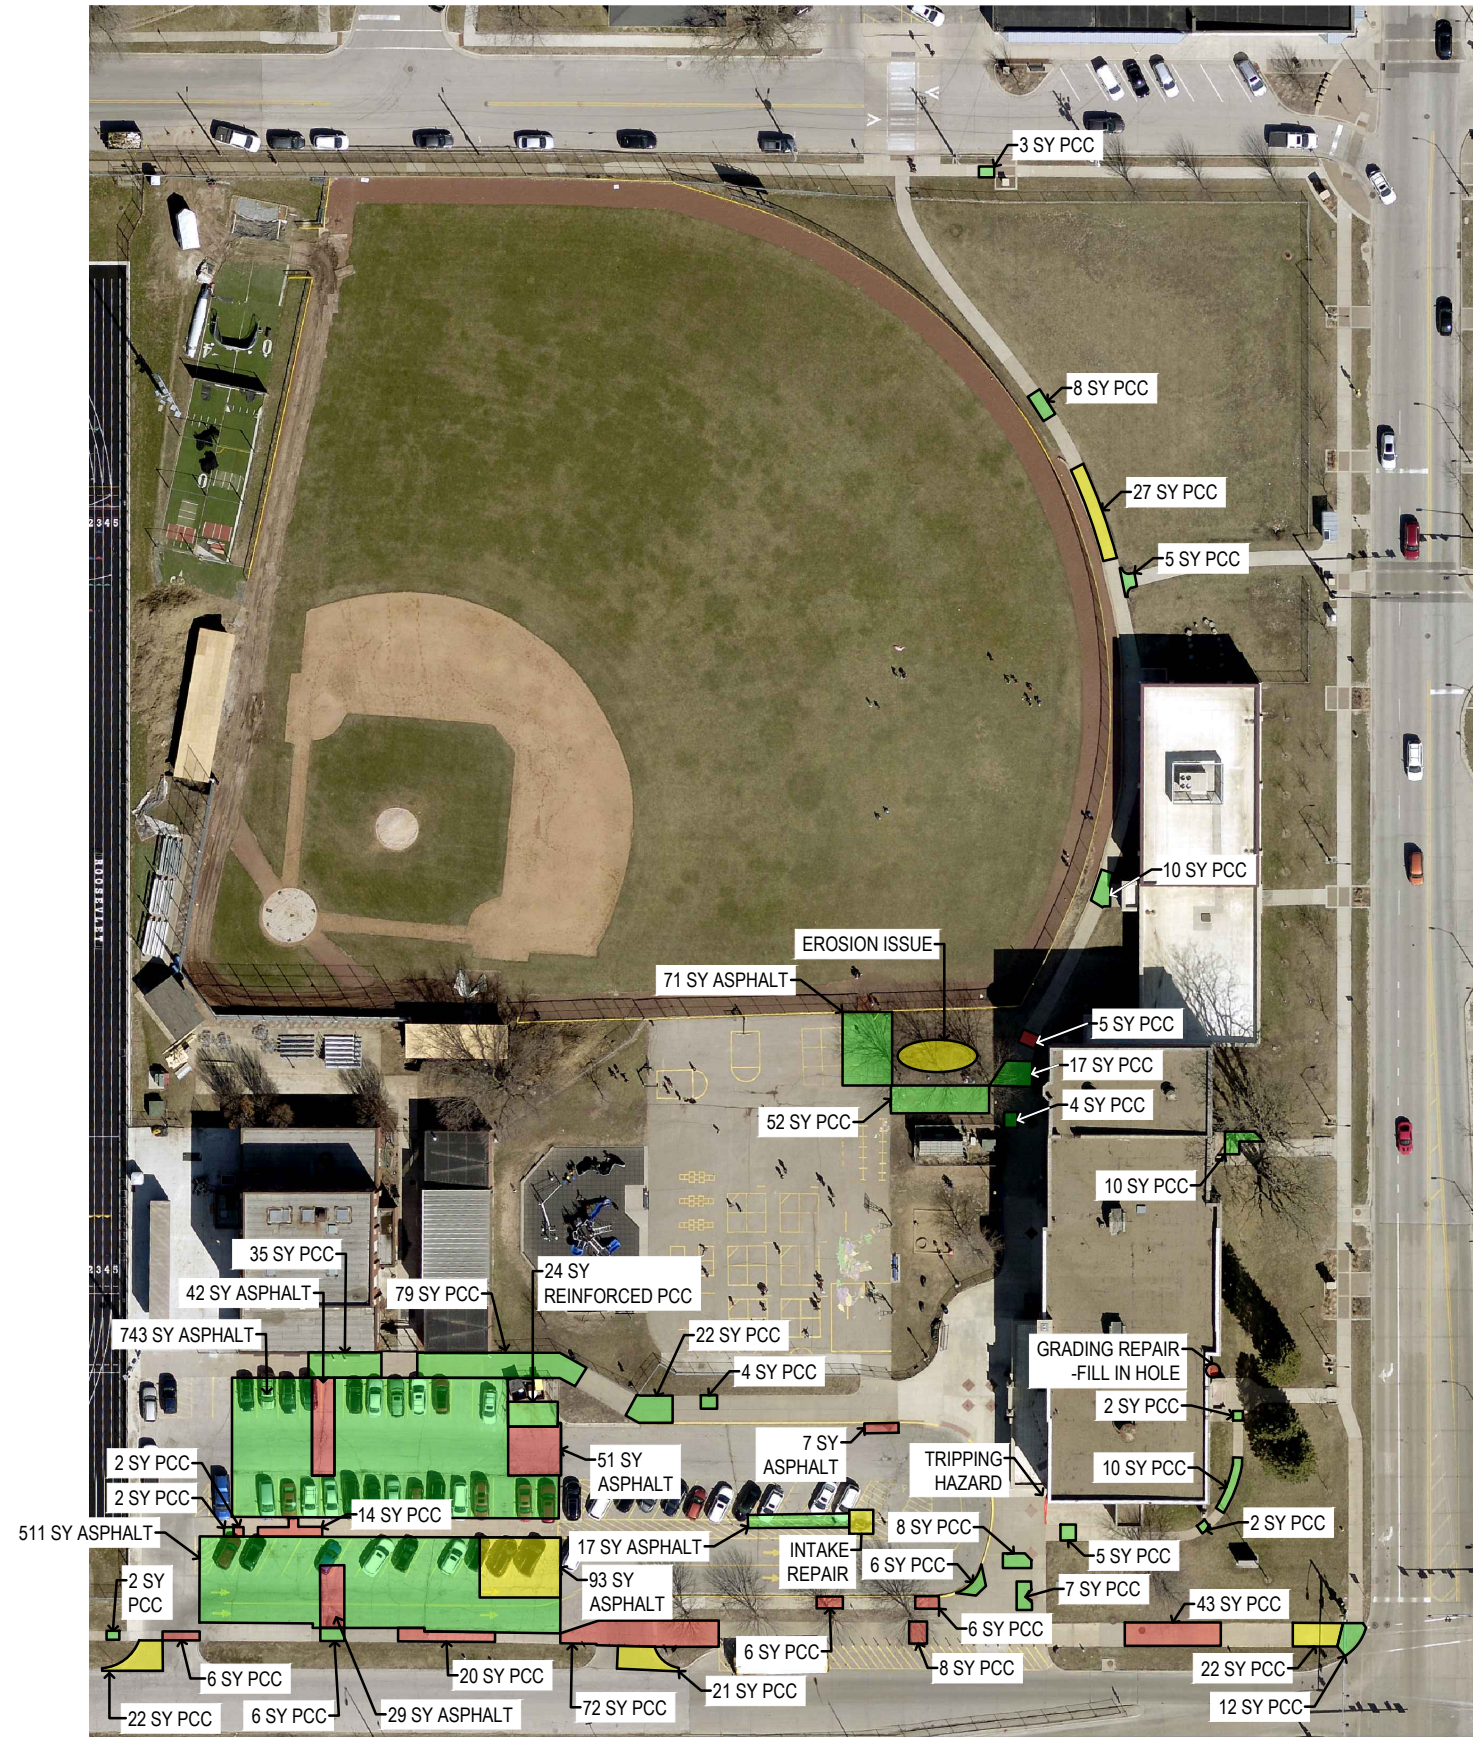
4.2 Parking areas are in good condition.	5	3	15	The parking asphalt was cracking throughout with the west side being worse than the east.
4.3 Drive areas are in good condition.	3	3	9	Some of the cracking asphalt has sealer applied to it but there still sections needing replacement. Same as the parking area, west is worse than the east.

4.5 Sidewalks around the facility are in good condition .	1	3	3	Sections of the south walk by the parking lot are in need of immediate replacement, other isolated areas need replacement across site.

4.6 Sidewalks are located in appropriate areas with adequate building access.	1	5	5	All doors with sidewalk access.
4.7 Hard surface playground surfaces are in good condition.	3	4	12	The NE asphalt corner is cracking, unclear if tree roots or subsurface moisture issues are the cause.

4.8 Fencing around the site is in good condition.	1	5	5	All appeared to be in good condition.
4.9 Trash enclosure is in good condition.	1	4	4	Some of the pavement in front of the dumpsters was cracking, recommend to replace with reinforced PCC.

4.10 Utilities are in newly constructed conditions and placed in suitable locations.	1	4	4	Intake in the circle drive needs replacement, all other utilities appeared in good condition.

Intake Repair	Repair the walls of one intake. For location, refer to civil site plan exhibit found in the appendix of this report.	\$9,000
Pavement Replacement	Remove and replace 136 SY of asphalt. For locations, refer to civil site plan exhibit found in the appendix of this report.	\$20,000
Heat Pump Replacement	Heat pumps are reaching the end of their useful life and will require replacement. Replace with a 2-speed unit to improve partial load performance and dehumidification.	\$1,900,000
Cooling Tower Replacement	Cooling Tower is reaching the end of its useful life and will need to be replaced.	\$260,000
