DMPS FACILITY ASSESSMENT |

Building Name: JF Taylor Early Childhood Center

Date: 01.24.2024

Address: 1801 16th St
Des Moines, IA 50314

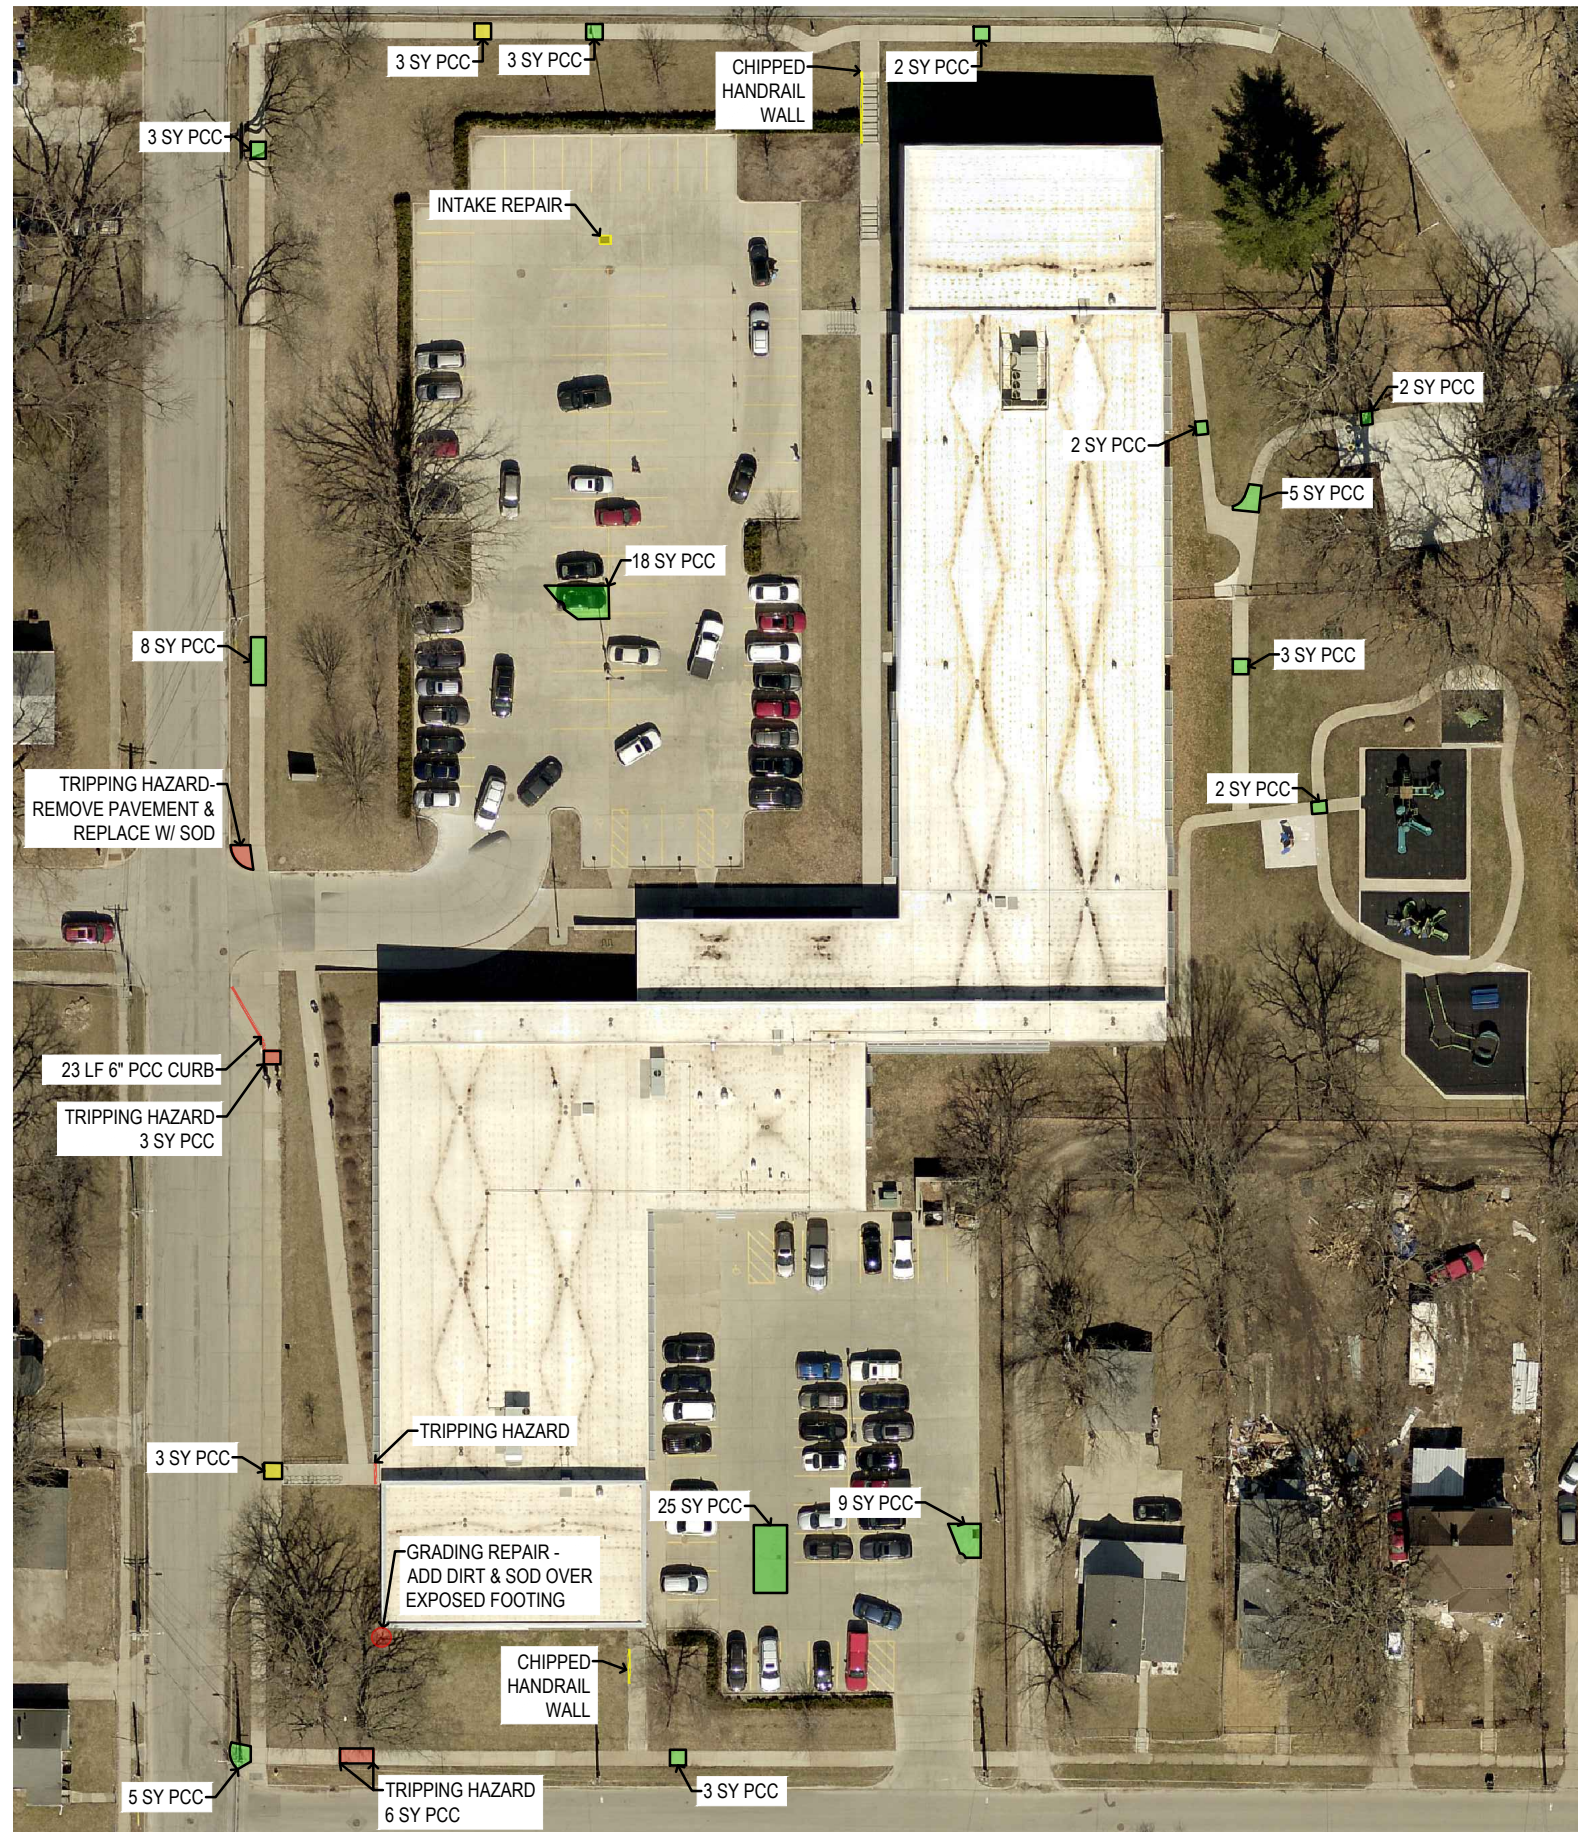
JF TAYLOR EDUCATION CENTER

4.2 Parking areas are in good condition.	5	5	25	A few cracked panels around the manholes in both north and south lots, pavement in good condition overall.

4.5 Sidewalks around the facility are in good condition .	1	4	4	There are a couple of tripping hazards across site and a few sidewalk panels around the playground will need replacement, but sidewalk conditions were mostly good across site. The handrail walls on the north and south stairs have chipped sections and need repair.

4.9 Trash enclosure is in good condition.	1	4	4	Some of the pavement around the bollards was cracked, masonry brick was in good condition, and the gate was lightly damaged.

Curb Repair	Return damaged curbs to new condition. Approximately 23 LF of 6" curbs. For locations, refer to civil site plan exhibit found in the appendix of this report.	\$7,000
MDF Panelboard Installation	Add 100A branch panelboard to MDF and refeed all circuits within MDF to new panel.	\$15,000
Camera Upgrade	Exterior cameras covering parking and student drop-off areas are only capable of black & white images after dark. Upgrade when possible.	\$25,000

Sidewalk Repair	Repair damaged sidewalks across the site. Approximately 6 SY. For locations, refer to civil site plan exhibit found in the appendix of this report.	\$7,000
VRF Head End and Branch Controller Replacement	VRF system is nearing end of serviceable life. Recommend replacement of head end controllers and branch controllers as 3-4 year Priority. See 5-10 year priority for replacement of condensing units and evaporator units.	\$200,000

Exterior Sealant Replacement	Replace sealant at perimeter of windows. (Approx. 1,970 LF)	\$35,000
Sidewalk Repair	Repair damaged sidewalks across the site. Approximately 38 SY. For locations, refer to civil site plan exhibit found in the appendix of this report.	\$12,000

Pavement Replacement	Remove and replace 52 SY of PCC. For locations, refer to civil site plan exhibit found in the appendix of this report.	\$13,000
VRF Fan Coil and Condensing Unit Replacement	VRF system is nearing end of serviceable life. Recommend replacement of head-end and branch controllers as year 3-4 priority. Replace fan coils and condensing units in 5-10 year priority.	\$1,200,000
