DMPS FACILITY ASSESSMENT | JACKSON ELEMENTARY

10.31.2023

EXECUTIVE BUILDING SUMMARY

Building Name: Jackson Elementary

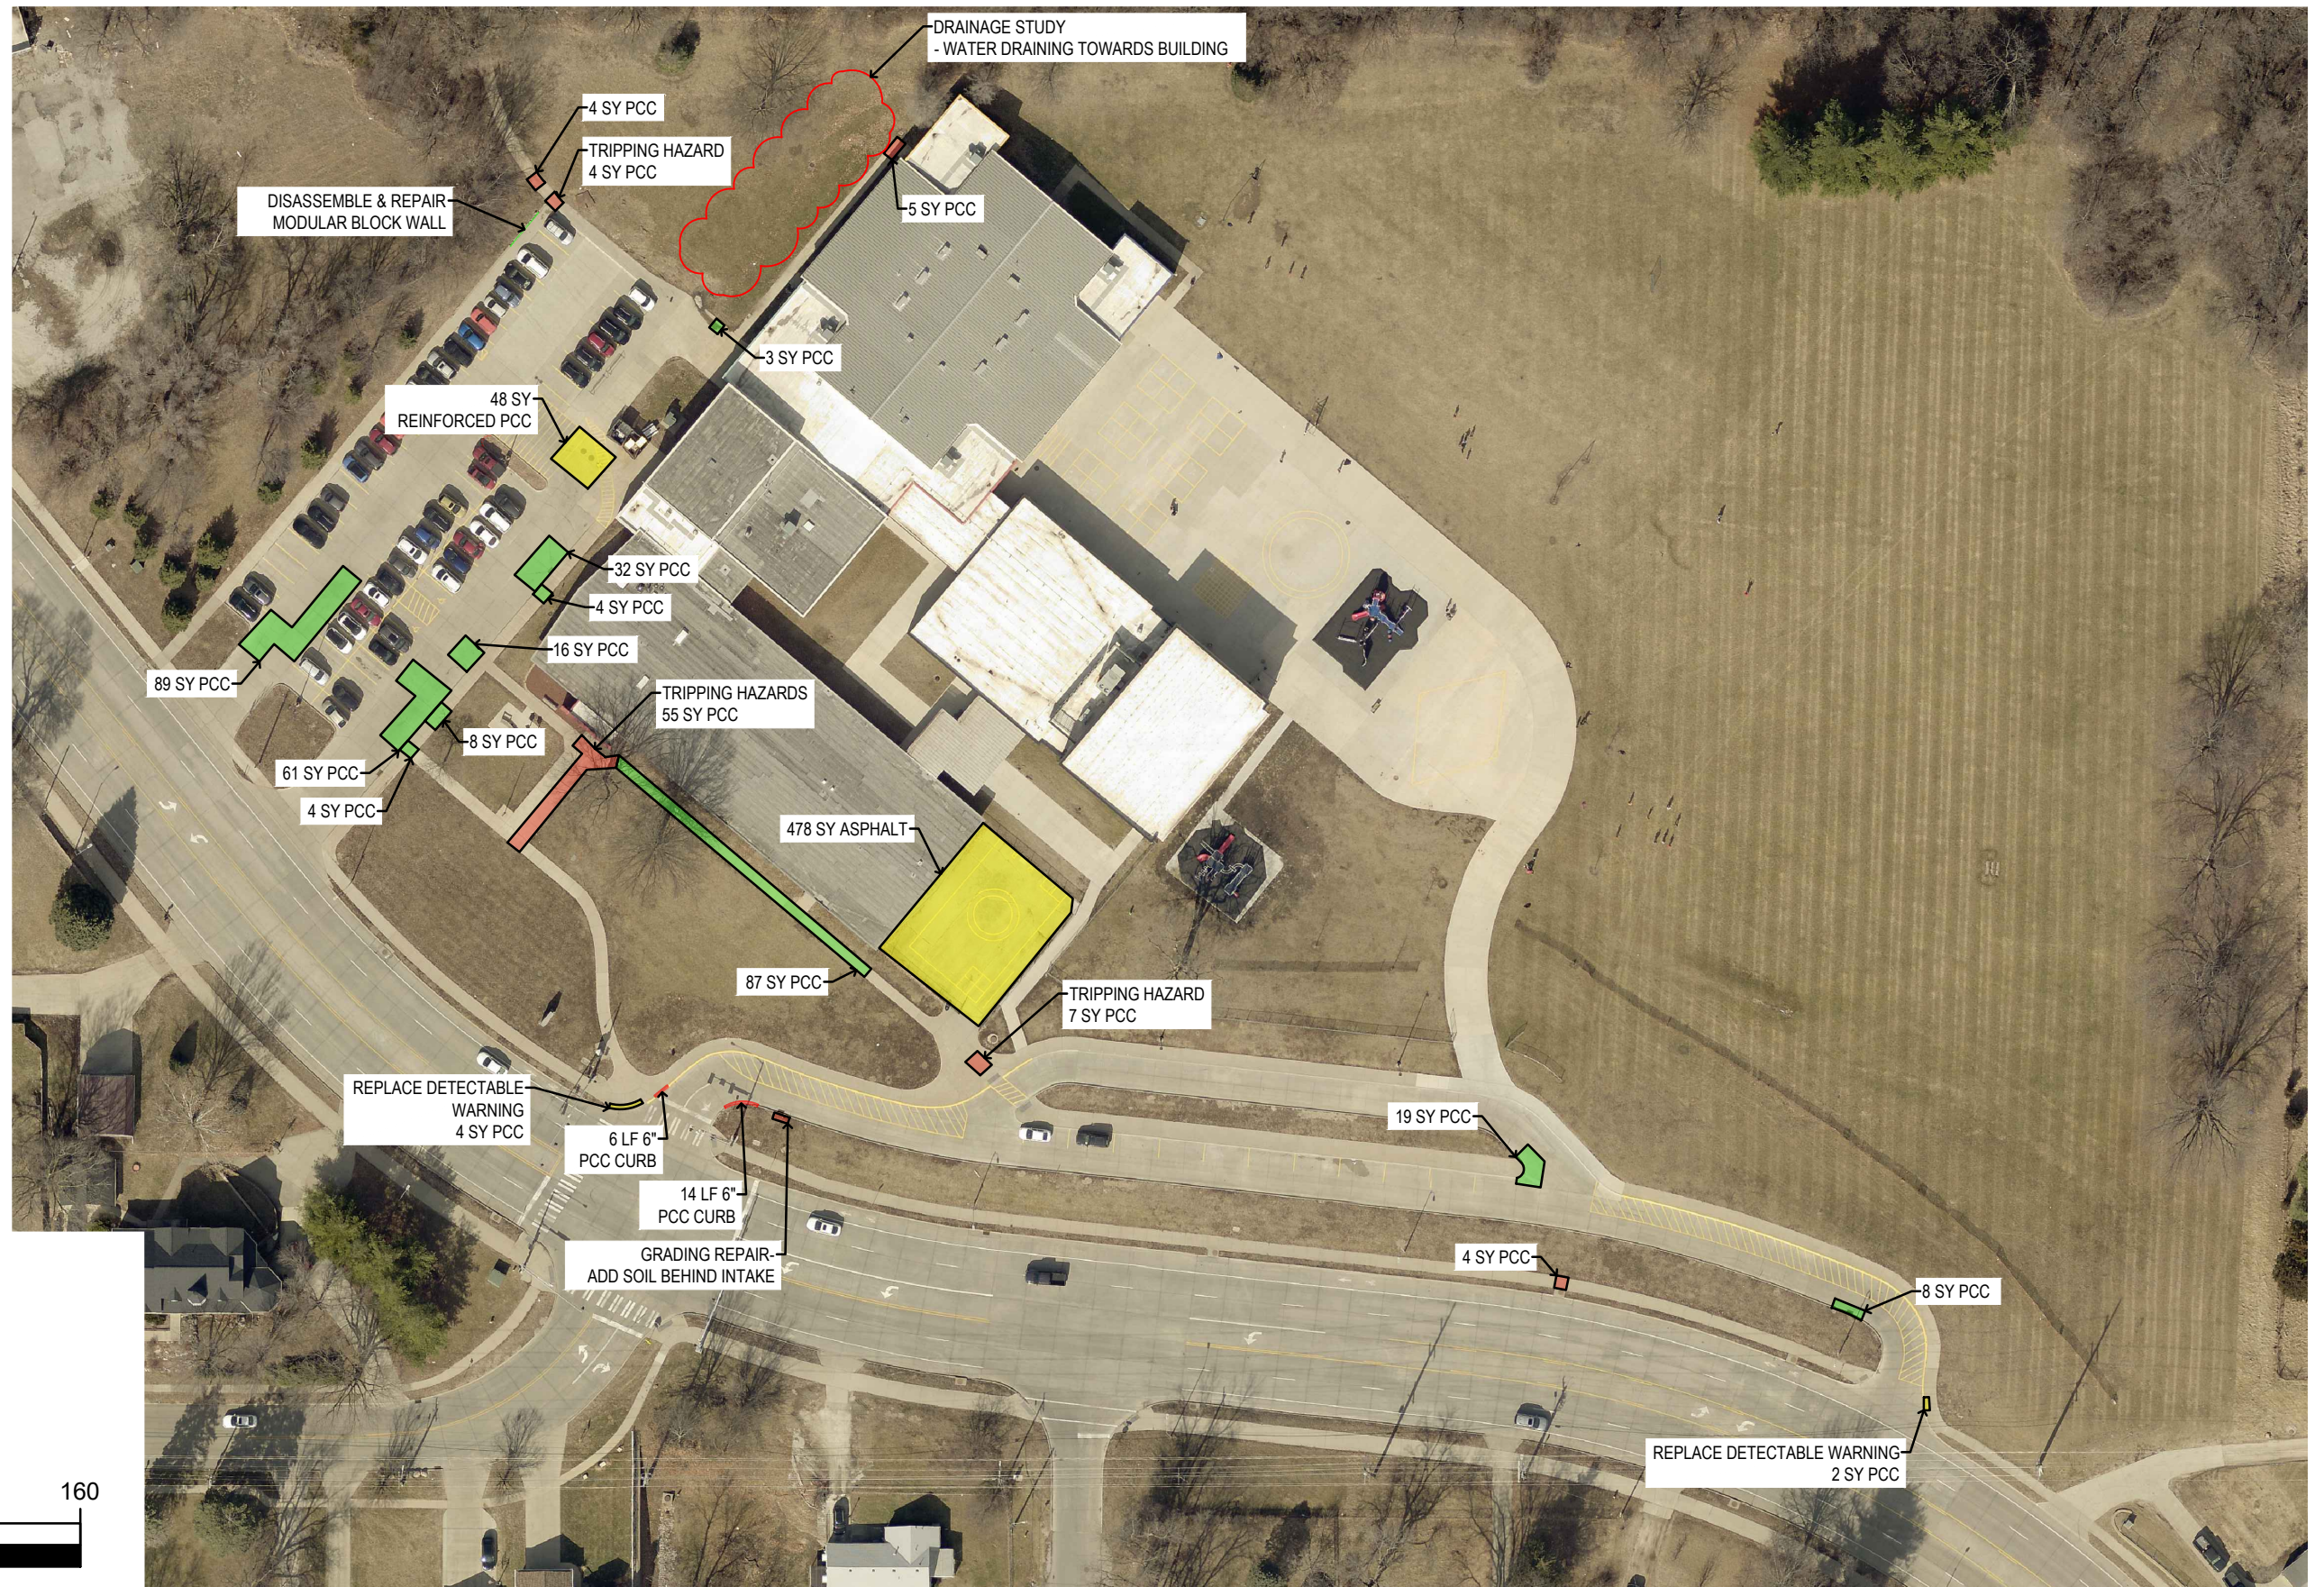
- 5+ YEAR REPLACEMENT
- 3-4 YEAR REPLACEMENT
- 1-2 YEAR REPLACEMENT

Roof Replacement	Remove 23,800 SF of TPO roofing and insulation over roof areas B, C, D, and L. Install code compliant insulation and TPO roofing.	\$760,000
Repair Modular Block Wall	Dissassemble and repair modular block wall, approximately 21 LF. For location, refer to civil site plan exhibit found in the appendix of this report.	\$10,000
Pavement Replacement	Remove and replace 225 SY of pavement. For location, refer to civil site plan exhibit found in the appendix of this report.	\$40,000
Sidewalk Repair	Repair damaged sidewalks across the site. Approximately 106 SY. For locations, refer to civil site plan exhibit found in the appendix of this report.	\$25,000
