# DMPS FACILITY ASSESSMENT |

# EXECUTIVE BUILDING SUMMARY

Building Name: Jefferson Elementary

Date: 11.15.2023

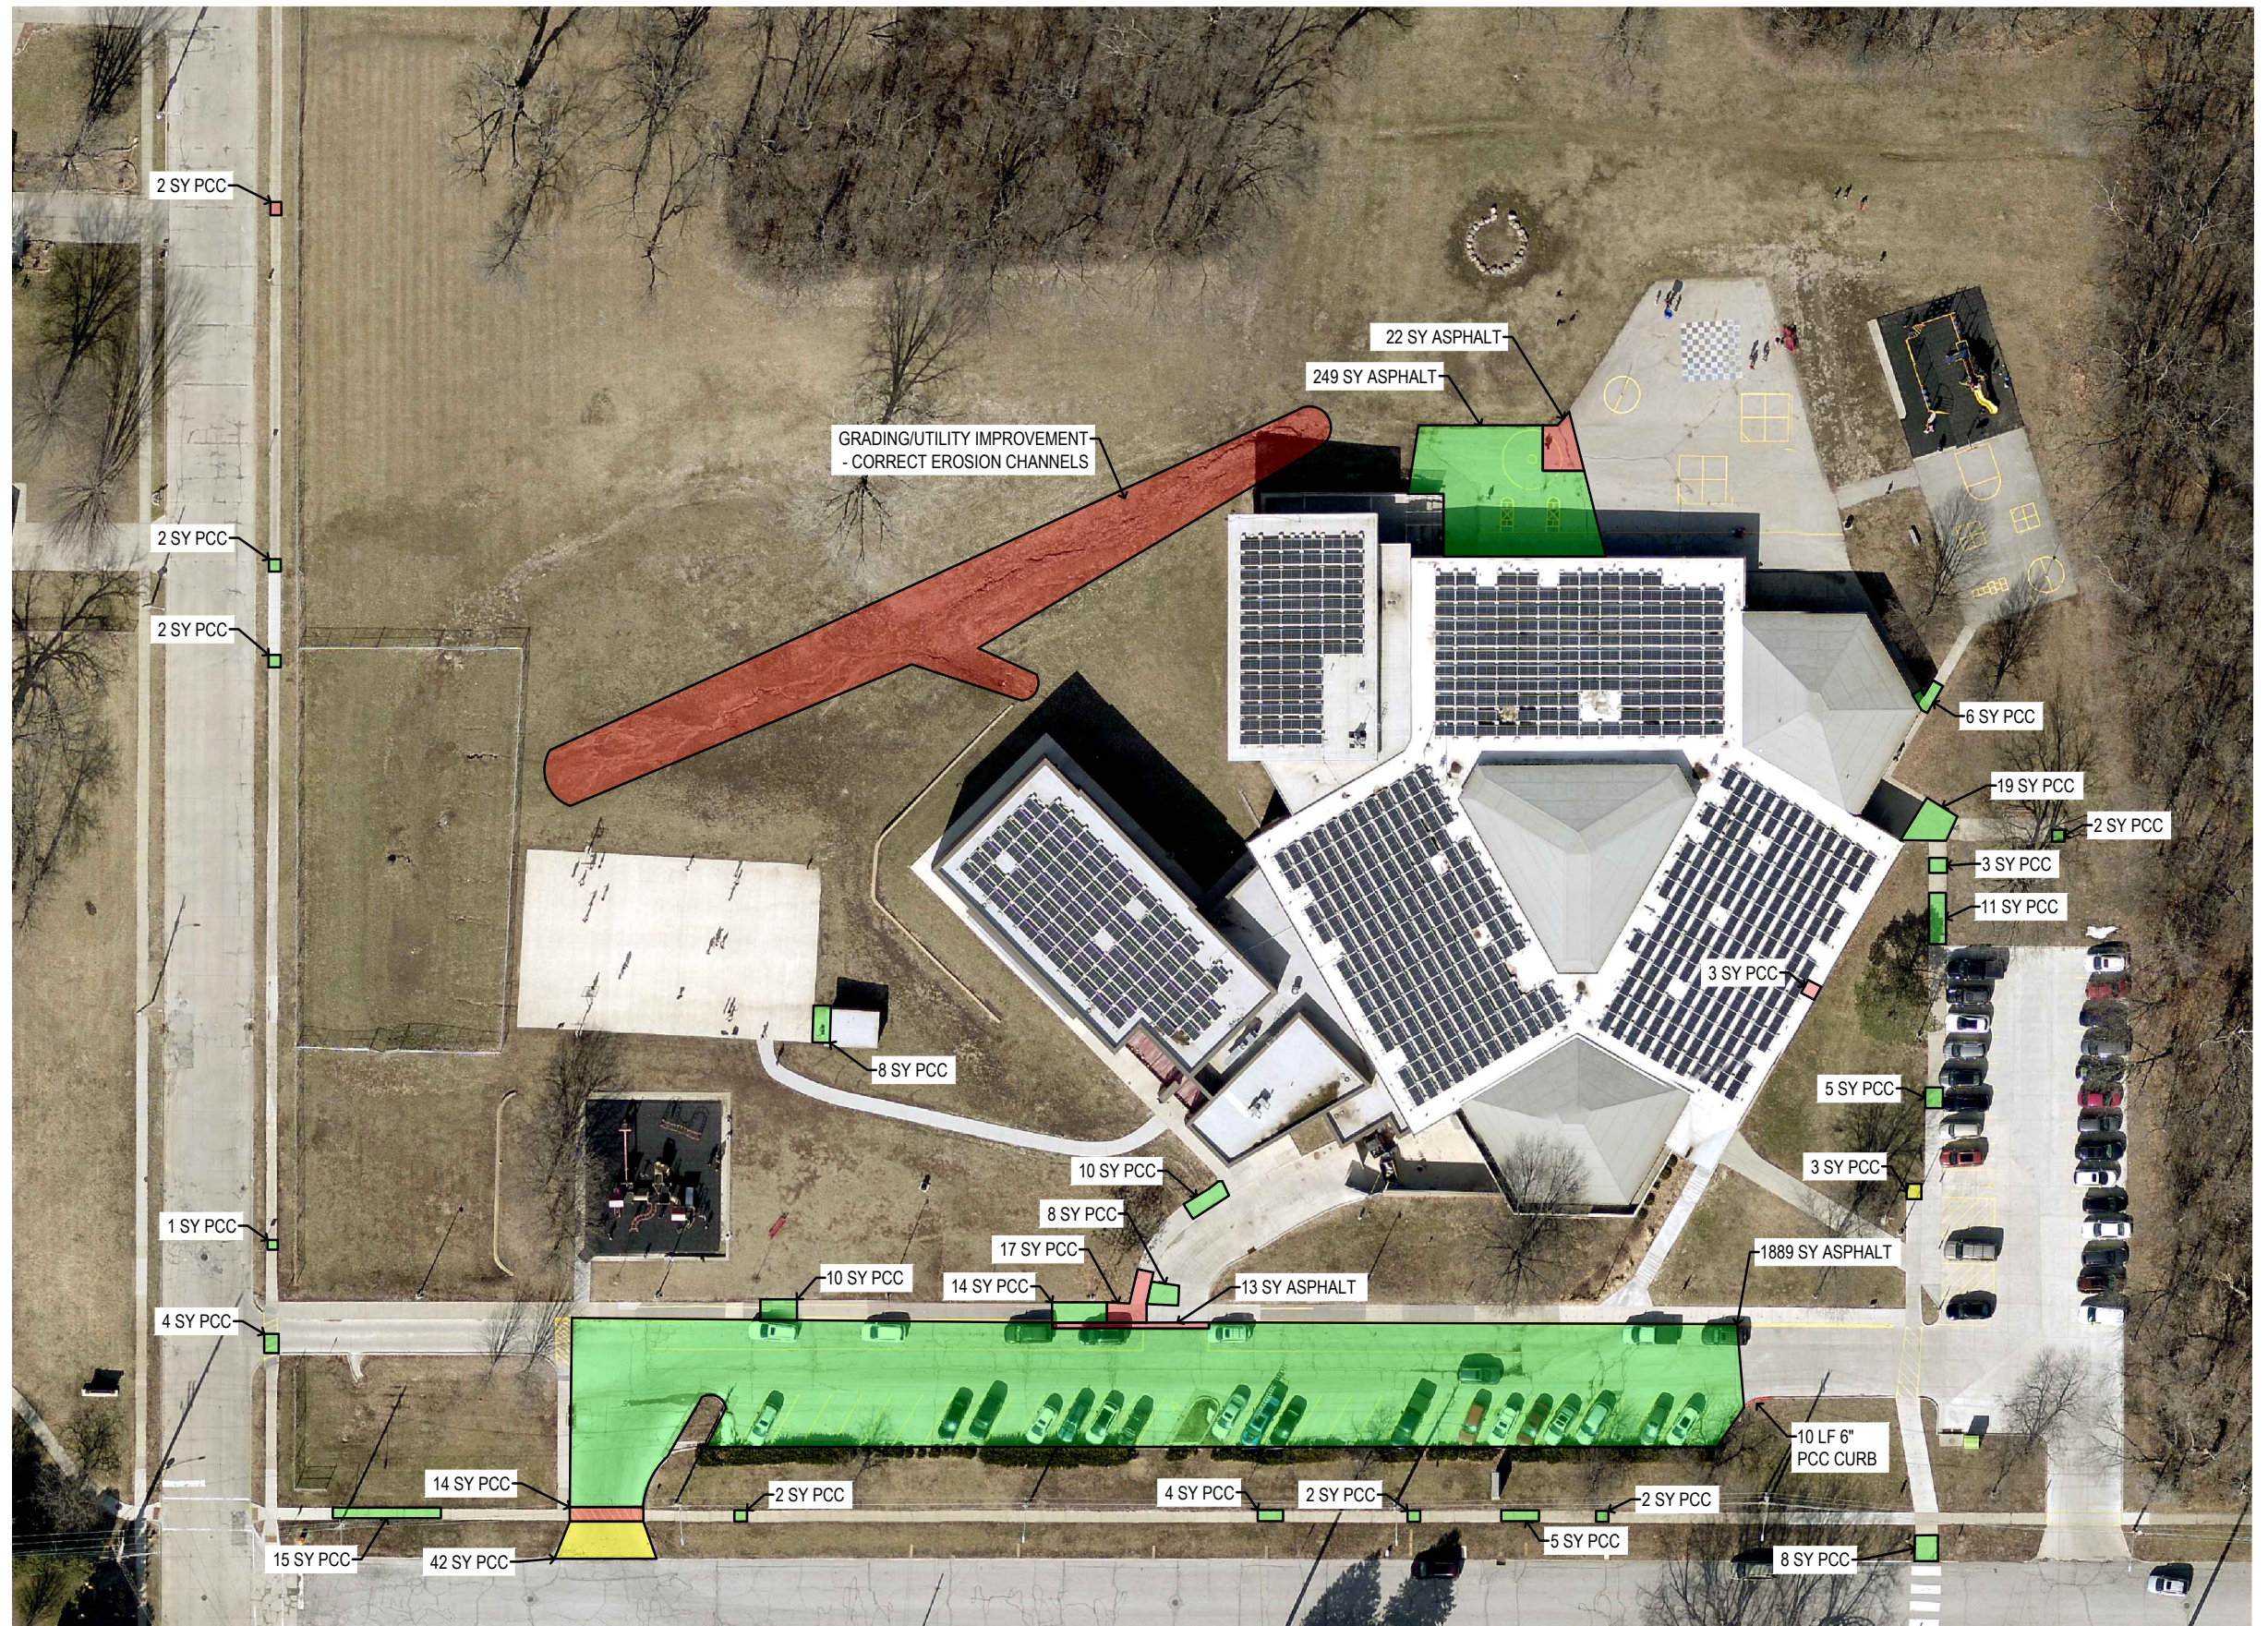
# JEFFERSON ELEMENTARY

- 5+ YEAR REPLACEMENT
- 3-4 YEAR REPLACEMENT
- 1-2 YEAR REPLACEMENT

Sidewalk Replacement	Take out and reinstall 34 SY of PCC sidewalk. For location, refer to civil site plan exhibit found in the appendix of this report.	\$11,000
Playground Pavement Replacement	Remove and replace 22 SY of asphalt. For location, refer to civil site plan exhibit found in the appendix of this report.	\$8,000
Parking Pavement Replacement	Remove 13 SY of asphalt in front of trash enclosure access and replace. For location, refer to civil site plan exhibit found in the appendix of this report.	\$7,000
Erosion Repairs	Install storm sewer line down to detention basin from existing storm sewer outlets on N side of site. For location, refer to civil site plan exhibit found in the appendix of this report.	\$110,000
Curb Repair	Return damaged curbs to new condition. Approximately 10 LF of 6" curbs. For locations, refer to civil site plan exhibit found in the appendix of this report.	\$6,000

Playground Pavement Replacement	Remove and replace 249 SY of asphalt. For location, refer to civil site plan exhibit found in the appendix of this report.	\$45,000
VRF Fan Coil and Condensing Unit Replacement	VRF system is nearing end of serviceable life. Recommend replacement of head-end and branch controllers as Year 1-2 Priority. Replace fan coils and condensing units in 5+ Year Priority.	\$1,100,000
