# DMPS FACILITY ASSESSMENT |

Kurtz Opportunity Center's on-site facility conditions assessment was conducted on March 26, 2024 and included visual conditions assessment from professionals covering interior architecture, exterior building envelope, the property's grounds (site), structural condition, mechanical (HVAC/Plumbing) systems, electrical systems (power, exterior lighting, interior lighting, fire alarm, and general IT), and the elevator conditions.

Building Name: Kurtz Opportunity Center

# KURTZ OPPORTUNITY CENTER

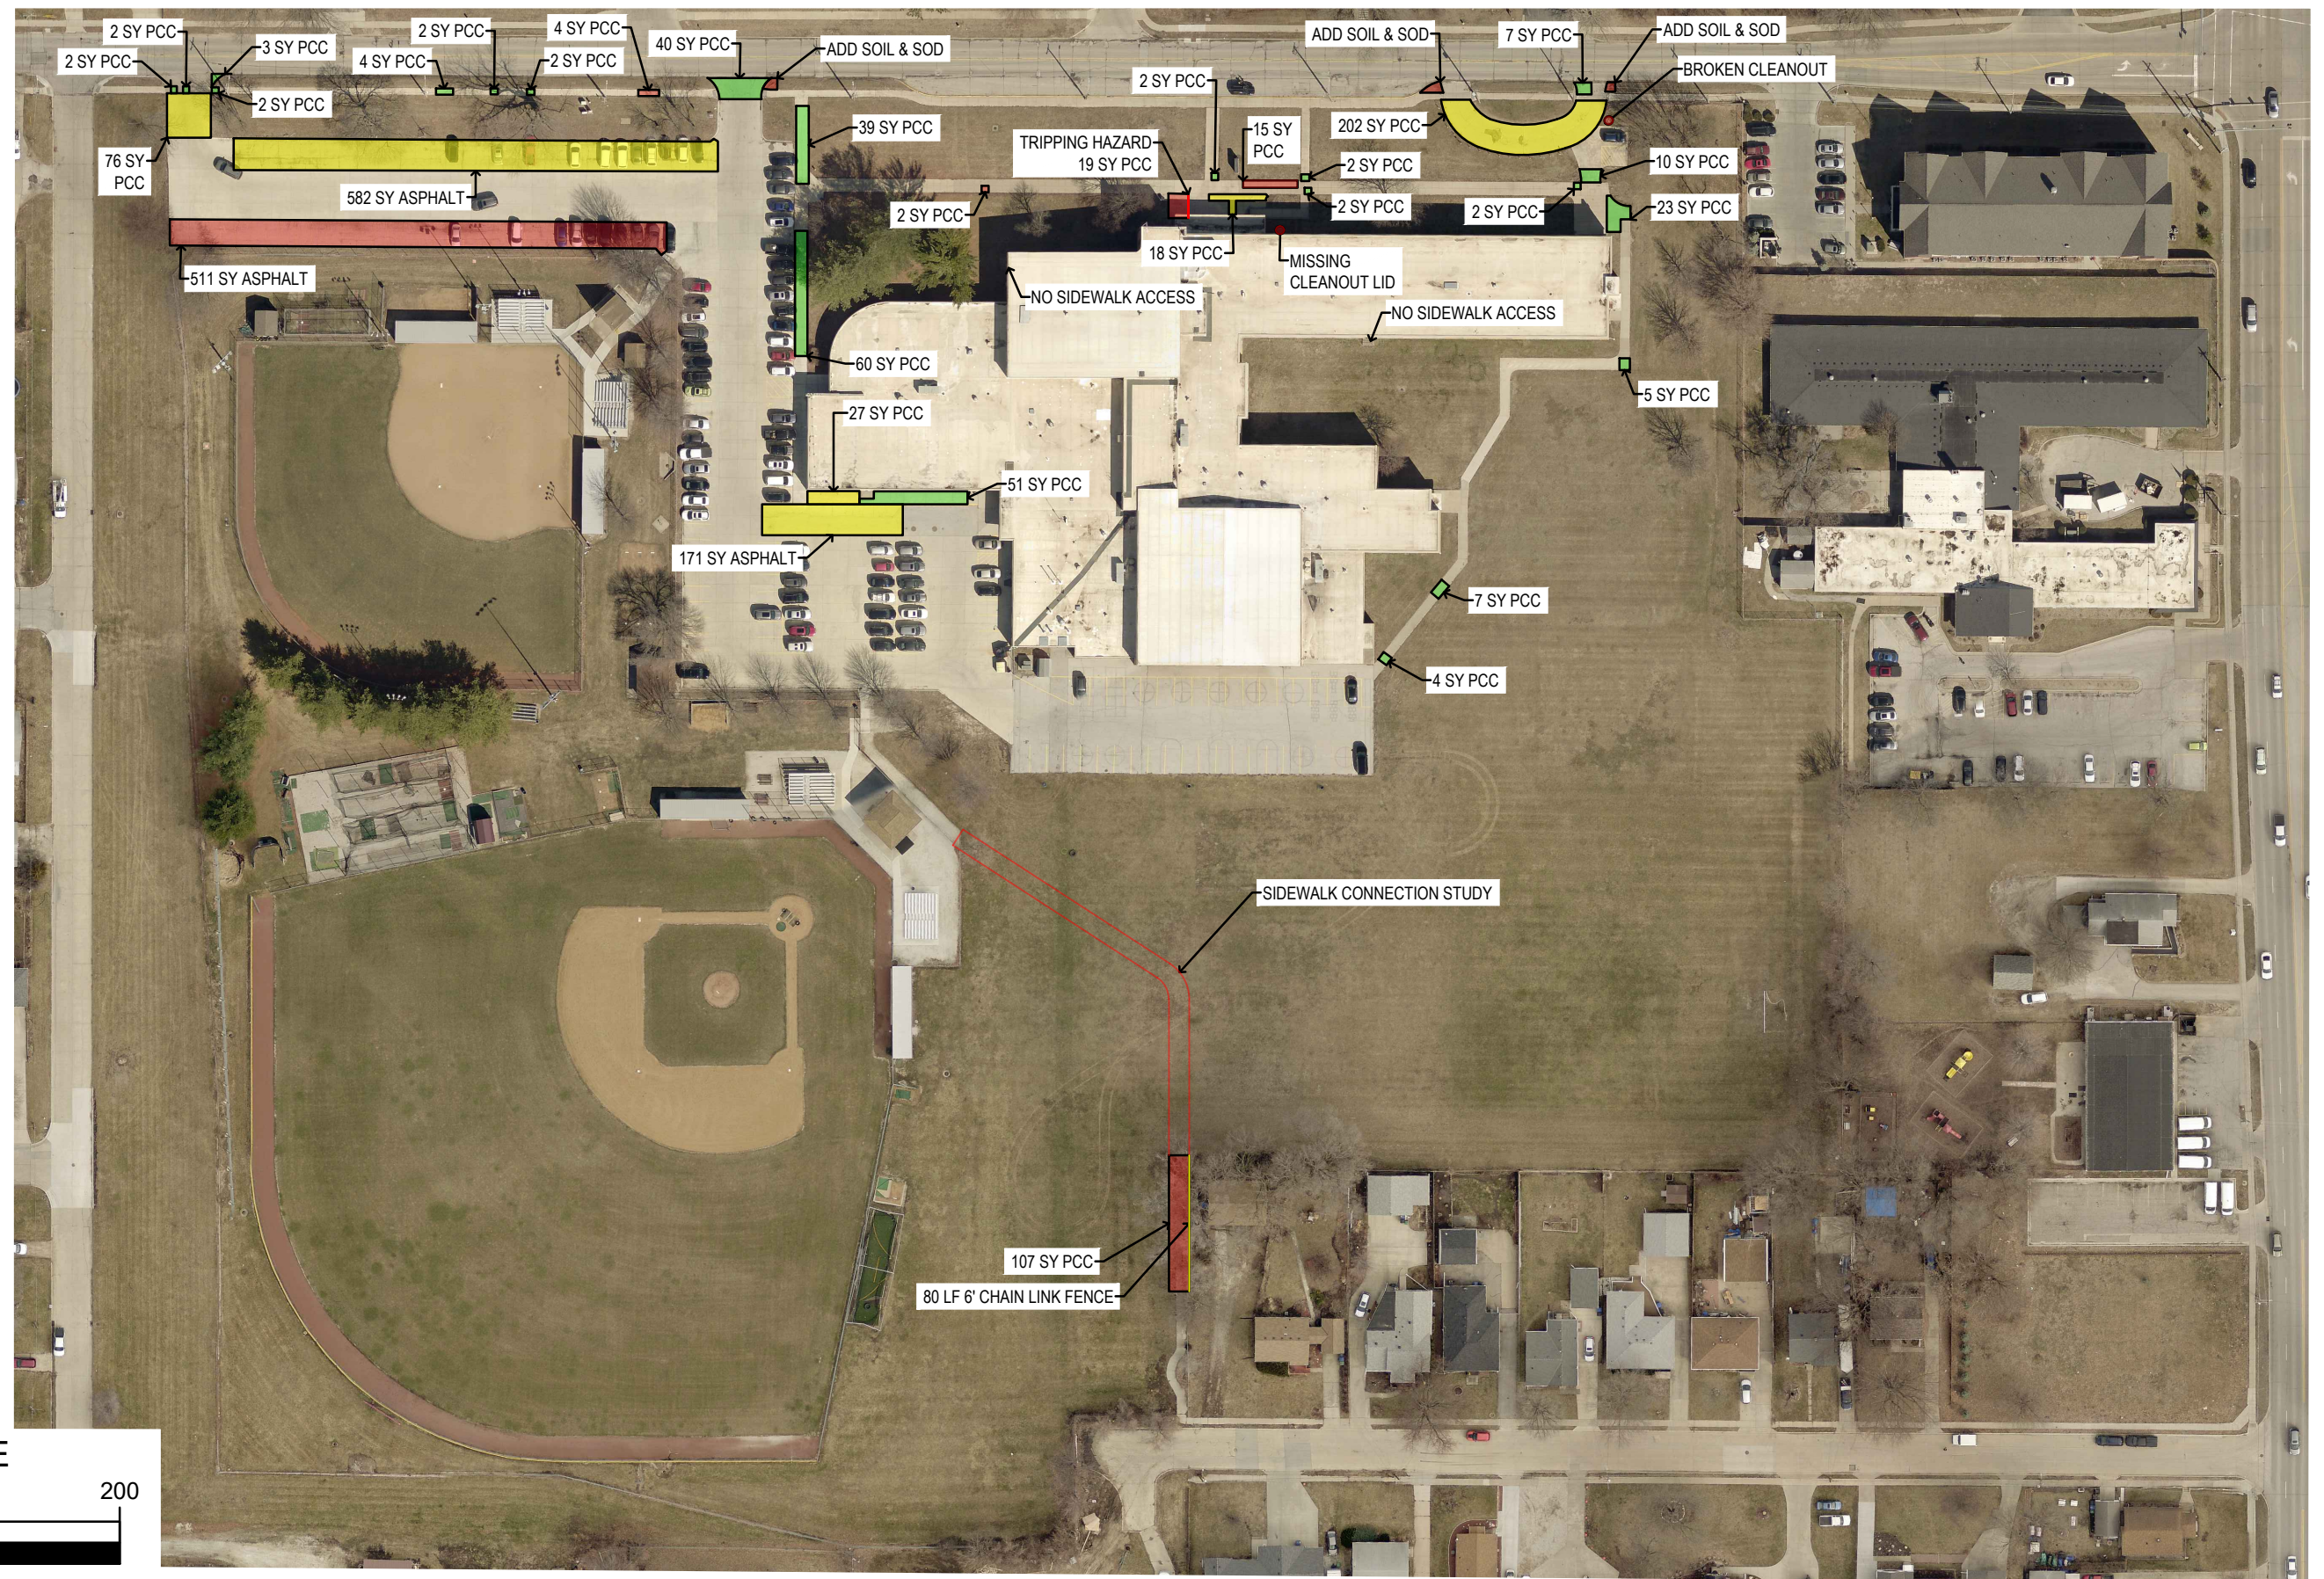
4.2 <b>Parking areas</b> are in good condition.	5	4	20	The asphalt sections in the NW lot are cracking throughout and will need replacement. Most of the concrete parking pavement is in good condition.

4.3 <b>Drive areas</b> are in good condition.	3	4	12	The NE circle drive is cracking and has had patch work done but will need replacement down the road. One of the drive accesses into the parking lot is also cracking but is in better condition.

4.5 <b>Sidewalks</b> around the facility are in good <b>condition.</b>	2	4	8	The sidewalk in front of the north building entrance has a tripping hazard and sections in need of immediate replacement, there are a few other isolated areas that need repair but overall sidewalks are in good condition.

4.7 <b>Fencing</b> around the site is in good condition.	1	4	4	The fencing was mostly in good condition, one location were the fence was overgrown and needs replacement.

Exterior Glazing Replacement	Replace insulated glazing unit in frame at gymnasium windows overlooking roof G, 2' x 4'.	\$6,000
Pavement Replacement	Remove and replace 582 SY of asphalt and 449 SY of PCC. For location, refer to the civil site plan exhibit found in the appendix of this report.	\$150,000

Sidewalk Repairs	Repair damaged sidewalks across the site. Approximately 45 SY. For locations, refer to civil site plan exhibit found in the appendix of this report.	\$12,000
Fence Replacement	Remove and replace 80 LF of 6' chain link fence. For locations, refer to civil site plan exhibit found in the appendix of this report.	\$12,000
Floor Slab Patch	Patch concrete in elevated concrete floor slab at the beginning of the East tunnel off of room 0100. 3'-0" X 3'-0" X 4" thick.	\$8,000
Concrete Patch	Patch 6" X 6" X 4" deep section of concrete at the NE and SE corner of the ramp railing posts at the main entrance.	\$6,000
Stoop Installation	Install stoops for doors outside of rooms 1535, 1530A, and 1400. Stoops should be 5' x 5' x 5" thick w/ #4 @ 9" o.c. ea. Way. Stoop walls shall be 8" wide x 3'-6" below grade w/ #4 bars @ 12" o.c. each way. Provide #4 dowels 3'-0" long from stoop slab to stoop walls.	\$13,000
