DMPS FACILITY ASSESSMENT | MADISON ELEMENTARY

12.19.2023

EXECUTIVE BUILDING SUMMARY

Building Data Record

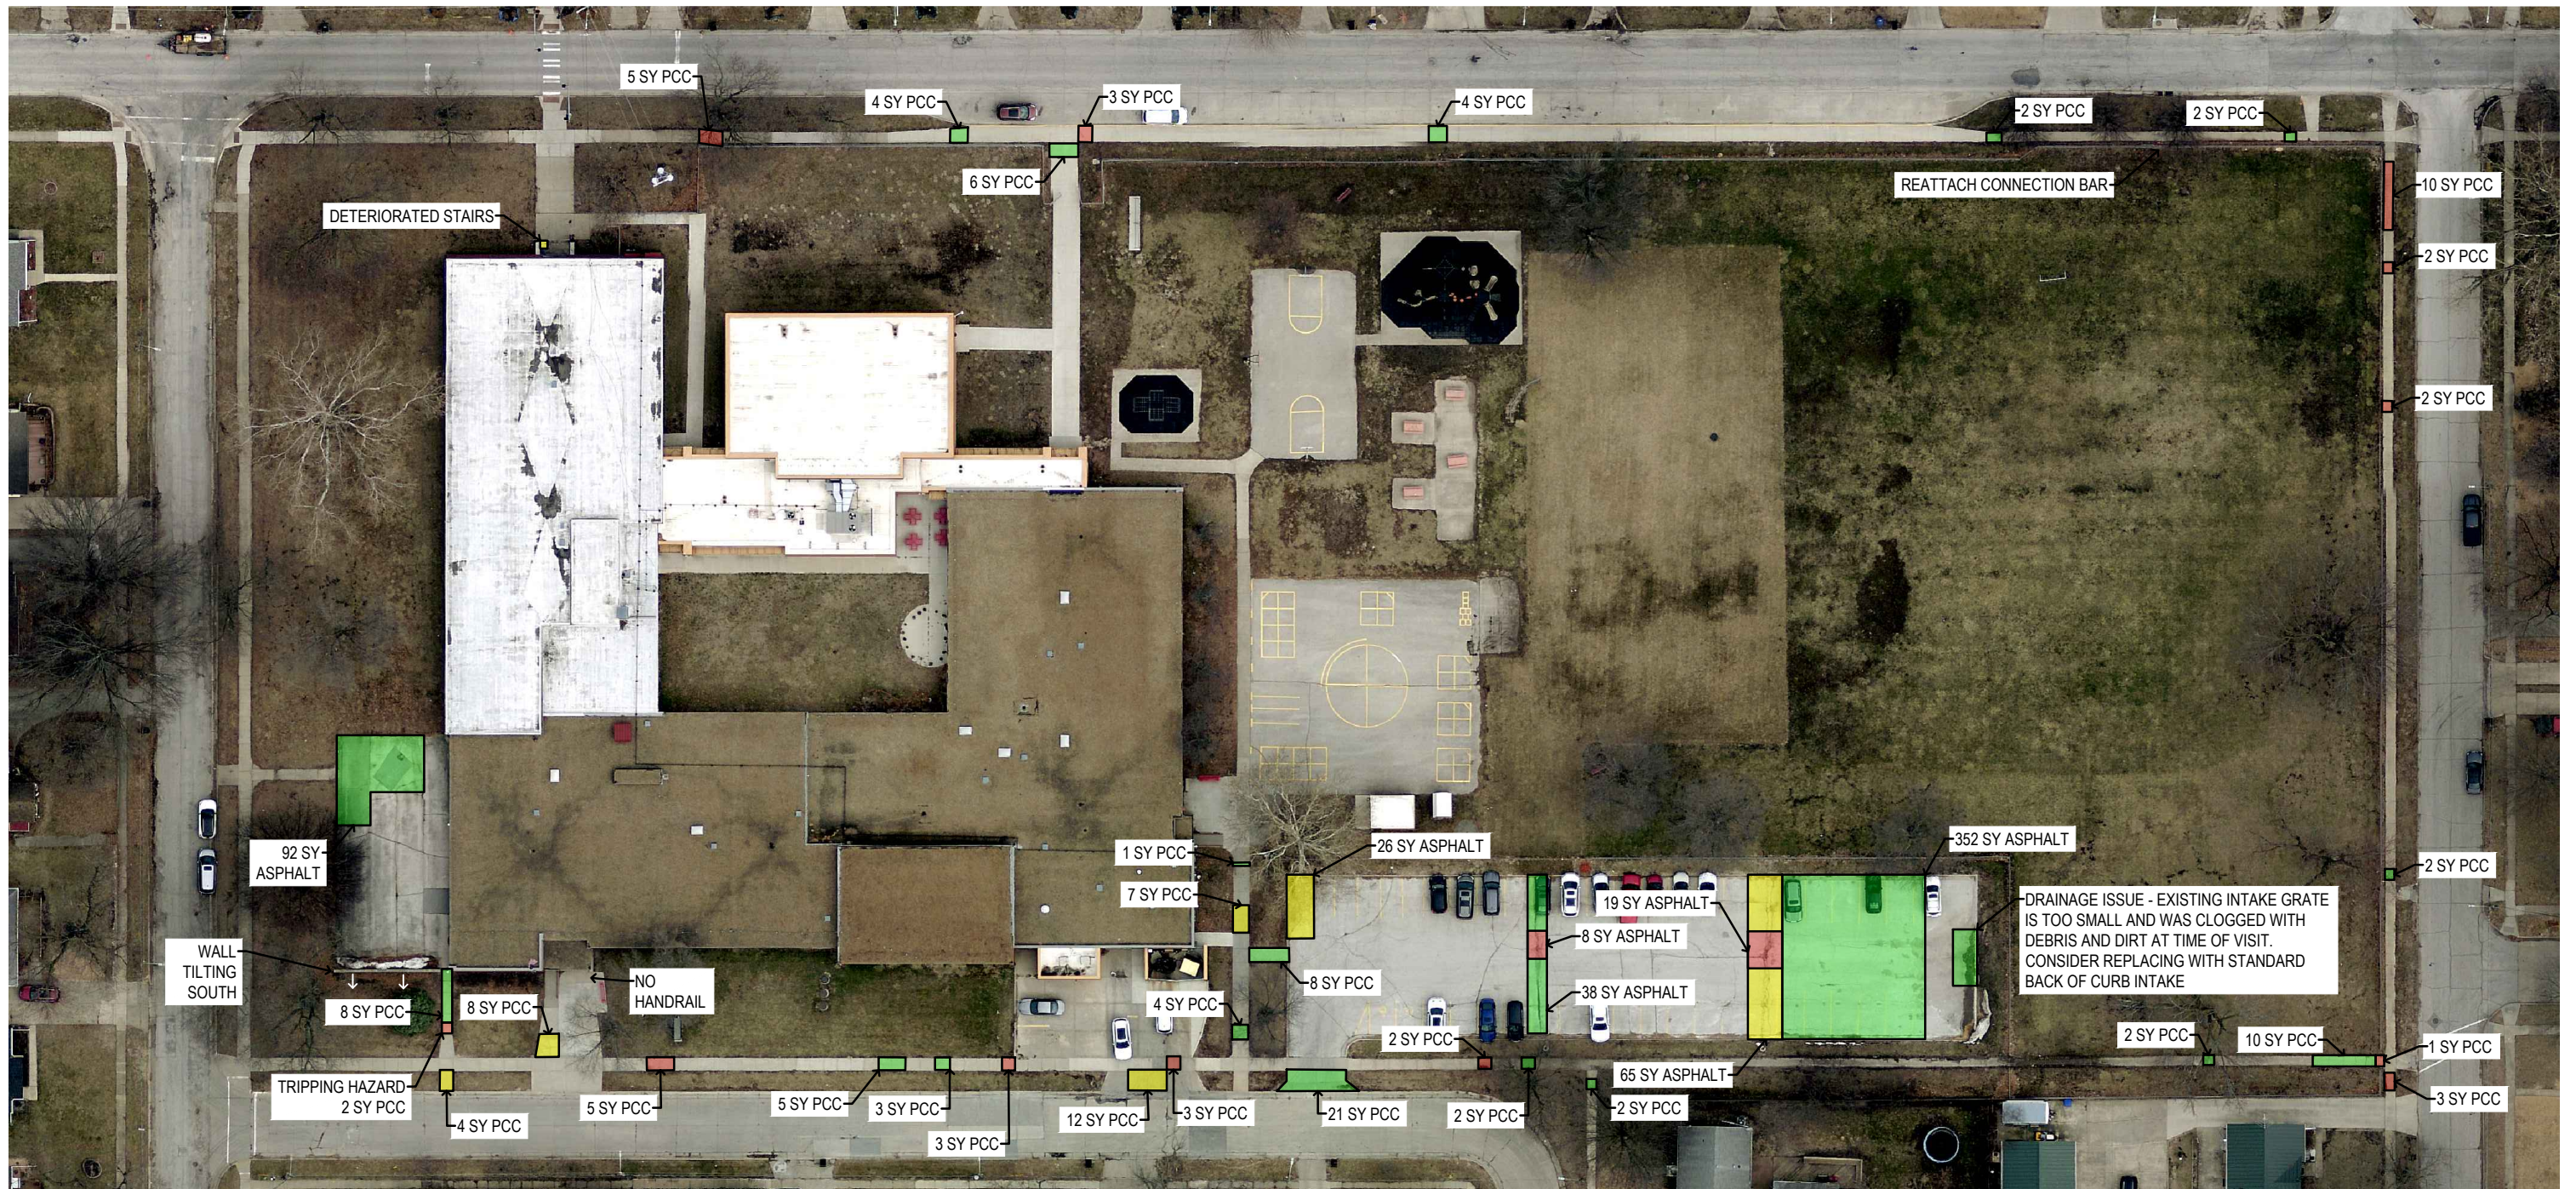
MADISON ELEMENTARY

4.5 Sidewalks around the facility are in good condition .	1	3	3	The east side of the site had sections needing replacement and there were portions of sidewalk by the south entrance also needing replacement.

4.7 Hard surface playground surfaces are in good condition.	3	4	12	Some of the asphalt on the western side is cracking and needs replacement, all other playground surfaces were good.

4.10 Utilities are in newly constructed conditions and placed in suitable locations.	1	4	4	The circular intake at the east end of the parking lot is too small and was clogged. Replacing with a standard back of curb intake

Pavement Replacement	Remove and replace 12 SY of PCC and 45 SY of asphalt. For locations, refer to civil site plan exhibit found in the appendix of this report.	\$12,000
Sidewalk Repair	Repair damaged sidewalks across the site. Approximately 19 SY. For locations, refer to civil site plan exhibit found in the appendix of this report.	\$9,000

Intake Replacement	Replace small circular intake with standard back of curb intake. For location, refer to civil site plan exhibit found in the appendix of this report.	\$25,000
Screen Brick Wall Replacement	Replace brick wall that is leaning over or just remove wall. For location, refer to civil site plan exhibit found in the appendix of this report.	\$35,000
