DMPS FACILITY ASSESSMENT |

EXECUTIVE BUILDING SUMMARY

Building Name: **McCombs Middle**

Date: **1.30.2024**

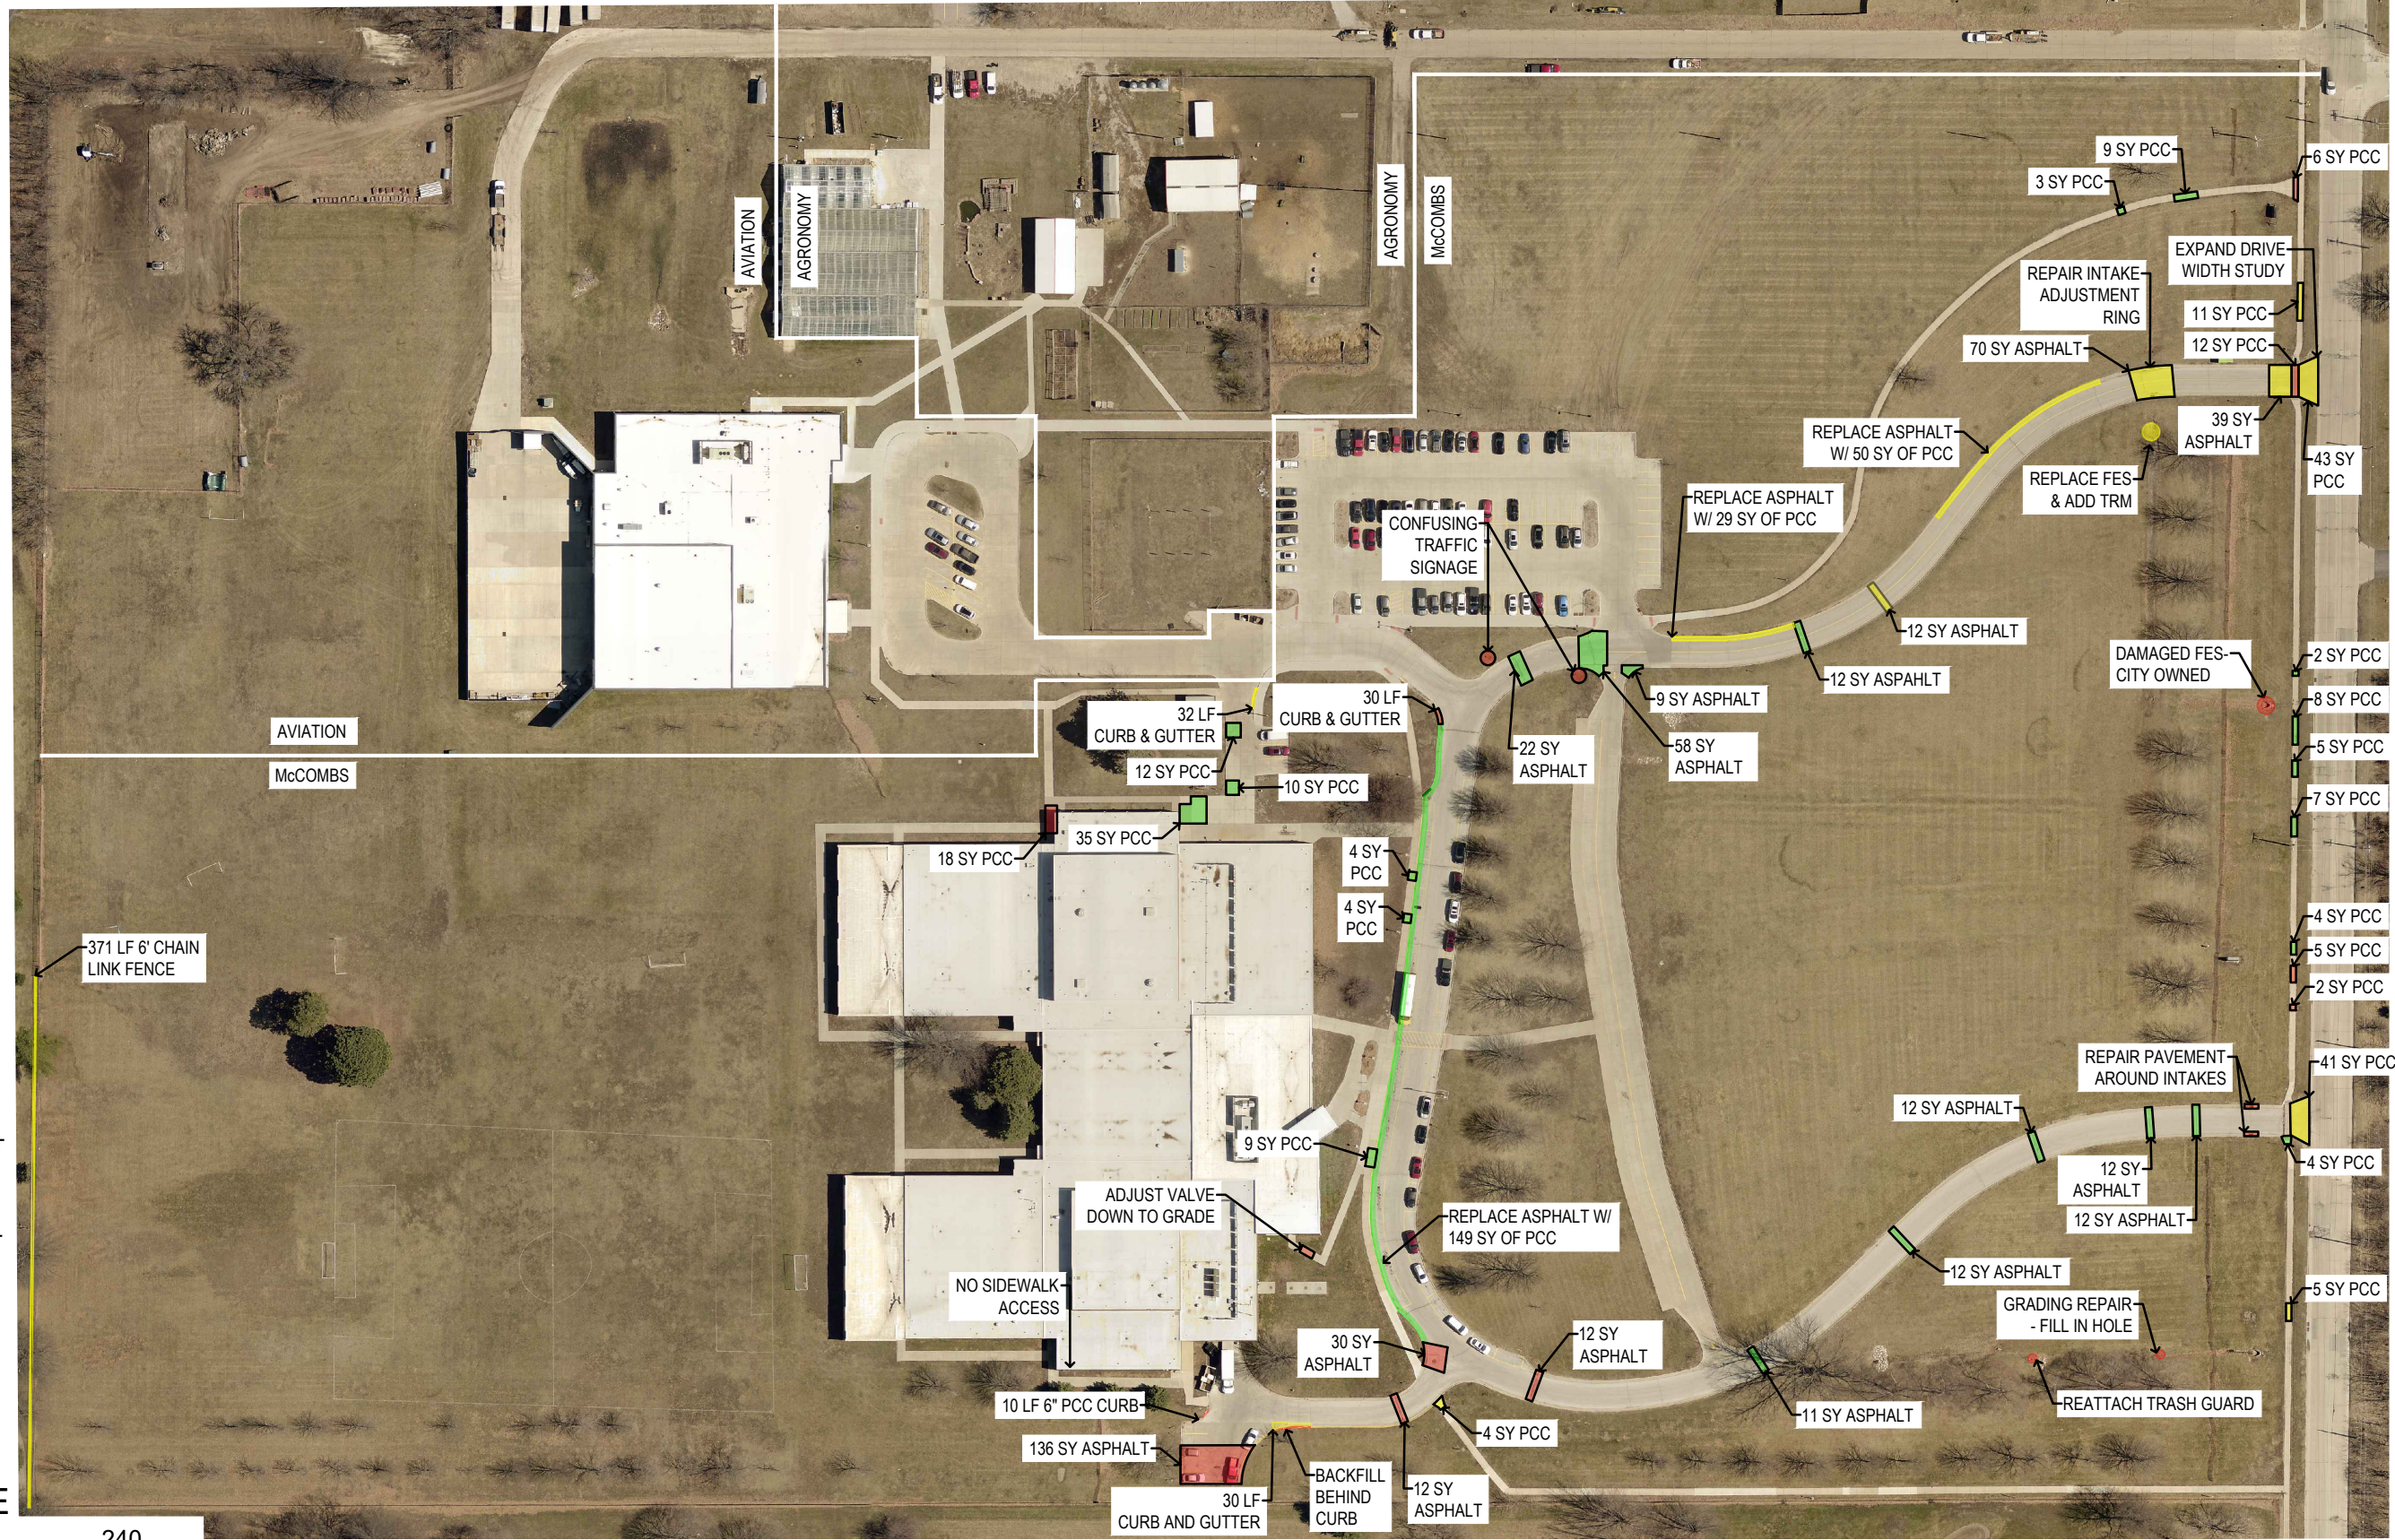
- 5+ YEAR REPLACEMENT
- 3-4 YEAR REPLACEMENT
- 1-2 YEAR REPLACEMENT

Pavement Replacement	Remove and replace 140 SY of PCC and 206 SY of asphalt. For location, refer to the civil site plan exhibit found in the appendix of this report.	\$45,000
Curb and Gutter Repairs	Return damaged curbs and adjacent pavement to new condition. Approximately 40 LF of 6" curbs. For locations, refer to civil site plan exhibit found in the appendix of this report.	\$8,000
Sidewalk Repairs	Repair damaged sidewalks across the site. Approximately 43 SY. For locations, refer to civil site plan exhibit found in the appendix of this report.	\$11,000
Mechanical Floor Patch	The mechanical room above room 1607 has a section of floor that has spalled concrete and exposed wire mesh. It appears to be the result of a concrete mechanical pad that was cut out and removed. The floor should be patch to ensure it's structural integrity. The area is 5ft x 10ft and requires a 3" thick patch. No additional reinforcement.	\$11,000

Sidewalk Repairs	Repair damaged sidewalks across the site. Approximately 20 SY. For locations, refer to civil site plan exhibit found in the appendix of this report.	\$9,000

Fence Replacement	Remove and replace 371 LF of 6' chain link fence. For locations, refer to civil site plan exhibit found in the appendix of this report.	\$40,000
Intake Repair	Repair the adjustment ring of intake, the project should be coordinated with pavement replacement of the area. For locations, refer to civil site plan exhibit found in the appendix of this report.	\$7,000
Curb and Gutter Repairs	Return damaged curbs and adjacent pavement to new condition. Approximately 33 LF of 6" curbs. For locations, refer to civil site plan exhibit found in the appendix of this report.	\$9,000
FES Replacement	Replace the damaged FES and add TRM at the outlet to prevent erosion wash out. For location, refer to civil site plan exhibit found in the appendix of this report.	\$12,000
Replace Domestic Water Galvanized Piping	Replace galvanized piping on service side of backflow preventer.	\$30,000
MDP Replacement	Replace existing 3000A fused switchboard MS with appropriately sized switchgear utilizing breakers to allow for appropriately sized equipment and ample breaker space for expansion.	\$460,000
