# DMPS FACILITY ASSESSMENT | MCKEE EDUCATION CENTER

01.23.2024

# EXECUTIVE BUILDING SUMMARY

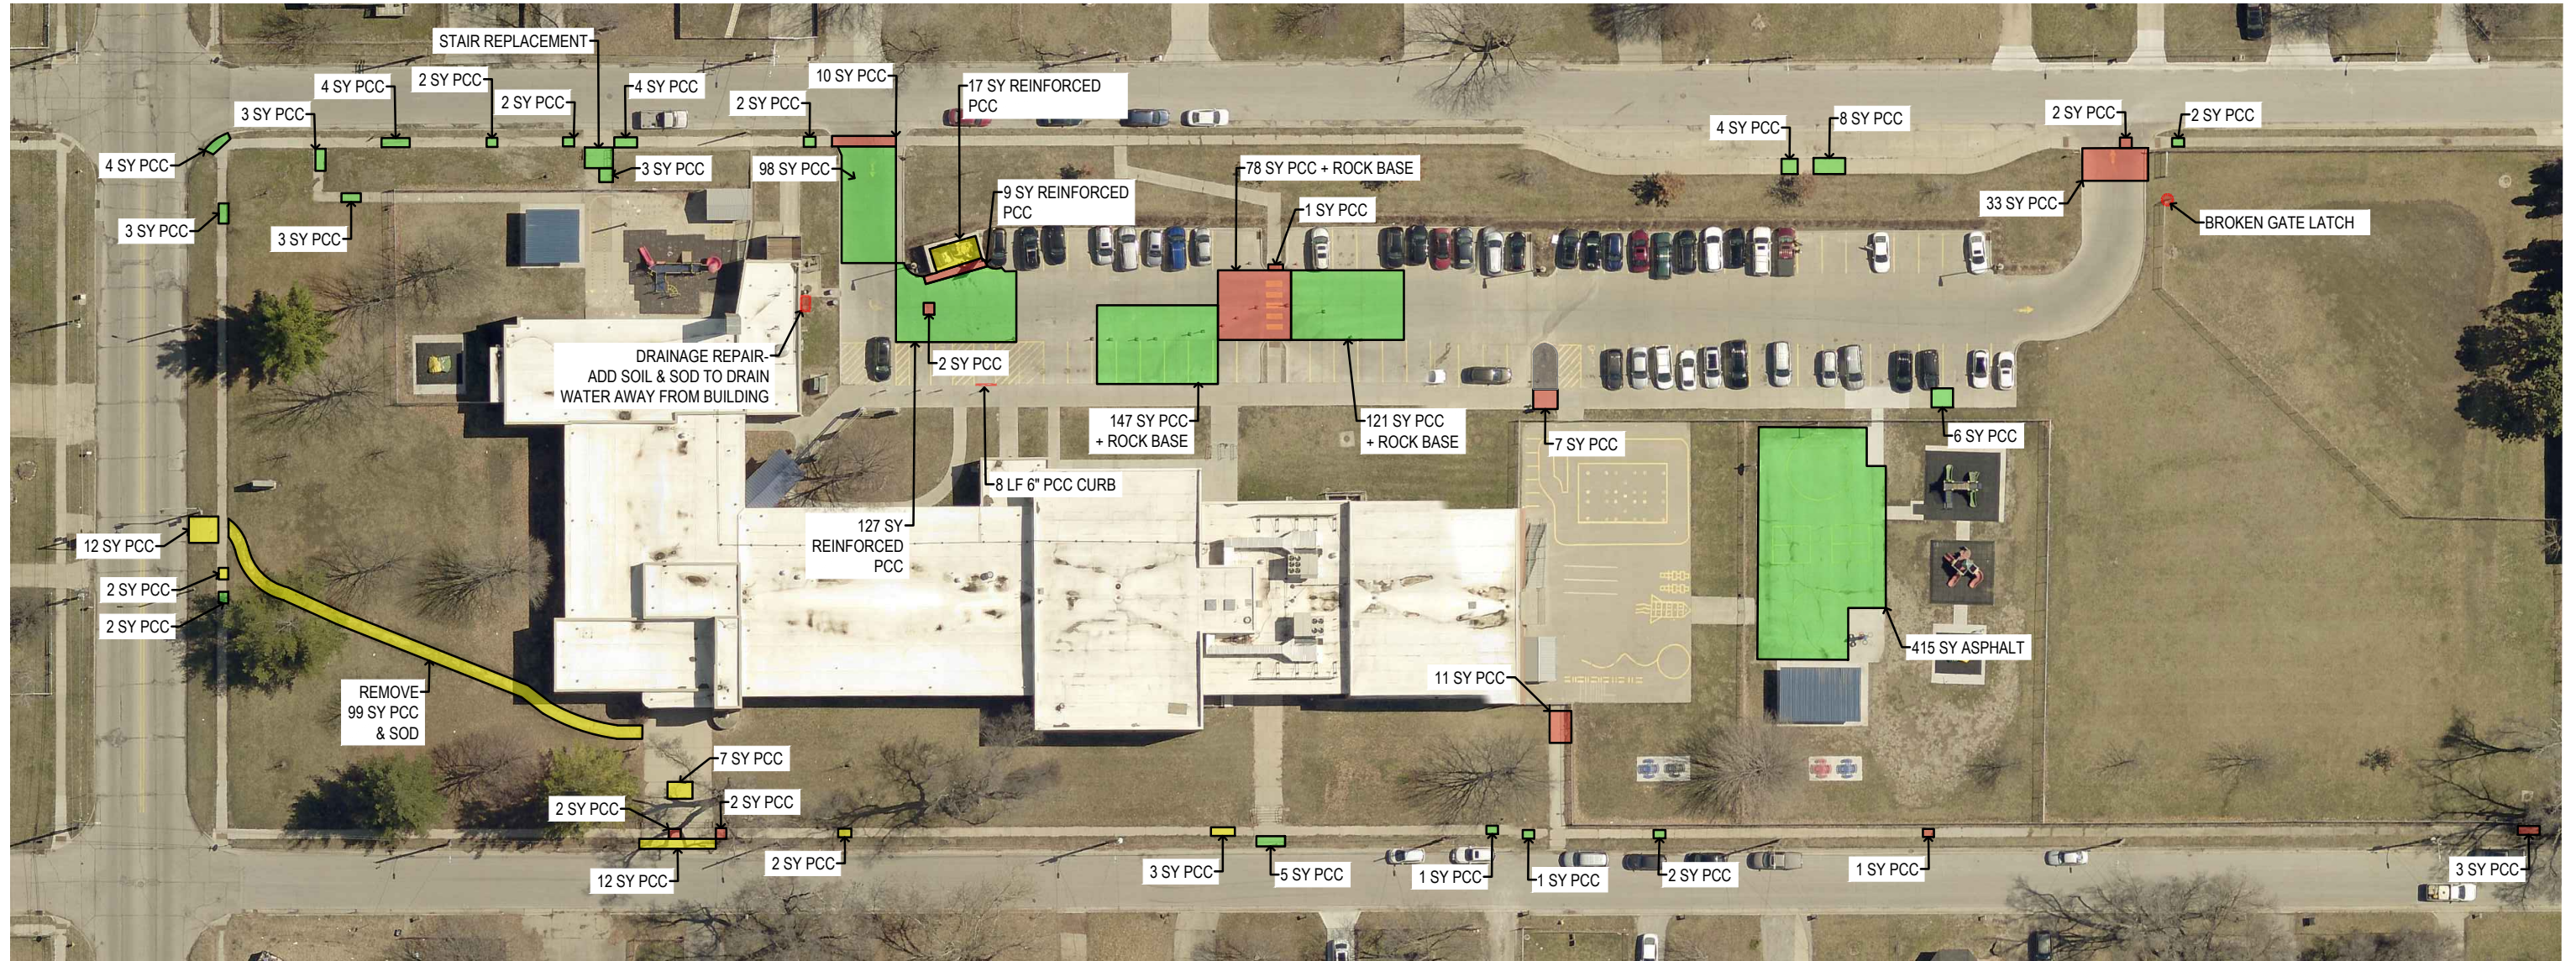
# McKEE EDUCATION CENTER

4.3 <b>Drive areas</b> are in good condition.	3	3	9	The access drives into the east parking lot have deteriorated and require replacement. The drive area in the between the sidewalk in the east parking lot is experiencing subsurface moisture issues and should be replaced soon.

4.5 <b>Sidewalks</b> around the facility are in good <b>condition</b> .	1	3	3	The west side sidewalk in front of the building appeared to have been redone recently, with a new ADA ramp included. What appeared to be the old ADA route to the west building door has deteriorated and should be removed. Other isolated sections across site and a set of stairs require replacement.

4.9 <b>Trash enclosure</b> is in good condition.	1	3	3	The pavement in front of the trash enclosure was broken and the pavement where the dumpsters sit was cracking, both should be replaced with reinforced PCC. The masonry brick and gate were in good condition.

Pavement Replacement	Remove 122 SY of pavement and replace with 9 SY of reinforced PCC and add a rock base under the 78 SY experiencing subsurface moisture issues. For locations, refer to civil site plan exhibit found in the appendix of this report.	\$25,000
Sidewalk Repair	Repair damaged sidewalks across the site. Approximately 39 SY. For locations, refer to civil site plan exhibit found in the appendix of this report.	\$11,000
Curb Repair	Return damaged curbs to new condition. Approximately 8 LF of 6" curbs. For locations, refer to civil site plan exhibit found in the appendix of this report.	\$6,000
DOAS Unit Modifications.	Review existing DOAS units to confirm why operation during wintertime is an issue. Correct this issue. This project costs included installing electric pre-heat coils, though actual solution needs to be confirmed.	\$50,000
Power Outlet Installation	Long extension cords were observed loosely taped to floors and walls in reach of children in rooms 105 and 106. Add two tamperproof power outlets (four total) at these rooms to reduce the need for extension cords.	\$9,000

Pavement Replacement	Remove 9 SY of trash enclosure pavement and replace with reinforced PCC. For location, refer to civil site plan exhibit found in the appendix of this report.	\$7,000
Sidewalk Repairs	Remove 137 SY of sidewalk, replace 38 SY of still in use sidewalk, and sod over the 99 SY of old ADA route sidewalk. For locations, refer to civil site plan exhibit found in the appendix of this report.	\$25,000

Stair Replacement	Remove and replace deteriorated stairs. For location, refer to civil site plan exhibit found in the appendix of this report.	\$35,000
