DMPS FACILITY ASSESSMENT | MEREDITH MIDDLE SCHOOL

02.13.2024

EXECUTIVE BUILDING SUMMARY

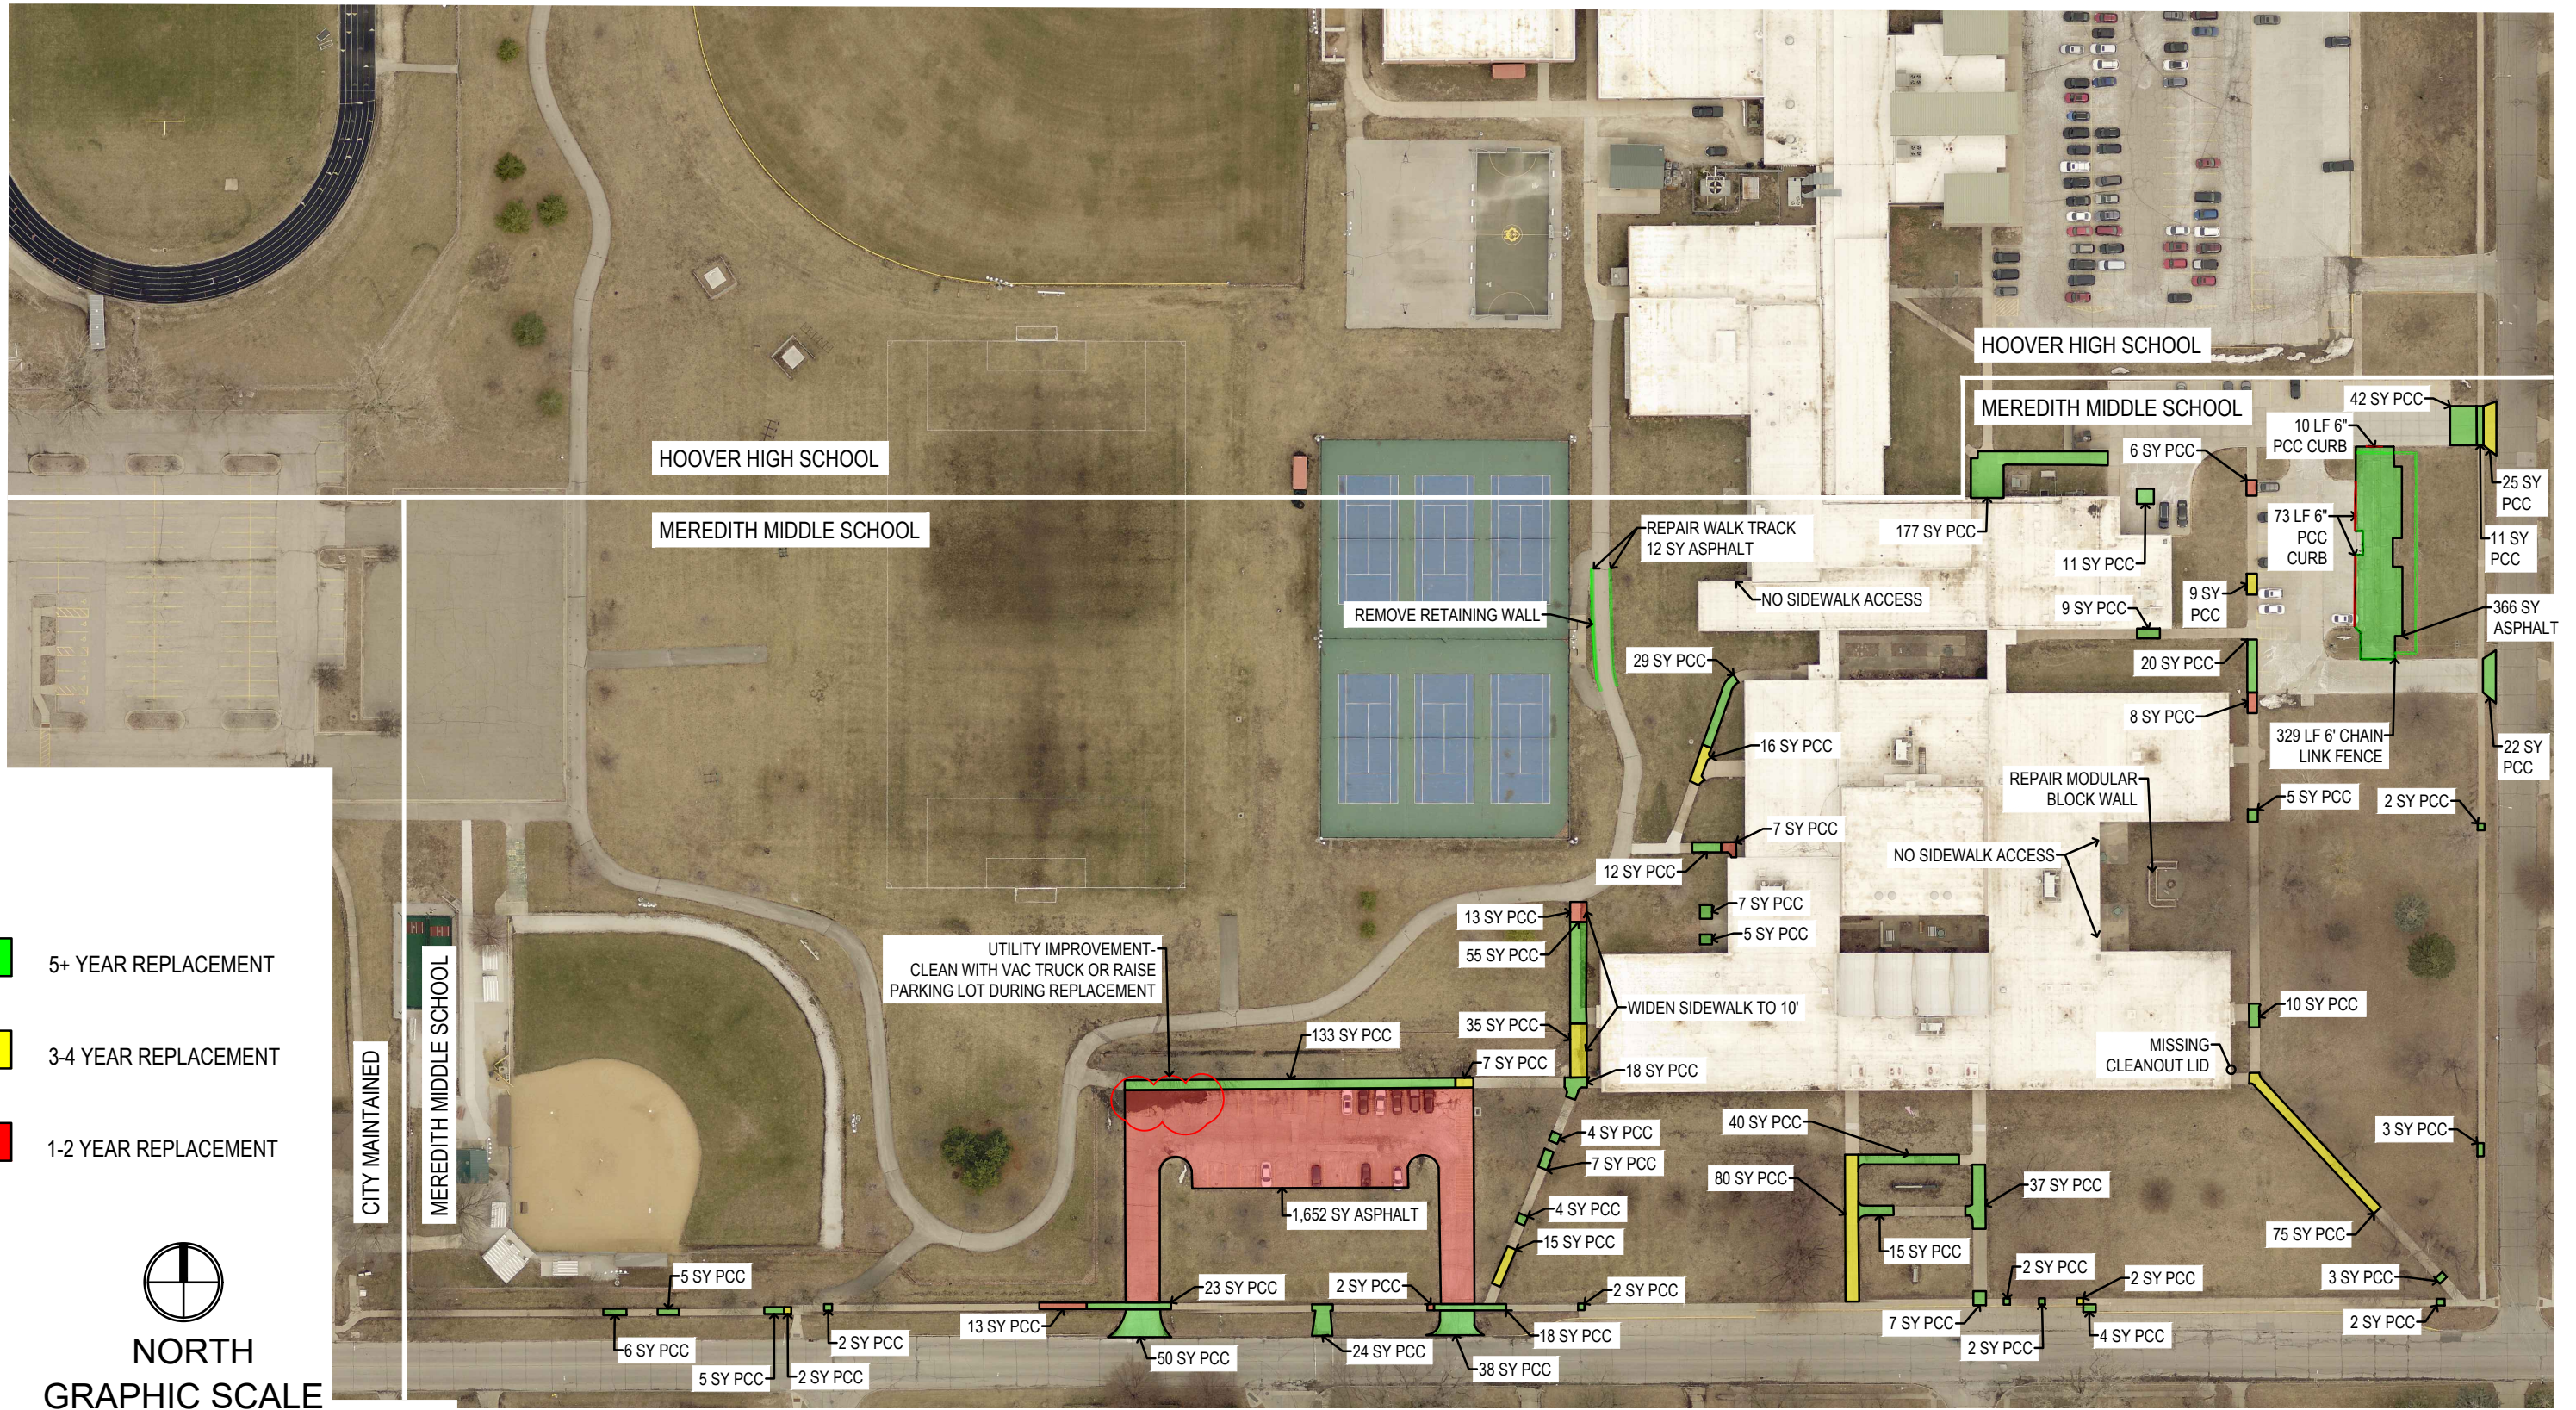
- 5+ YEAR REPLACEMENT
- 3-4 YEAR REPLACEMENT
- 1-2 YEAR REPLACEMENT

Pavement Replacement	<p>Remove and replace 1,652 SY of asphalt. For location, refer to the civil site plan exhibit found in the appendix of this report.</p>	\$220,000
Sidewalk Repairs	<p>Repair damaged sidewalks across the site. Approximately 36 SY. For locations, refer to civil site plan exhibit found in the appendix of this report.</p>	\$11,000
Curb Repairs	<p>Return damaged curbs to new condition. Approximately 83 LF of 6" curbs. For locations, refer to civil site plan exhibit found in the appendix of this report.</p>	\$10,000
Thermsotatic Mixing Valve Replacement	<p>Install digital thermsotatic mixing valve in place of existing.</p>	\$13,000
Geo-loop Bypass Valve Repiping	<p>Repipe three way valve to allow exterior well field to be bypassed. Currently three way valve bypasses flow around boilers.</p>	\$85,000

Pavement Replacement	Remove and replace 163 SY of PCC. For location, refer to the civil site plan exhibit found in the appendix of this report.	\$30,000
Sidewalk Repairs	Repair damaged sidewalks across the site. Approximately 635 SY. For locations, refer to civil site plan exhibit found in the appendix of this report.	\$140,000
Bike Rack Pavement Replacement	Remove and replace 390 SY of asphalt around the bike racks. For location, refer to the civil site plan exhibit found in the appendix of this report.	\$70,000
Fence Replacement	Remove and replace 329 LF of 6' chain link fence. For location, refer to the civil site plan exhibit found in the appendix of this report.	\$45,000
Wall Removal and Track Repairs	Remove the wooden retaining wall and repair the damaged section of walk track. For location, refer to the civil site plan exhibit found in the appendix of this report.	\$25,000
