DMPS FACILITY ASSESSMENT |

EXECUTIVE BUILDING SUMMARY

Building Name: **Merrill Middle**

MERRILL MIDDLE SCHOOL

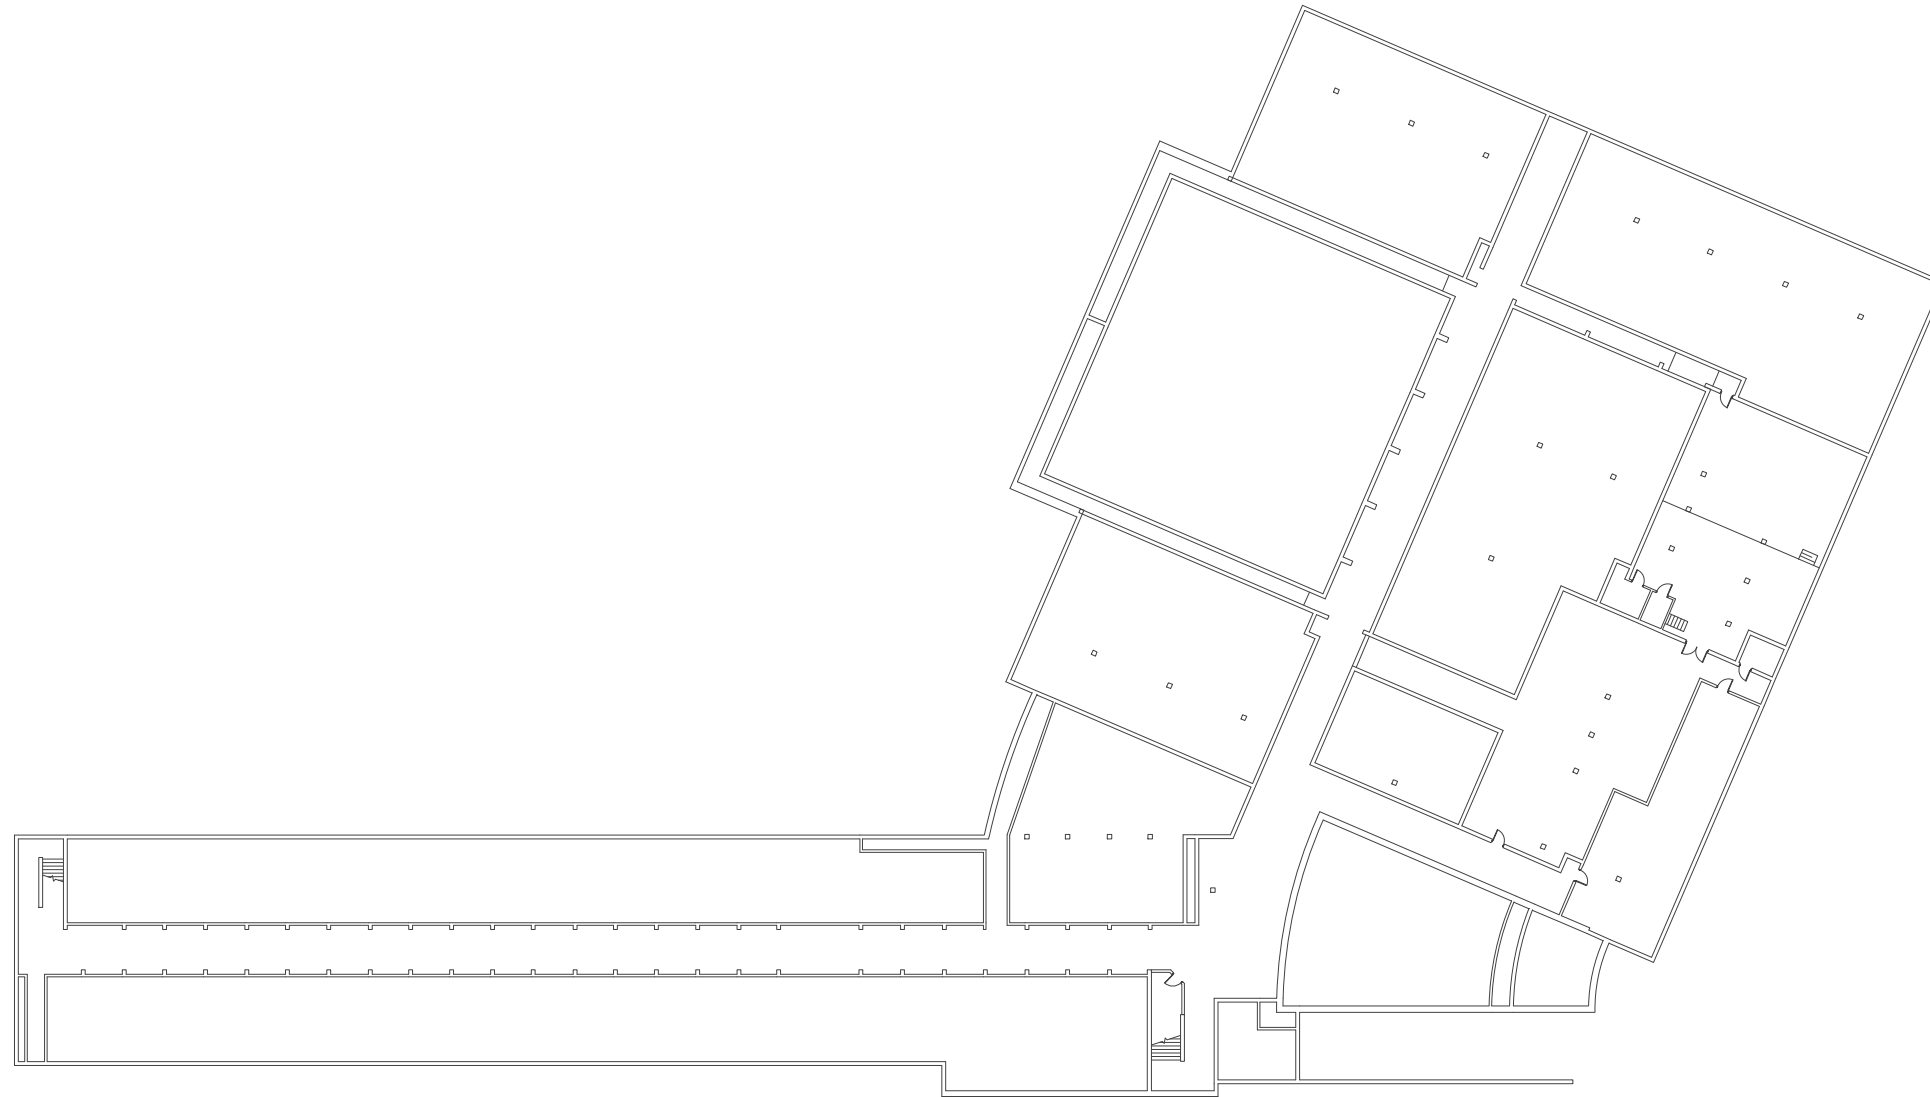
Fully-adhered TPO roofs appear to be in good condition, with only minor areas of ponded water. Staff stated that there is an active leak near rooftop equipment on Roof A (See appendix for roof identification plan) which has not been able to be identified/repaired.

Significant buildup of leaves/acorns in several areas of roof, most notably on Roof D (see appendix for roof identification plan) where piles of vegetative debris found in several locations along roof edge, and surrounding a couple of roof drain strainers.
