# DMPS FACILITY ASSESSMENT | MITCHELL EARLY LEARNING CENTER

01.23.2024

# EXECUTIVE BUILDING SUMMARY

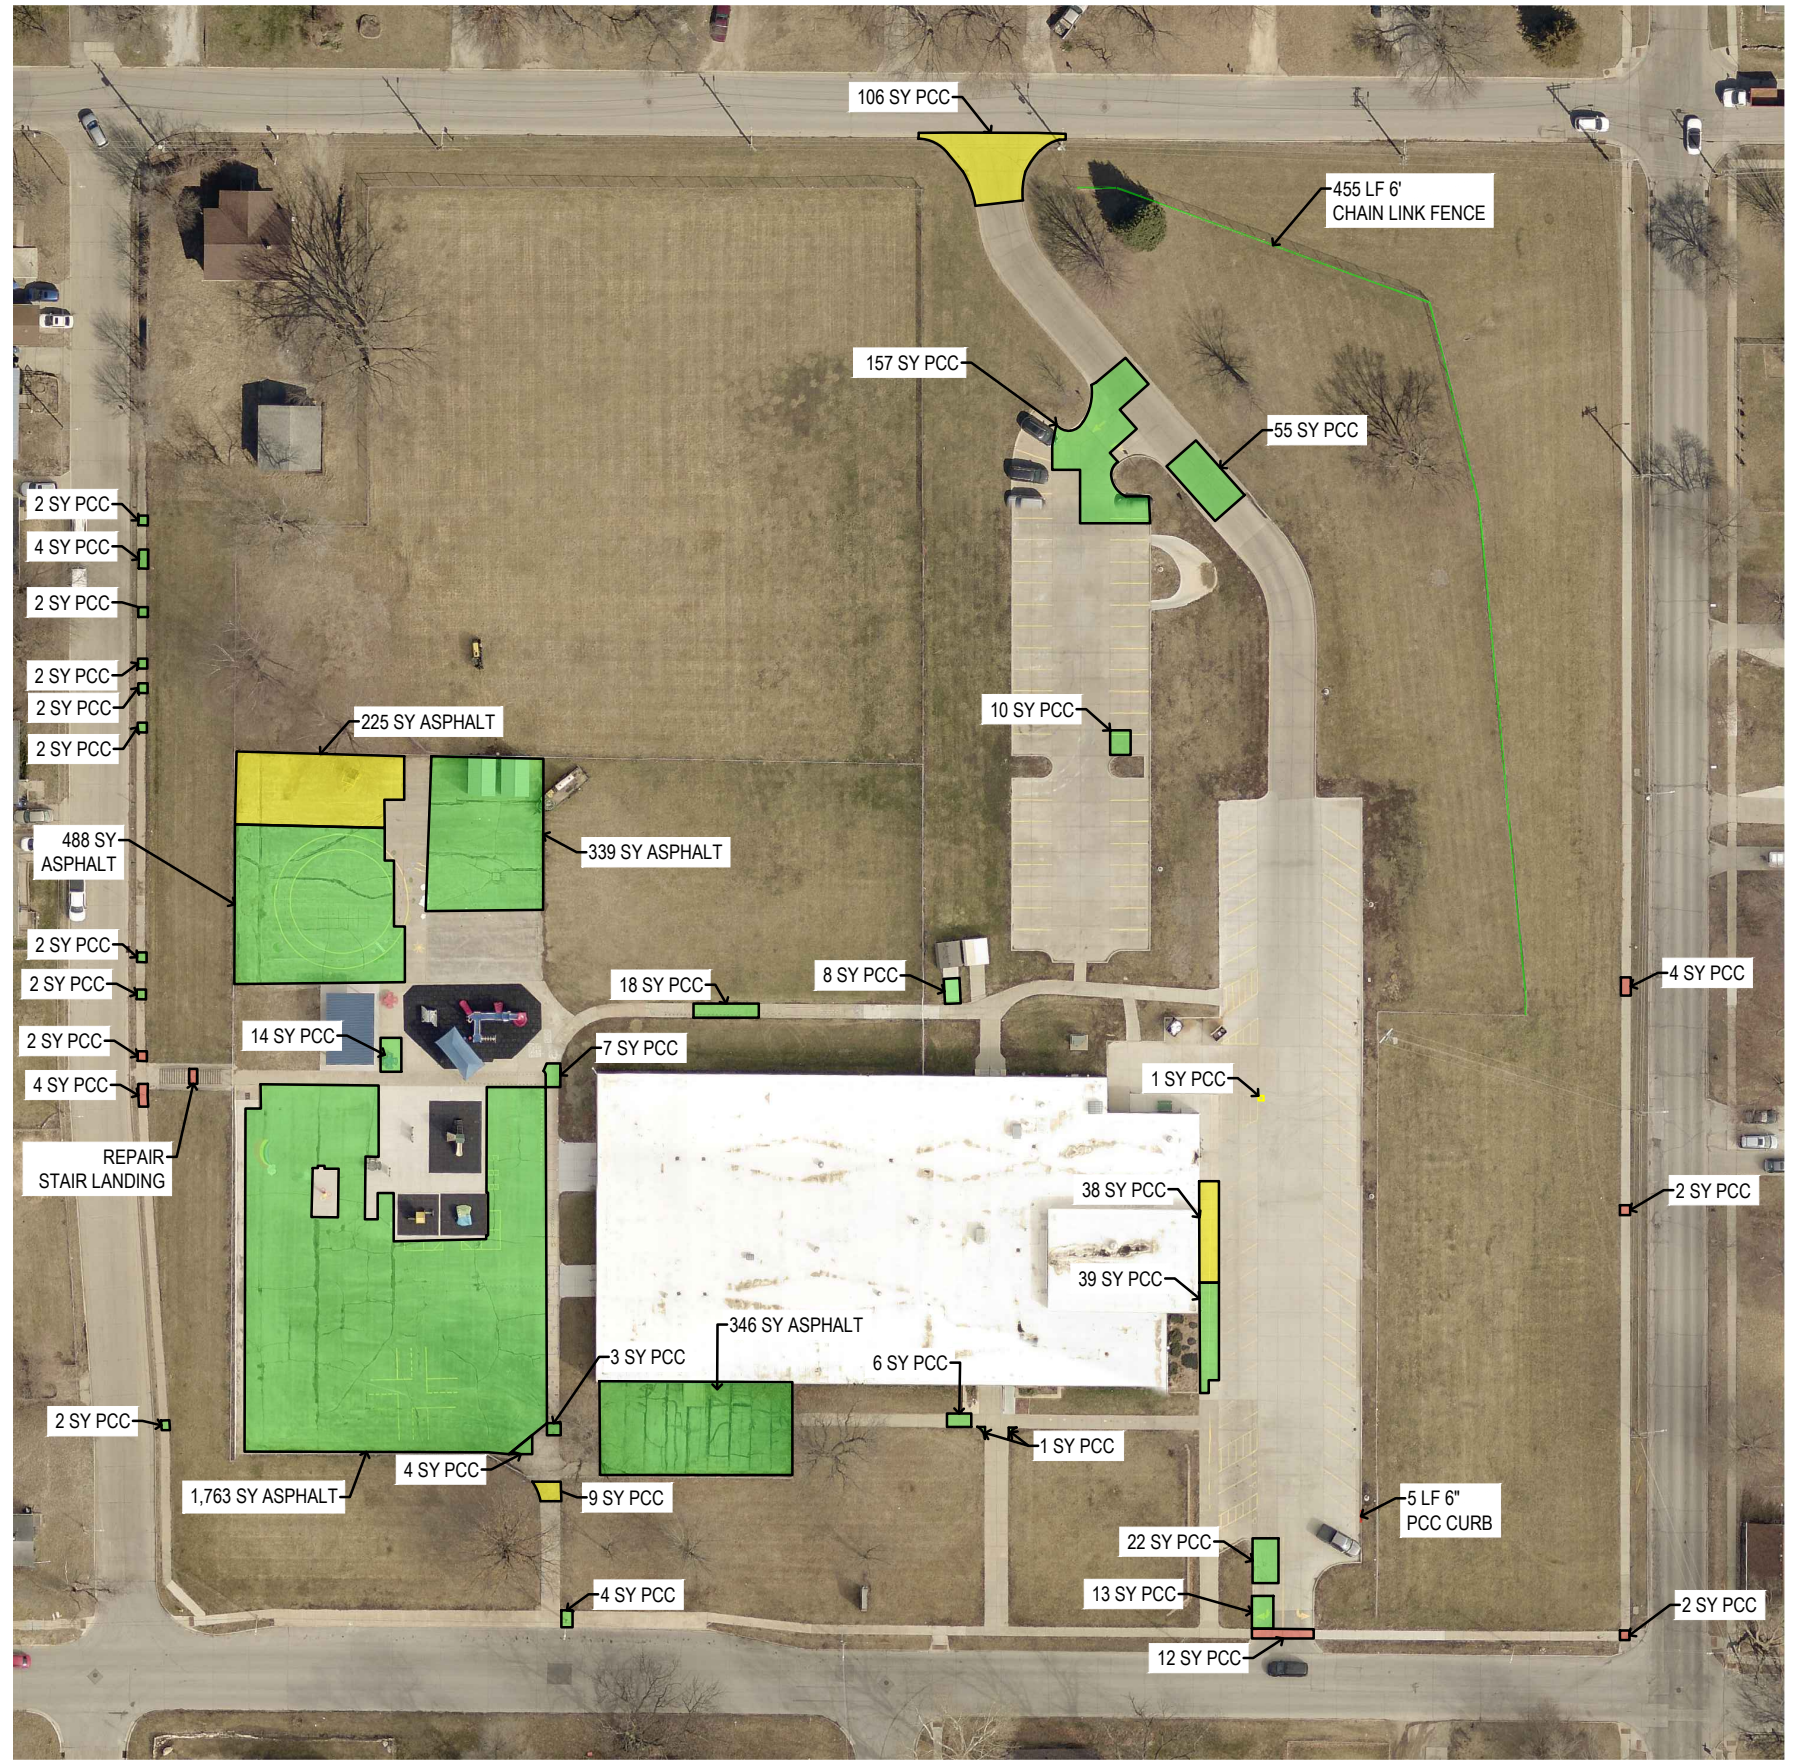
# MITCHELL EDUCATION CENTER

- 5+ YEAR REPLACEMENT
- 3-4 YEAR REPLACEMENT
- 1-2 YEAR REPLACEMENT

Pavement Replacement	Remove and replace 107 SY of PCC. For location, refer to civil site plan exhibit found in the appendix of this report.	\$20,000
Sidewalk Repair	Repair damaged sidewalks across the site. Approximately 38 SY. For locations, refer to civil site plan exhibit found in the appendix of this report.	\$11,000
Playground Pavement Replacement	Remove and replace deteriorated playground asphalt. Approximately 225 SY. For locations, refer to civil site plan exhibit found in the appendix of this report.	\$35,000
RTU Replacement	Replace existing RTU serving Offices with new gas-fired DX unit. Existing RTU is a water-source heat pumps with water piping extended into the unit curb outside of the building envelope, which is not desirable.	\$310,000
New Grease Interceptor	Install new grease interceptor that complies with Des Moines WRA Requirements	\$530,000

Fence Replacement	Remove and replace approximately 455 LF of 6' chain link fence. For locations, refer to civil site plan exhibit found in the appendix of this report.	\$65,000
Pavement Replacement	Remove and replace 257 SY of PCC. For location, refer to civil site plan exhibit found in the appendix of this report.	\$50,000
Sidewalk Repair	Repair damaged sidewalks across the site. Approximately 103 SY. For locations, refer to civil site plan exhibit found in the appendix of this report.	\$25,000
Playground Pavement Replacement	Take out and restore deteriorated playground asphalt. Approximately 2936 SY. For locations, refer to civil site plan exhibit found in the appendix of this report.	\$520,000
