# DMPS FACILITY ASSESSMENT |

# EXECUTIVE BUILDING SUMMARY

Building Name: **Monroe Elementary**

Date: **11.1.2023**

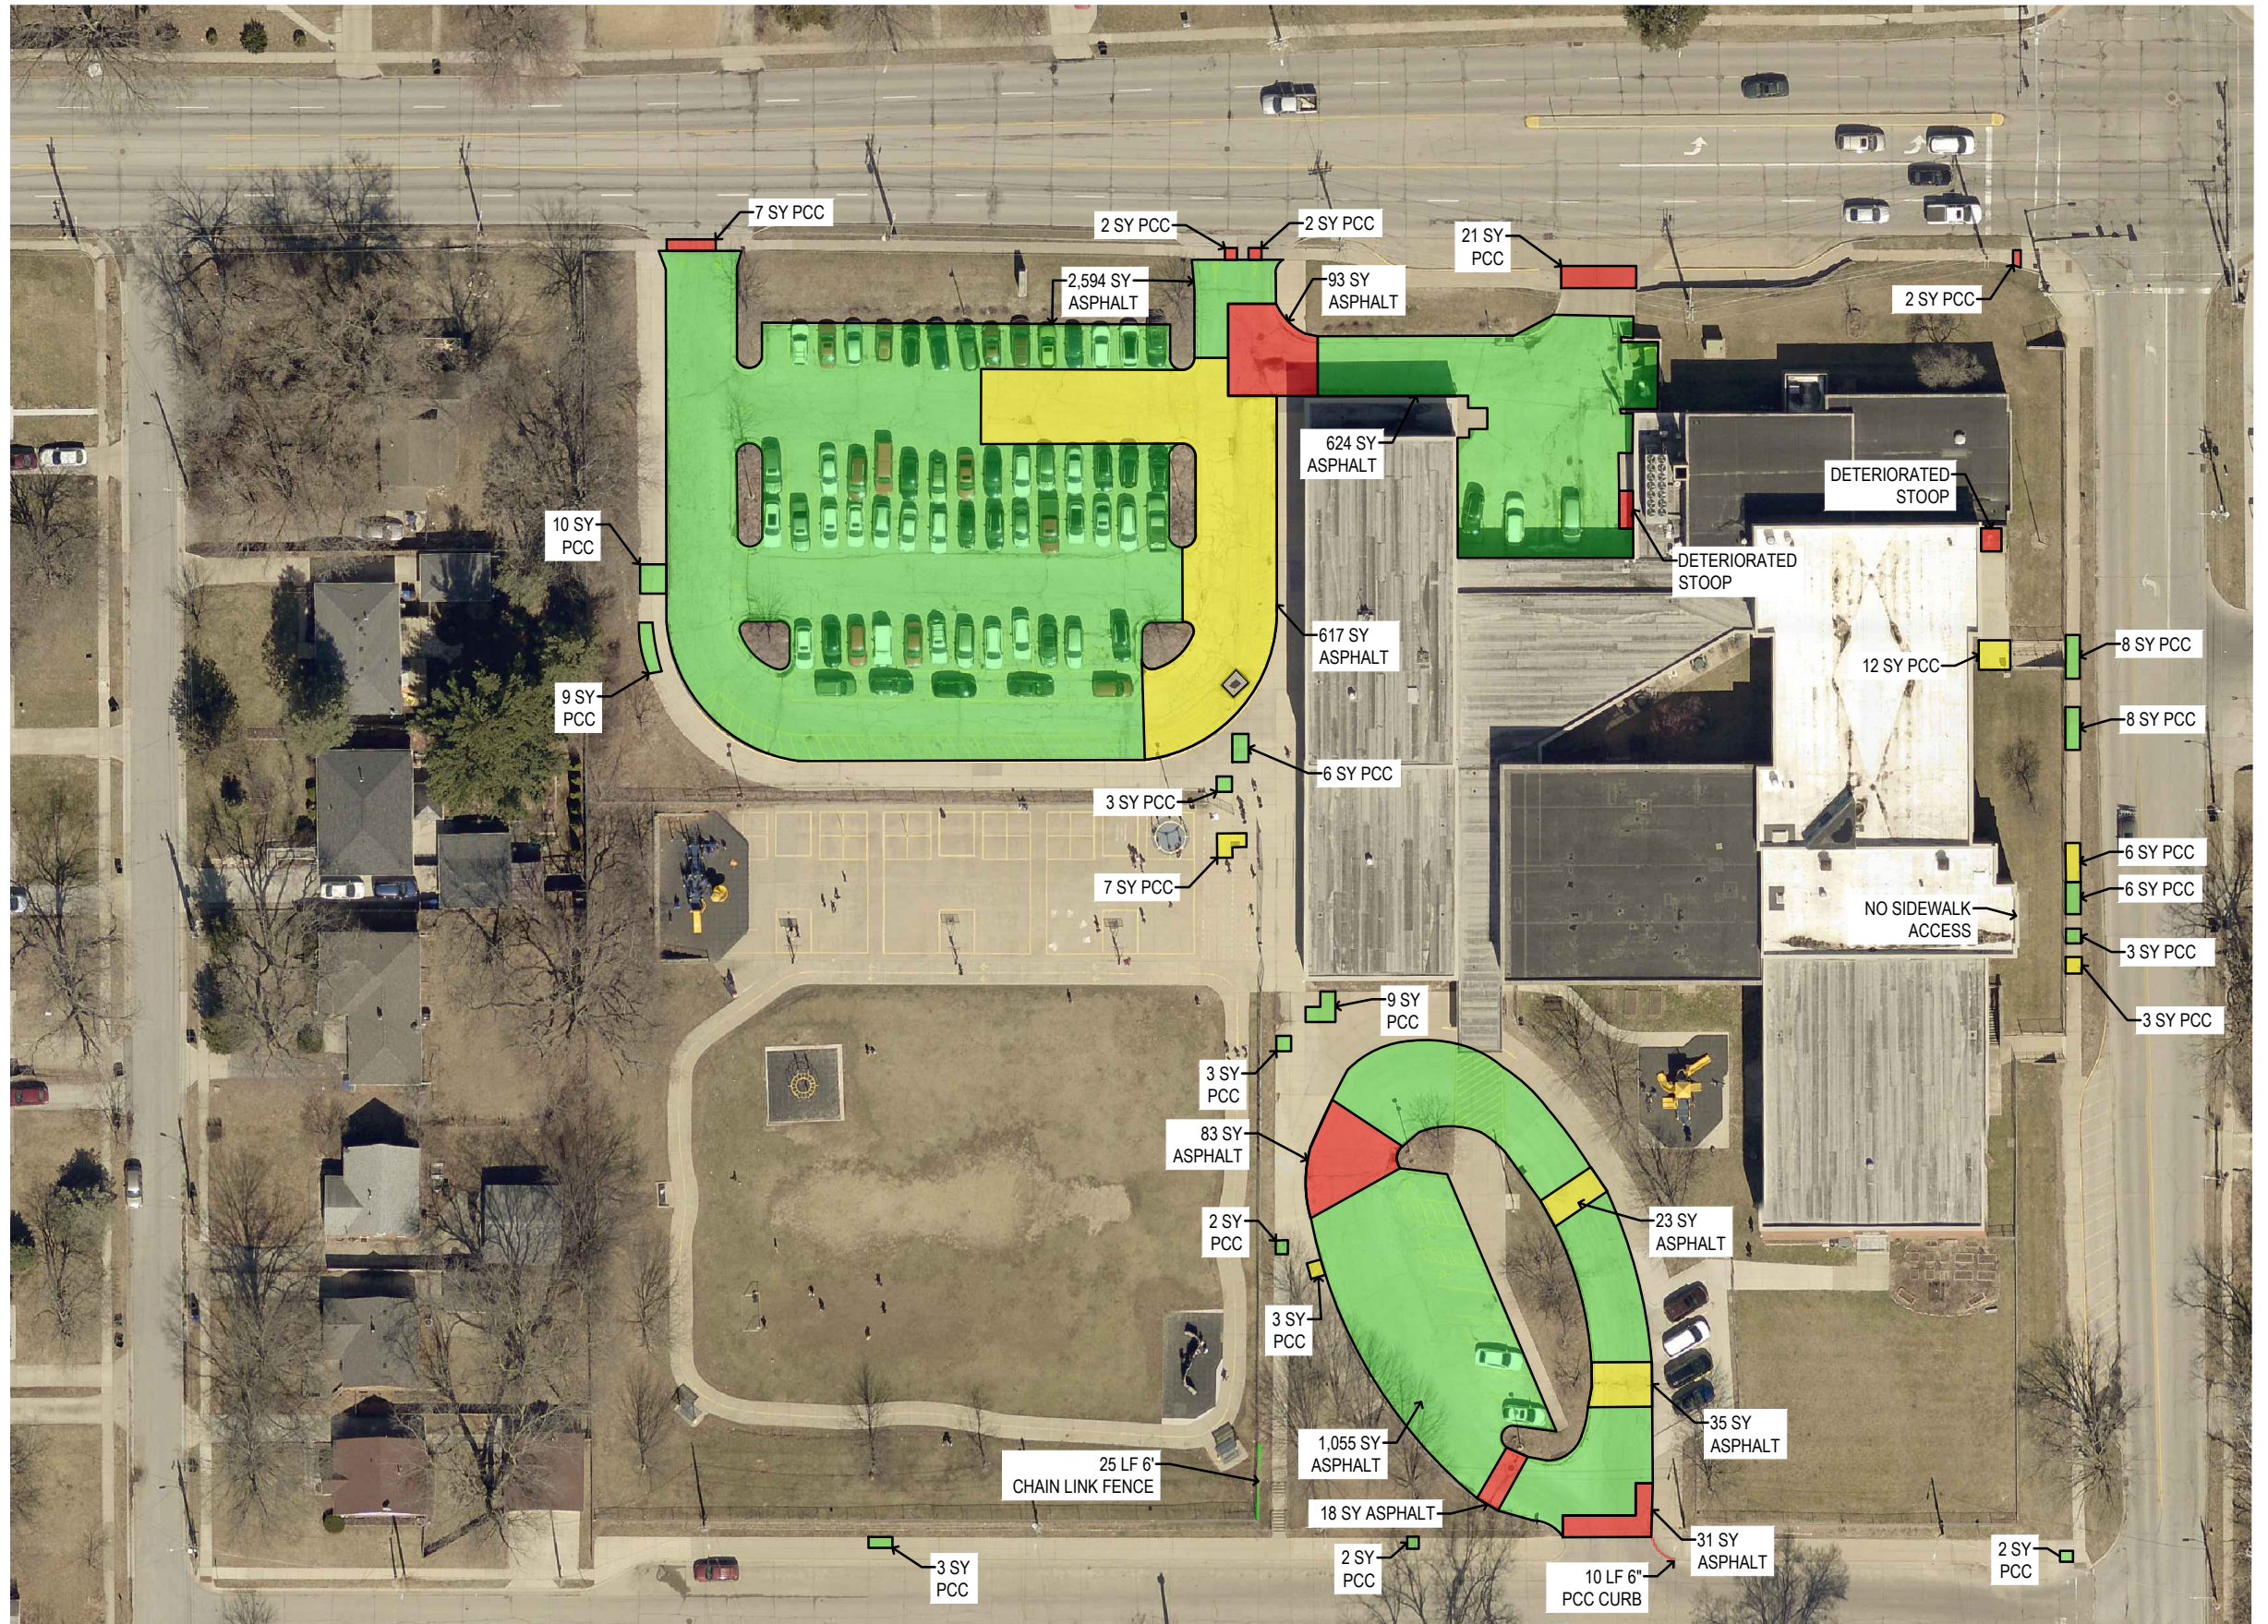
# MONROE ELEMENTARY

4.2 <b>Parking areas</b> are in good condition.	5	1	5	The south lot has an area of new concrete parking that is in good condition otherwise it is deteriorating in the remainder. The northwest parking area has considerable cracking.

4.3 <b>Drive areas</b> are in good condition.	3	1	3	The northwest lot pavement has deteriorated significantly with large pot holes and cracks in the center drive aisles, and worn out pavement along the bus lane drop off. The south lot is heavily patched but the asphalt is degrading, some sections don't appear to have much more than a year or two left

4.5 <b>Sidewalks</b> around the facility are in good <b>condition</b> .	1	3	3	Most of the new pavement was performing well. However, the east side sidewalk and sidewalk through the north drive accesses had multiple trip hazards and need repairs. The landing at the top of ramp of the entrance by the trash enclosure is in poor condition.

Sidewalk Repair	Repair significantly damaged sidewalks across the site. Approximately 34 SY. For locations, refer to civil site plan exhibit found in the appendix of this report.	\$11,000
Curb Repair	Return damaged curbs to new condition. Approximately 10 LF of 6" curbs. For locations, refer to civil site plan exhibit found in the appendix of this report.	\$6,000
Floor Deck Repair	Install W8x15x10' beam under floor deck transition and repair floor crack and slab depression with self leveling compound (Approximately 50 SF of 3/8" compound). Location is under the main corridor around rooms 122 and 125. Relocation of electrical conduit and lighting will be required.	\$8,000
Tunnel Entrance Header Installation	Install (2) W8x15x6' lintels with 3/8"x20" wide b/plate to support unsupported brick masonry wall above existing entrance to basement utility tunnel (south wing). Relocation of electrical conduit and sanitary sewer line will be required.	\$10,000

Sidewalk Repair	Repair damaged sidewalks across the site. Approximately 31 SY. For locations, refer to civil site plan exhibit found in the appendix of this report.	\$11,000
Parking Pavement Replacement	Remove and replace 675 SY of deteriorated asphalt parking pavement. For location, refer to civil site plan exhibit found in the appendix of this report.	\$100,000
Retaining Wall Repairs	Patch repair spalled concrete at east exterior site retaining wall. 8 ft2 at 3" depth of patch repair.	\$8,000
Boiler Replacement	Boilers are likely nearing their expected useful life and planning for replacement is advised. Heating water pumps and boiler circulation pumps should also be replaced.	\$540,000
Elevator Control Replacement	Replace obsolete controls and prepare for a comprehensive modernization project to keep the elevator maintainable.	\$150,000

Parking Pavement Replacement	Remove and replace 4,241 SY of less deteriorated asphalt parking pavement. For location, refer to civil site plan exhibit found in the appendix of this report.	\$750,000
Sidewalk Replacement	Repair less damaged sidewalks across the site. Approximately 74 SY. For locations, refer to civil site plan exhibit found in the appendix of this report.	\$20,000
Fence Replacement	Remove and replace 25 LF of chain link fence. For location, refer to civil site plan exhibit found in the appendix of this report.	\$9,000
