# DMPS FACILITY ASSESSMENT | MORRIS ELEMENTARY

11.07.2023

# EXECUTIVE BUILDING SUMMARY

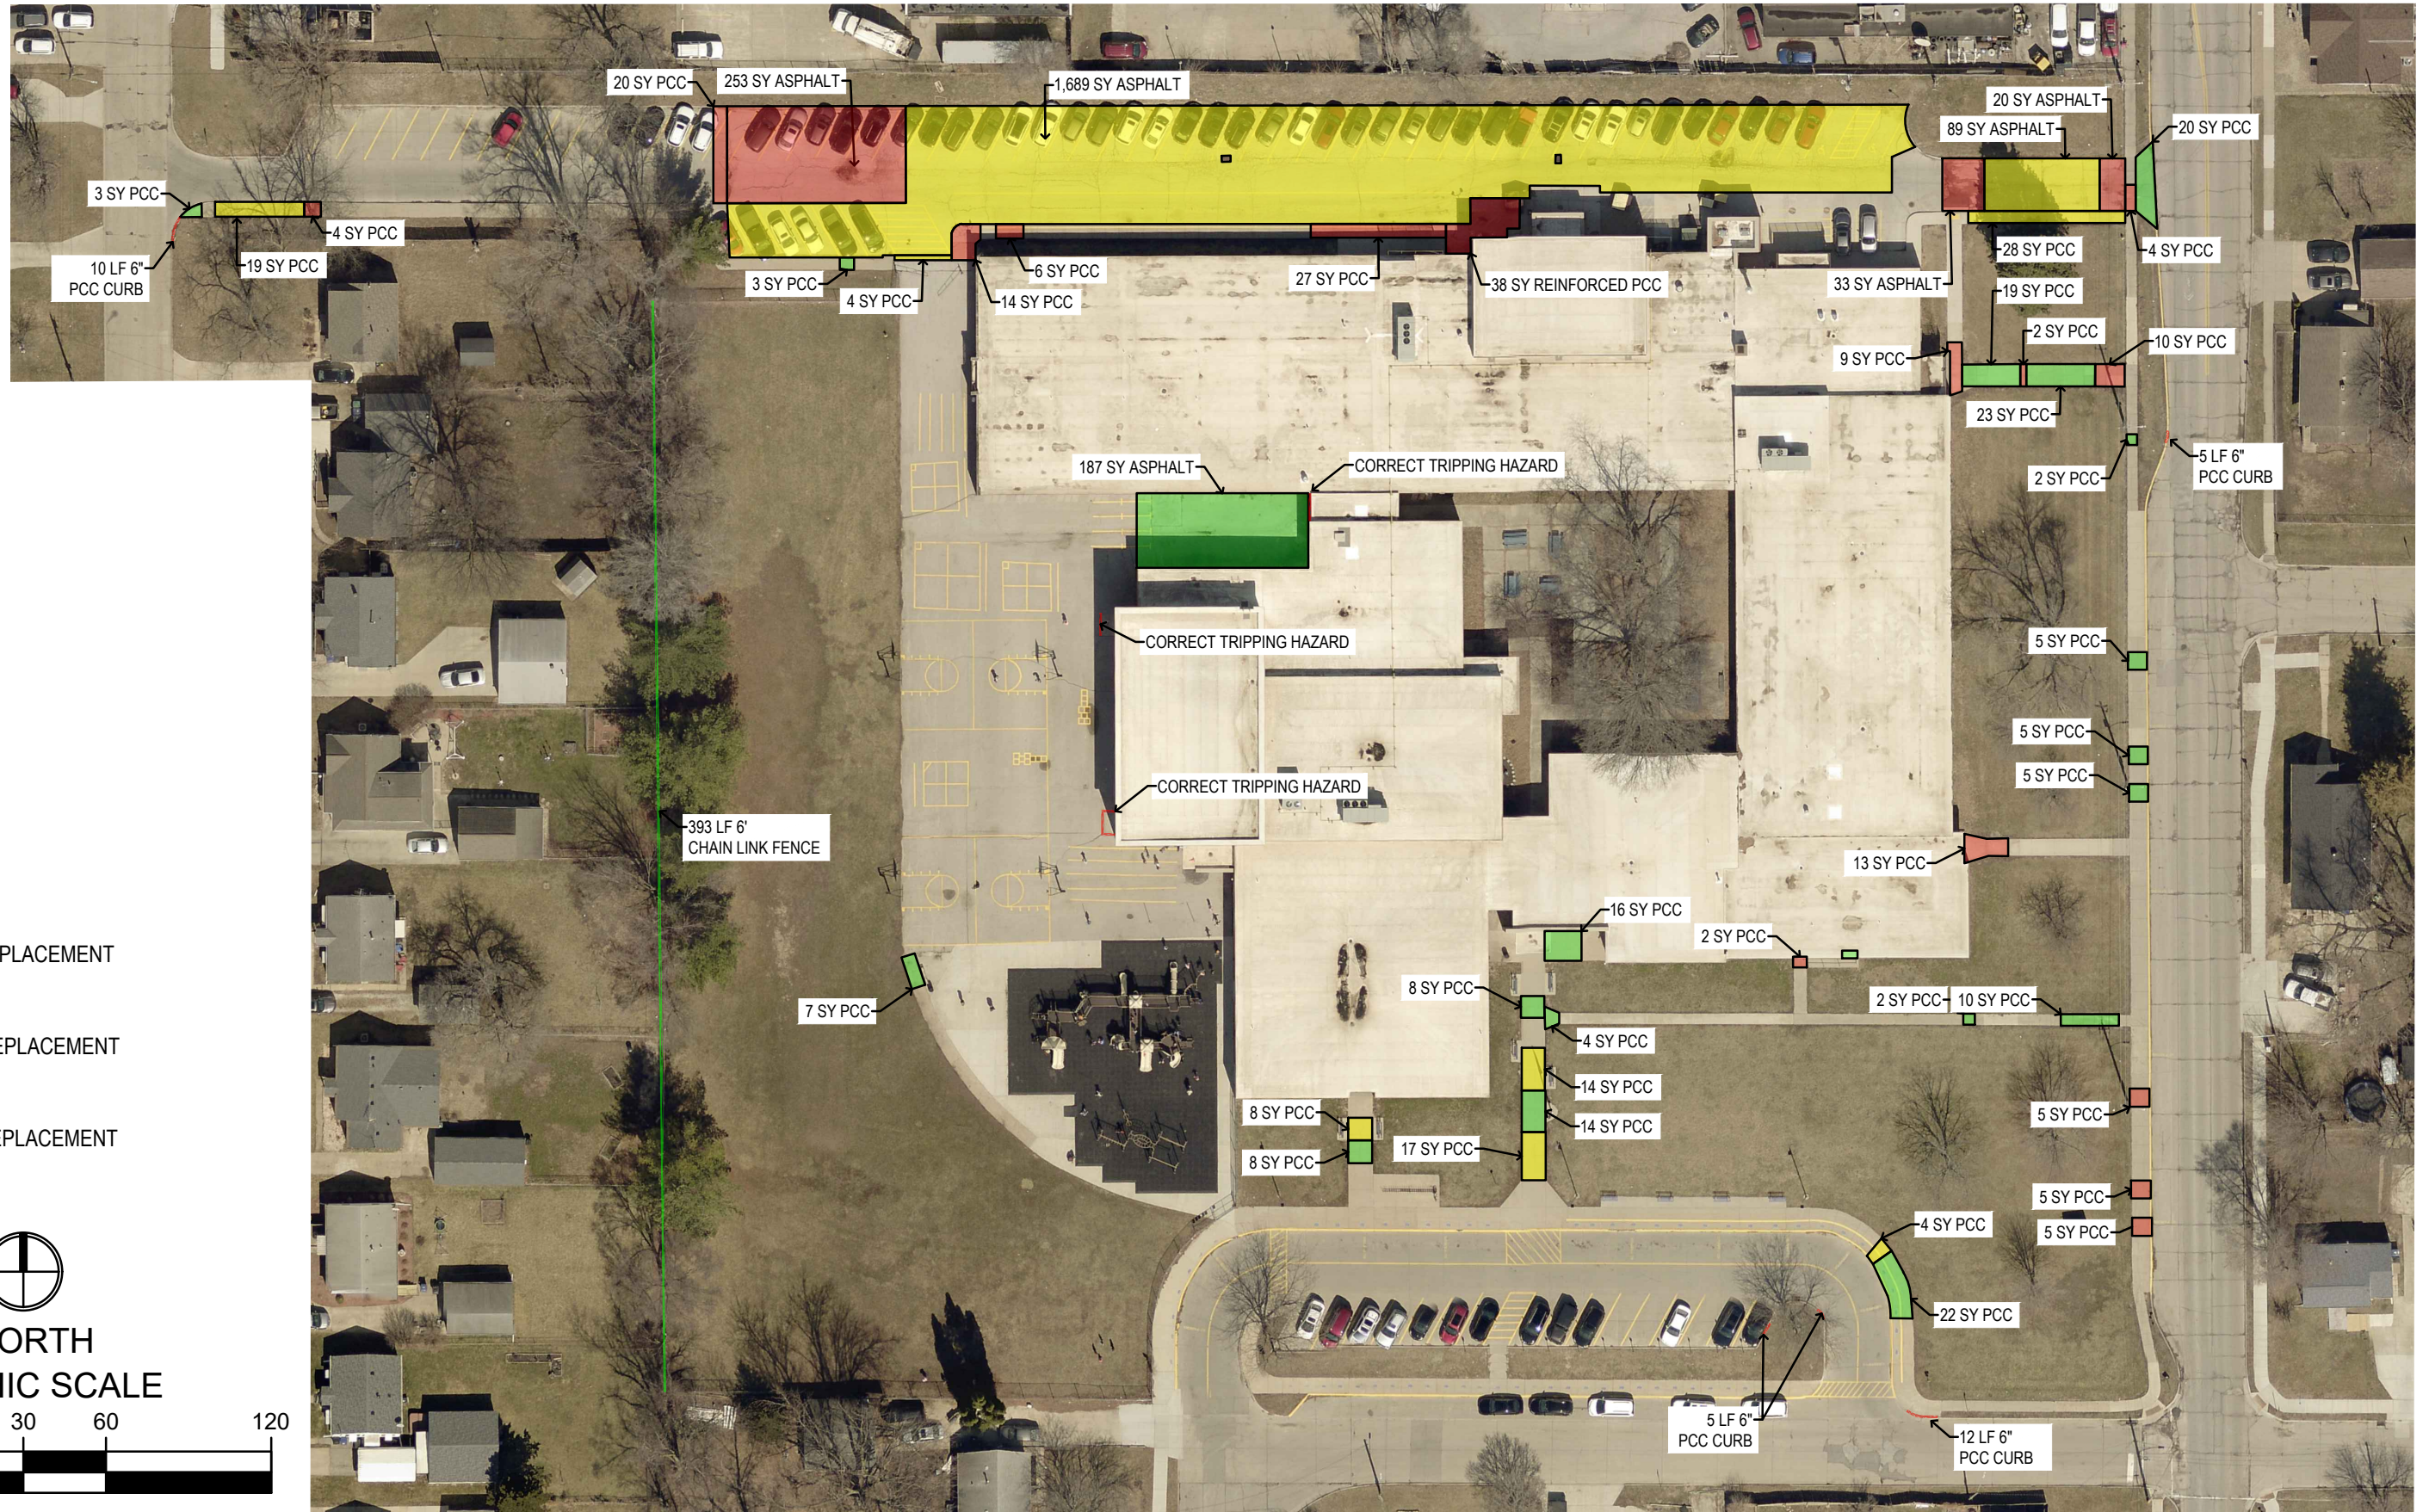
4.2 <b>Parking areas</b> are in good condition.	5	2	10	The south parking lot is concrete and in good condition. The north lot is primarily asphalt and is cracking throughout.

4.3 <b>Drive areas</b> are in good condition.	3	1	3	The south lot drive areas are in good condition. The north lot, from the east entrance to the concrete parking addition, had substantial cracking and some potholes in the drive areas.

4.5 <b>Sidewalks</b> around the facility are in good <b>condition</b> .	1	2	2	Tripping hazards were observed in the east sidewalk and along the drop off area on the north side of the school. The sidewalk to the west along 16th St had shifted and created a tripping hazard near the tree there. A portion of the south walk was cracking but not profusely.

- 5+ YEAR REPLACEMENT
- 3-4 YEAR REPLACEMENT
- 1-2 YEAR REPLACEMENT

Pavement Replacement	Remove and replace 20 SY of PCC and 306 SY of asphalt. Install 38 SY of reinforced PCC in front of trash enclosure. For locations refer to civil site plan exhibit found in the appendix of this report.	\$50,000
Sidewalk Repair	Repair damaged sidewalks across the site. Approximately 106 SY. For locations, refer to civil site plan exhibit found in the appendix of this report.	\$20,000
Curb Repair	Return damaged curbs to new condition. Approximately 37 LF of 6" curbs. For locations, refer to civil site plan exhibit found in the appendix of this report.	\$7,000
Stoop & Railing Replacement	Remove and replace concrete stoop and railing at entrance near room 115. Approximately 120 SF concrete stoop and 30 LF of railing.	\$30,000
