# DMPS FACILITY ASSESSMENT | NORTH HIGH SCHOOL

03.12.2024

# EXECUTIVE BUILDING SUMMARY

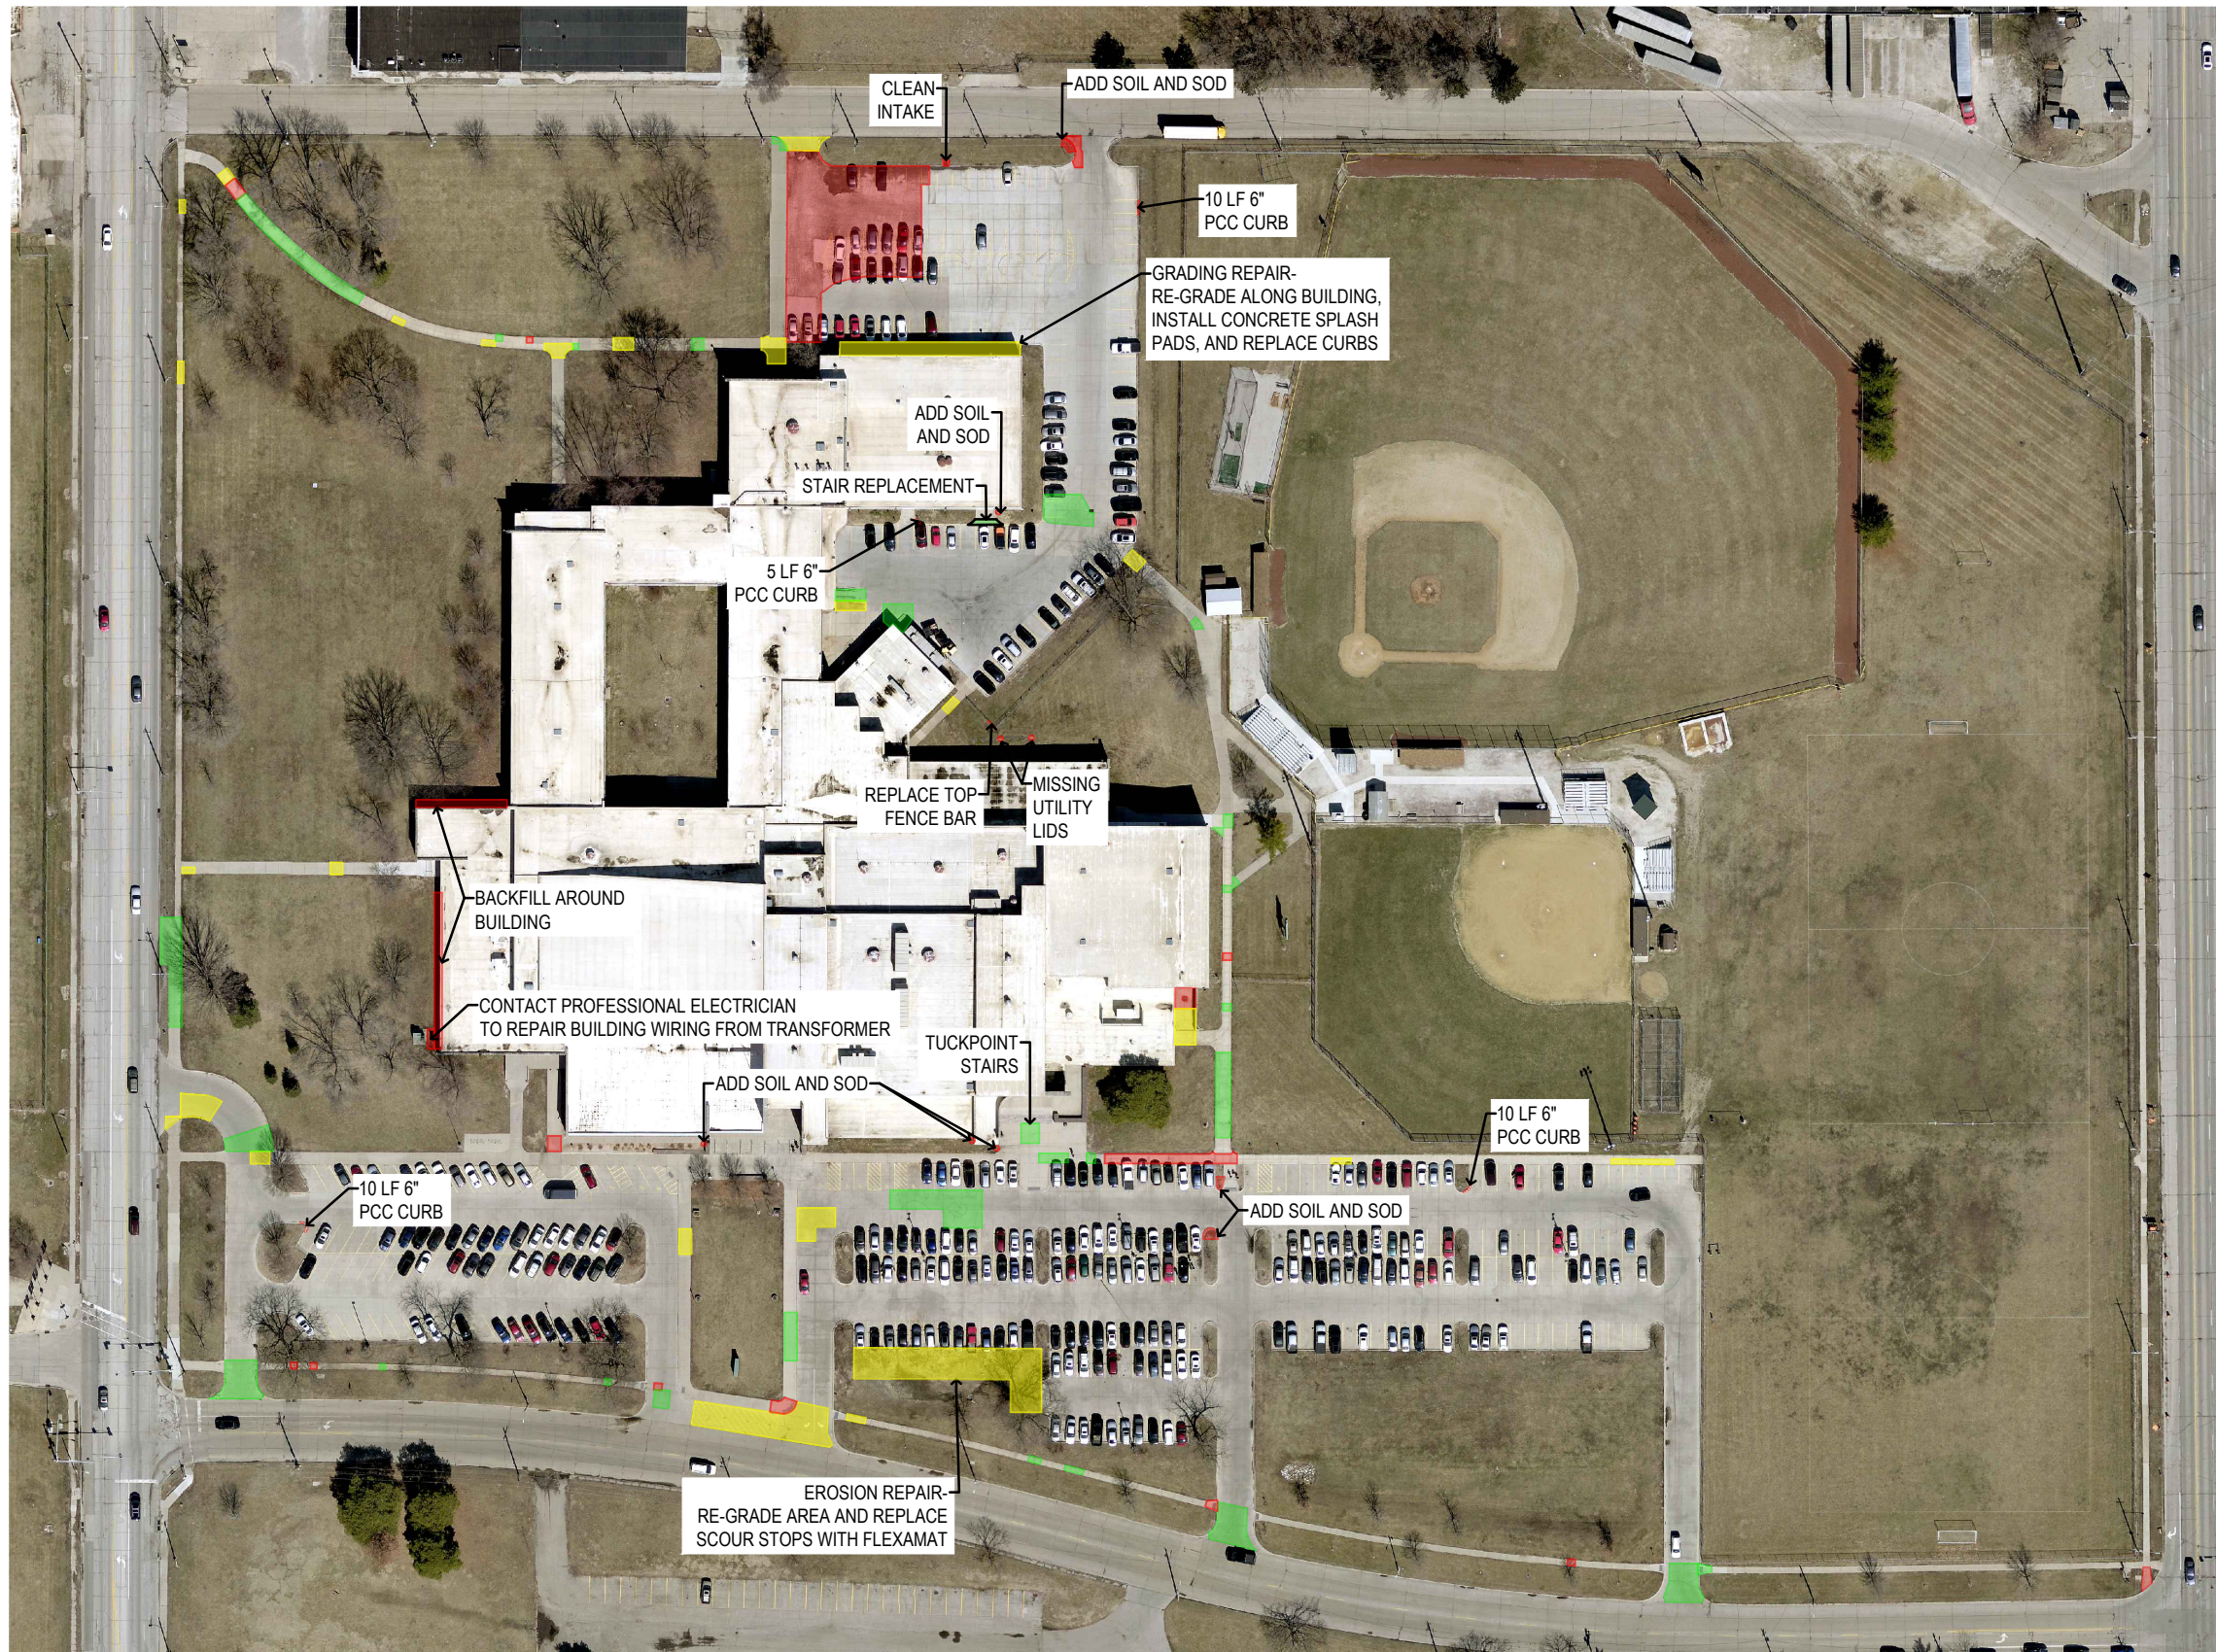
EXHIBIT  
PROJECT # 230286-52  
DATE 3/15/2024

Sidewalk Repairs	<p>Repair damaged sidewalks across the site. Approximately 195 SY. For locations, refer to civil site plan exhibit found in the appendix of this report.</p>	\$35,000

Grading Repair	Re-grade along the building, install concrete splash pads, and replace curbs to restore positive drainage along building. For location, refer to the civil site plan exhibit found in the appendix of this report.	\$11,000
Erosion Repair	Remove the existing scour stops, re-grade area, and install flexamat to prevent further erosion and any potential undermining of pavement. For location, refer to the civil site plan exhibit found in the appendix of this report.	\$12,000
Pool Wall Steel Repair	Sand Blast and re-paint 30 L.F. of the steel framed pool wall on the NW side. Approximately 400 sq. ft. of steel to be sand blasted and re-painted.	\$11,000
Restroom Fixture Upgrades	Install auto flush and hands-free fixtures in restrooms and other public areas.	\$80,000

Masonry Repointing	Repoint stone cap at roof M and S, approx. 120 SF. Repoint at outside corner of roof P over roof O, 6 SF. Repoint glass block at east and west of roof R, 750 SF. Repoint brick at SW corner of courtyard, 8 SF.	\$25,000
Exterior Glazing Replacement	Replace insulated glazing unit in frames from room 1511-1514, (2) units 8 SF each	\$8,000
Pavement Replacement	Remove and replace 456 SY of PCC. For location, refer to the civil site plan exhibit found in the appendix of this report.	\$85,000
Sidewalk Repairs	Repair damaged sidewalks across the site. Approximately 338 SY. For locations, refer to civil site plan exhibit found in the appendix of this report.	\$75,000
Stairs Repointing	Professionally repoint the grout joints of the marble stairs to restore the stairs to good condition and prolong the life of the stairs. For location, refer to civil site plan exhibit found in the appendix of this report.	\$13,000

Stair Replacement	Remove and replace the deteriorated stairs. For location, refer to civil site plan exhibit found in the appendix of this report.	\$35,000
Boiler Replacement	Replace existng standard eff. boilers with new high efficiency units. Exisitng boilers were intsalld in 2010 but it appears that repairs have been done to them.	\$300,000
Console Heat Pump Replacements	Replace console WSHPs and consider two stage unit to better match load and improve dehumidification and reduced load on wellfield.	\$4,900,000
Add Geothermal Wellpoints	The existing well field apears to not have adequate capacity. Add additional well points to the north of the existing field.	\$830,000
