DMPS FACILITY ASSESSMENT | OAK PARK ELEMENTARY

12.19.2023

EXECUTIVE BUILDING SUMMARY

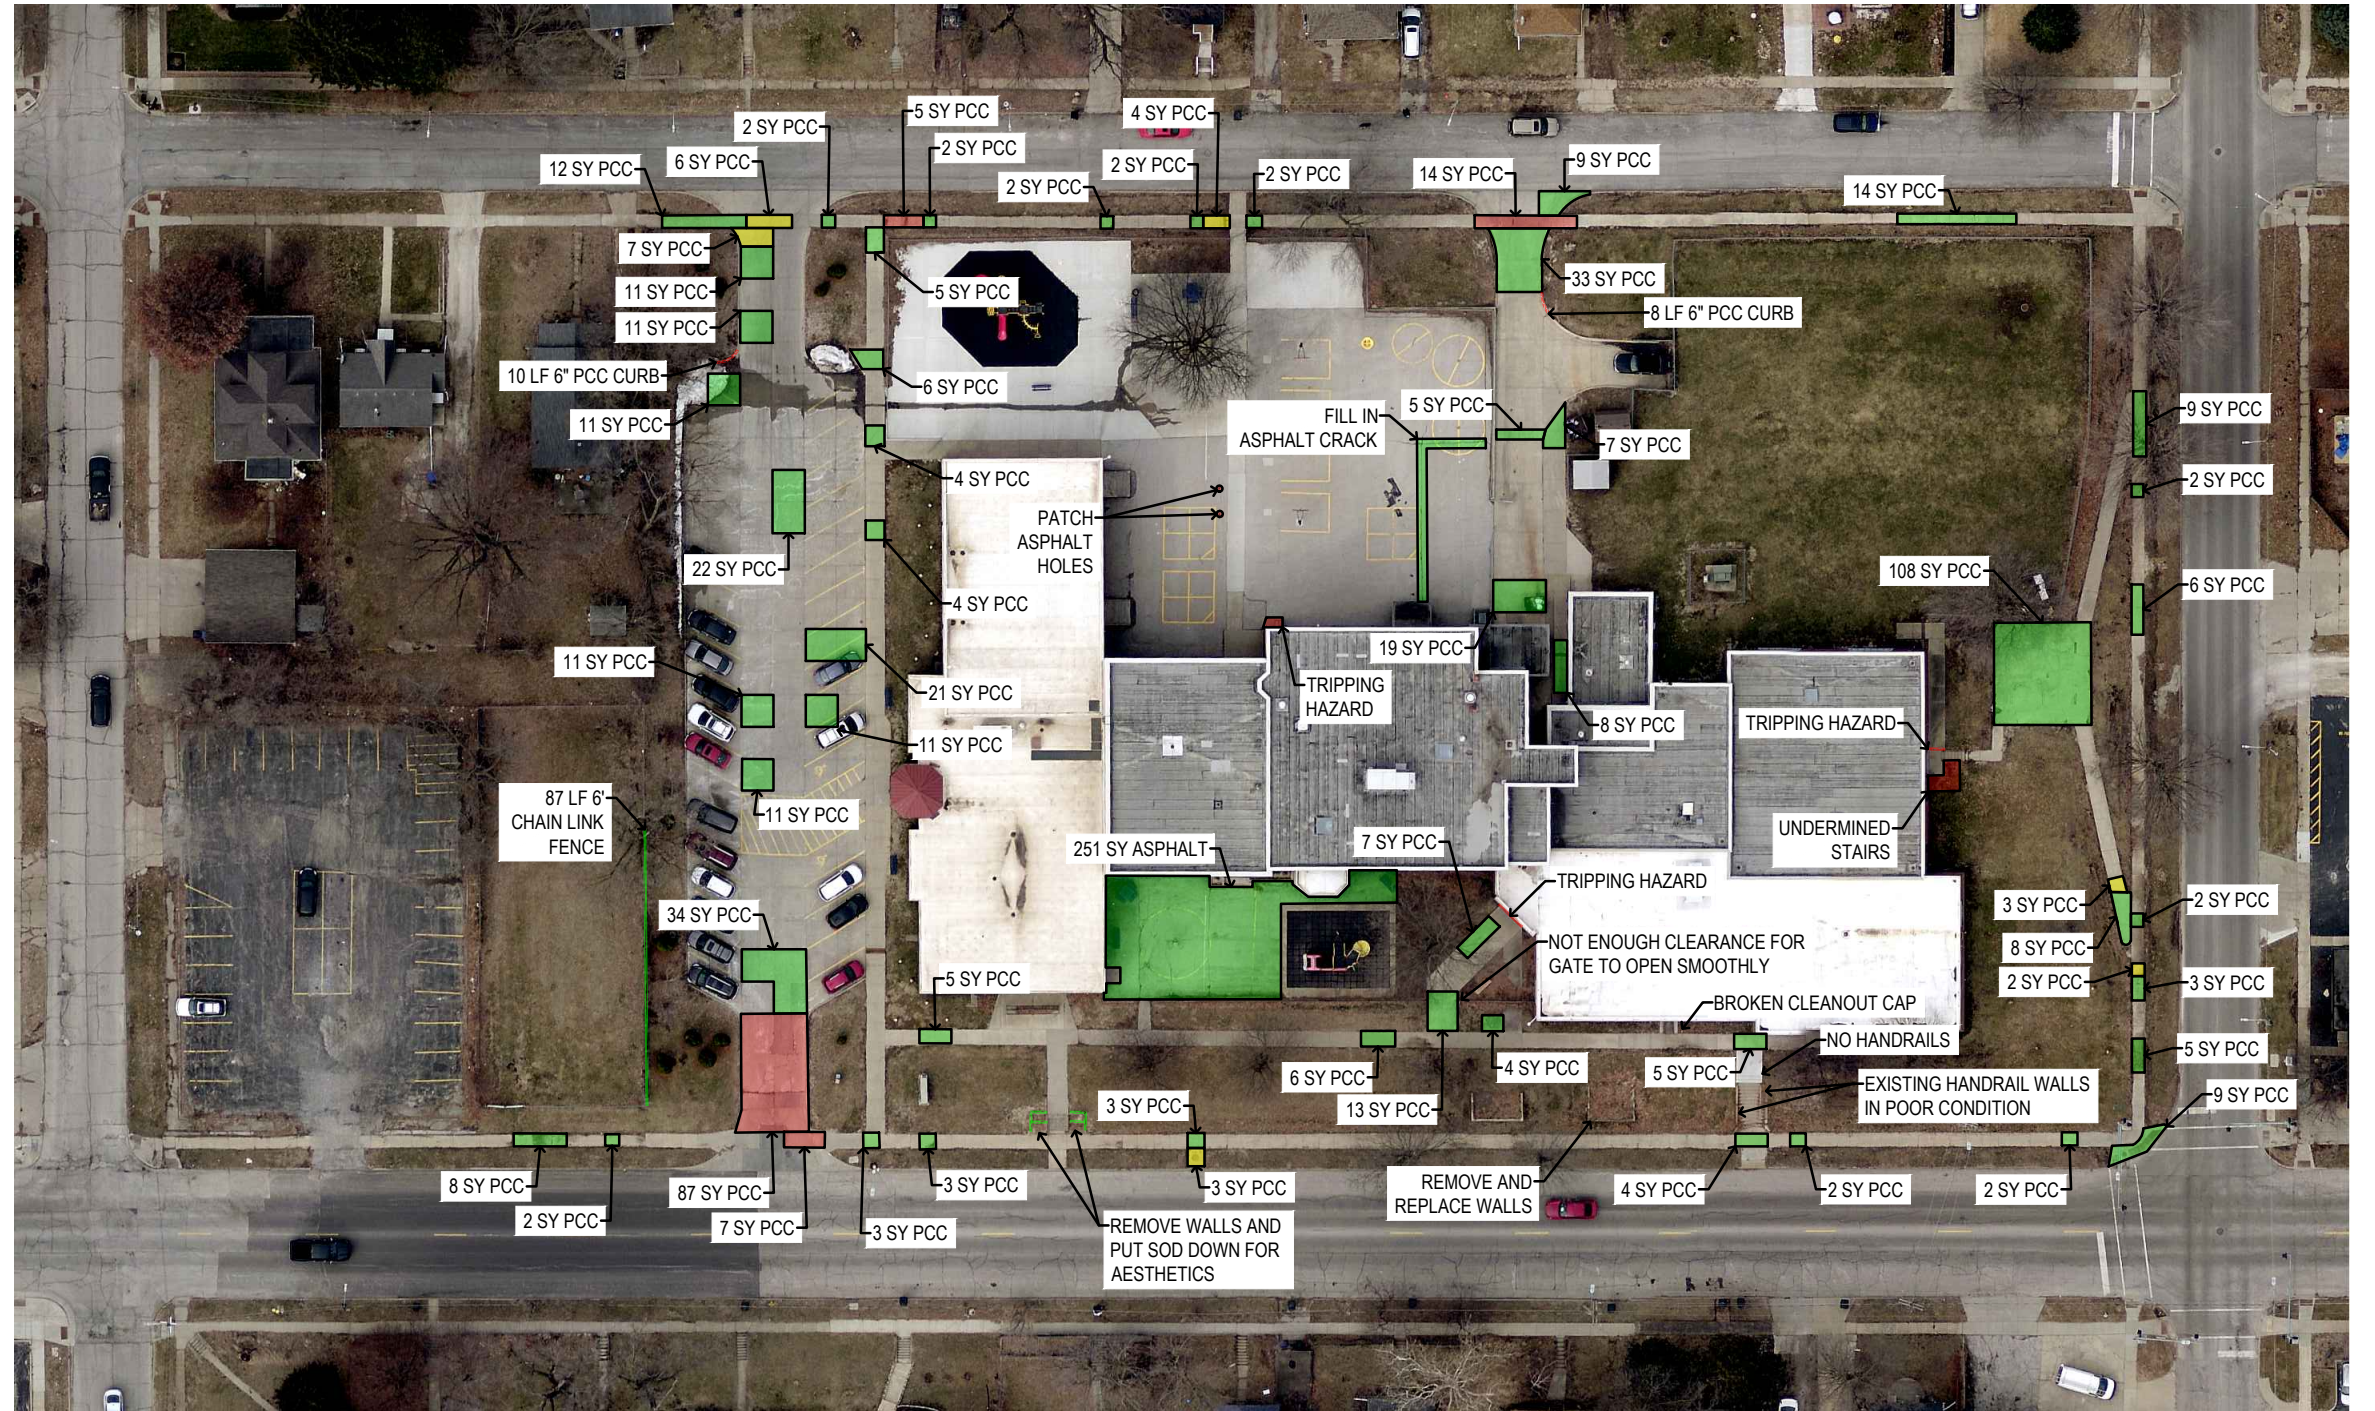
EXHIBIT
 PROJECT # 230286-25
 DATE 11/6/2023

Pavement Replacement	Remove and replace 209 SY of PCC. For location, refer to the civil site plan exhibit found in the appendix of this report.	\$40,000
Sidewalk Repairs	Repair damaged sidewalks across the site. Approximately 289 SY. For locations, refer to civil site plan exhibit found in the appendix of this report.	\$65,000
Playground Asphalt Replacement	Take out and restore deteriorated playground asphalt. Approximately 251 SY. For locations, refer to civil site plan exhibit found in the appendix of this report.	\$45,000
Fence Replacement	Replace 87 LF of 6' chain link fence. For location, refer to civil site plan exhibit found in the appendix of this report.	\$14,000
Wall Replacement	Remove and replace shifted wall. For location, refer to civil site plan exhibit found in the appendix of this report.	\$11,000
Wall Removal and Sod Installation	Remove failing existing modular block wall and put down sod for better site aesthetics. For location, refer to civil site plan exhibit found in the appendix of this report.	\$10,000
