DMPS FACILITY ASSESSMENT |

EXECUTIVE BUILDING SUMMARY

Building Name: Park Ave Elementary

Date: 11.15.2023

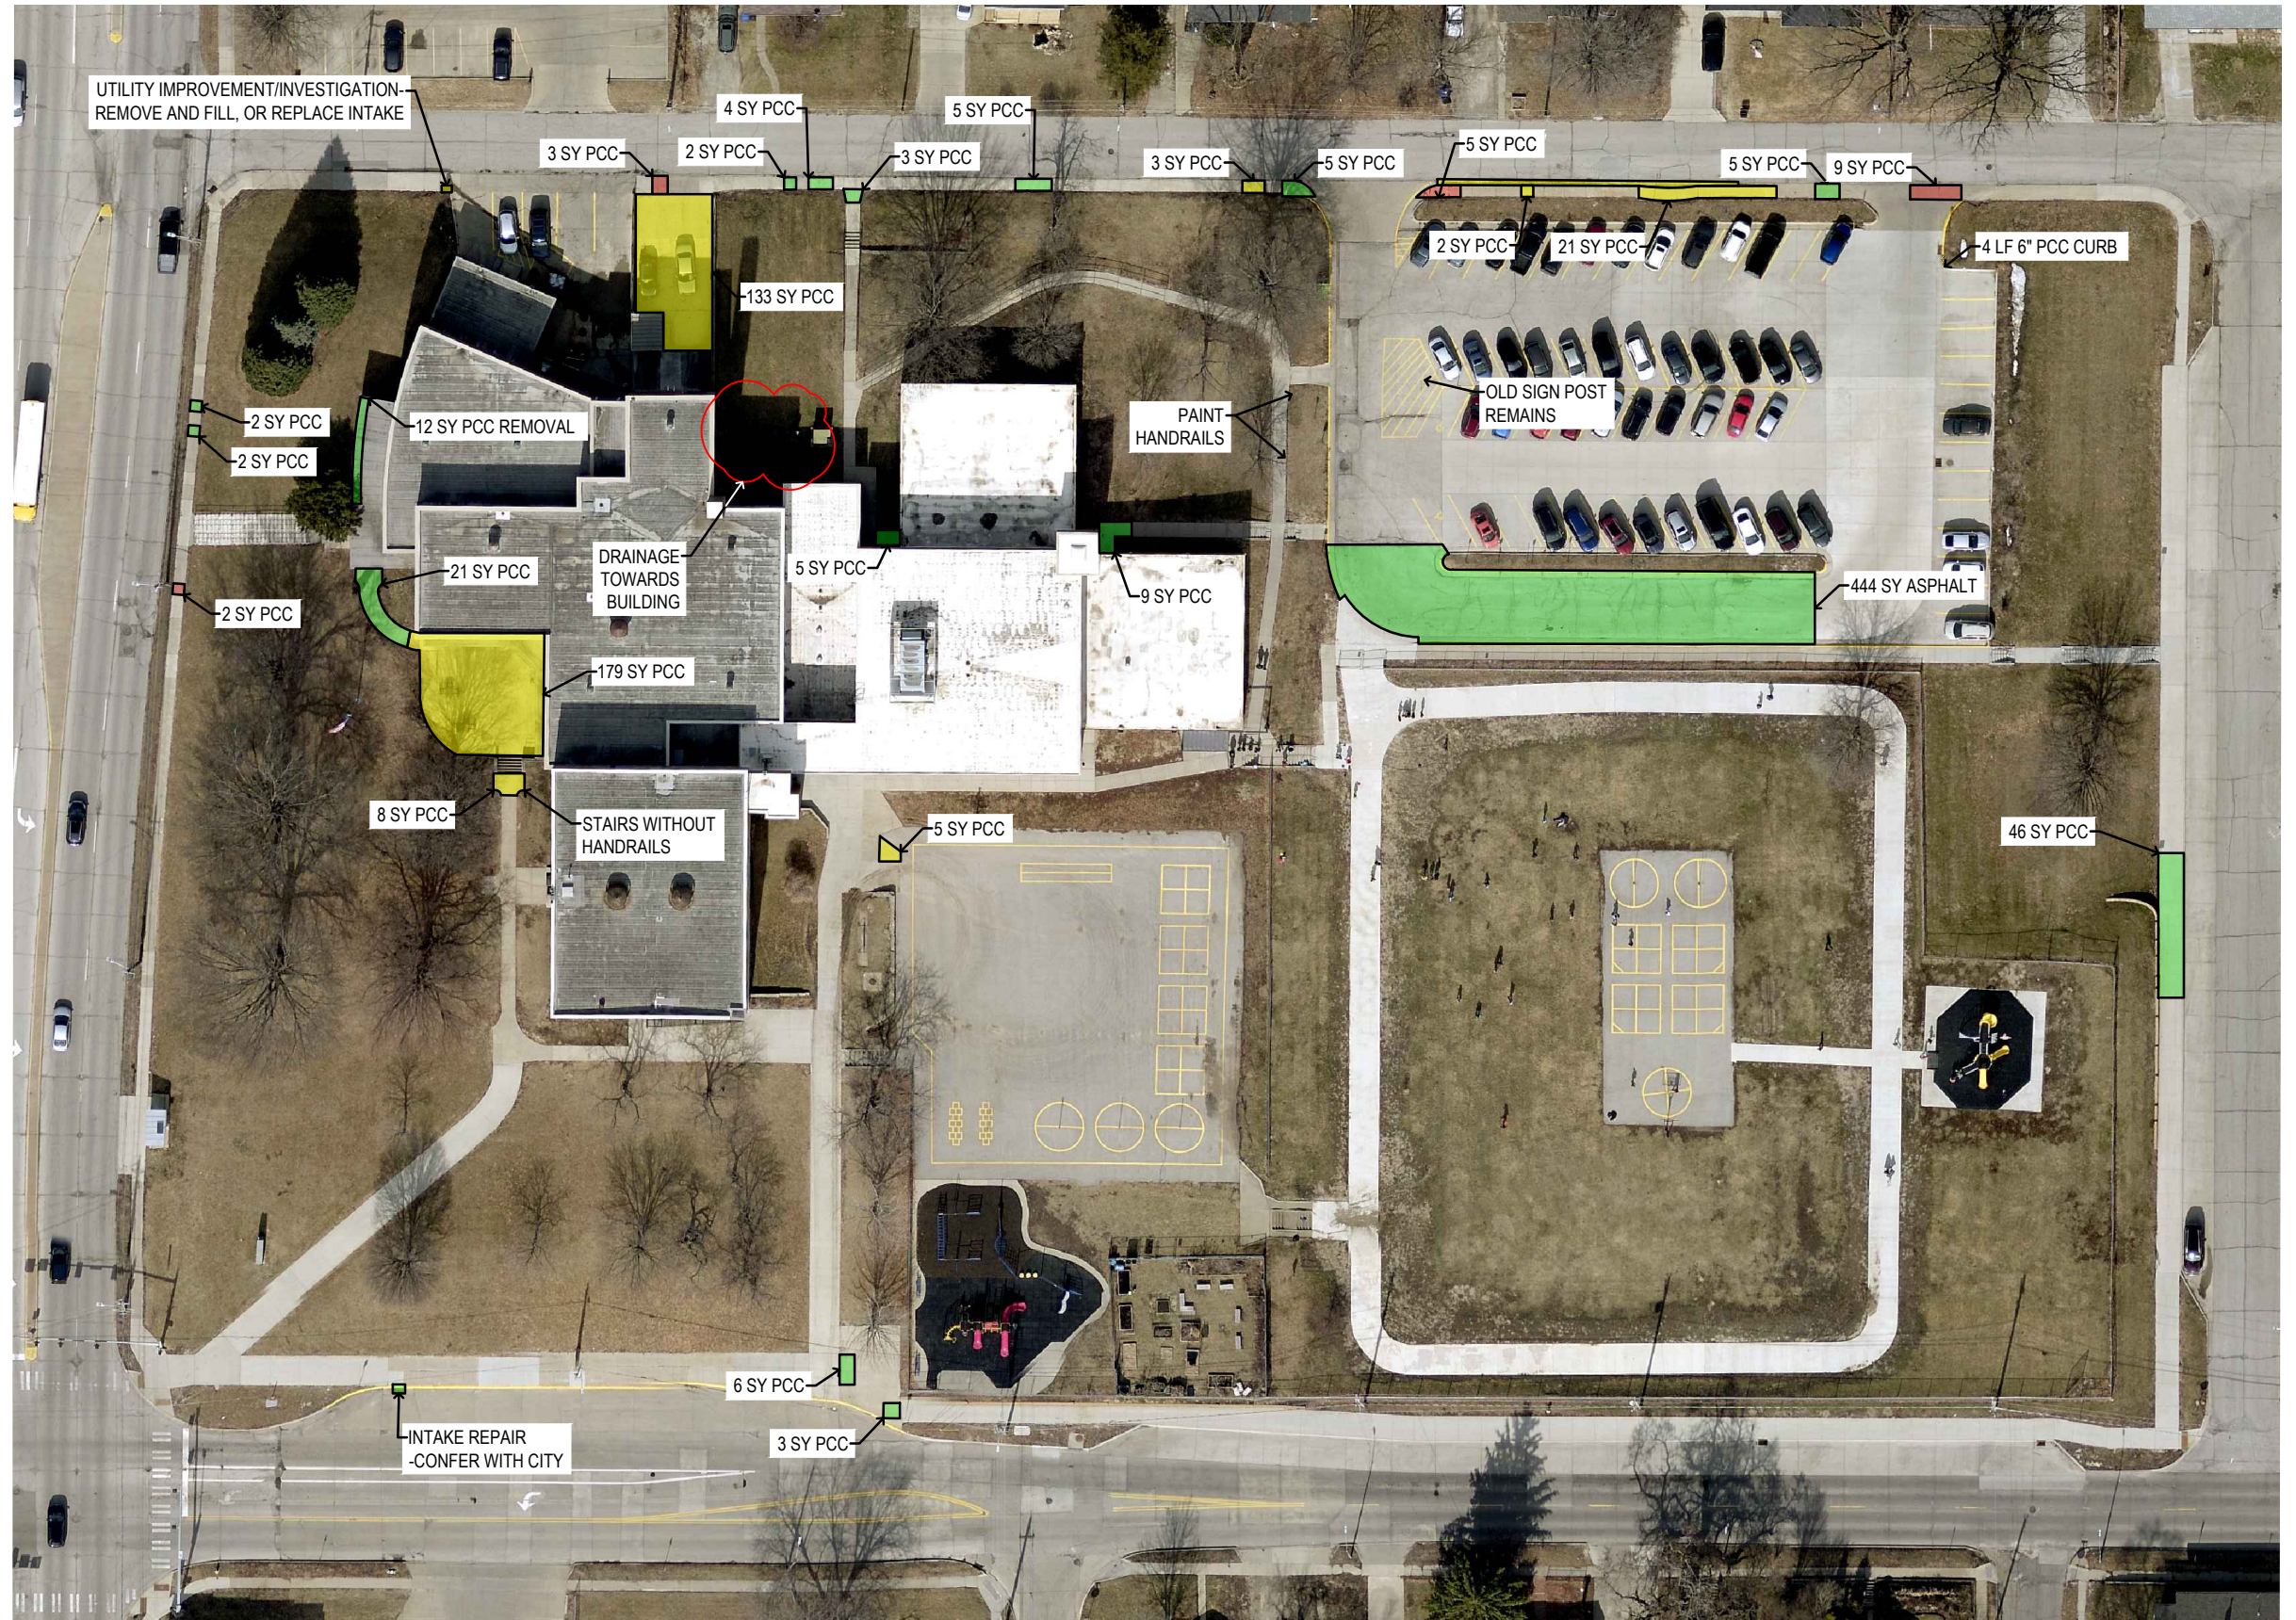
EXHIBIT
 PROJECT # 230286-26
 DATE 10/25/2023

- 5+ YEAR REPLACEMENT
- 3-4 YEAR REPLACEMENT
- 1-2 YEAR REPLACEMENT

Sidewalk and Stoop replacement	Replace portions of damaged sidewalks on the west and north areas of the site (approx 17 see, see civil exhibit). Add stoops outside doors on the east side of the building including doors near rooms 155, 165, and 188.	\$8,000
Lintel Refinishing	There are several rusted lintels that should be scraped, prepped and re-painted. These lintels include windows at rooms 204, 206, 208. Total lintel length = 100 LF. This project should occur in conjunction with the Interior Repairs Project, with Exterior Masonry Repairs Project, with Exterior Sealant Replacement Project, and with Lintel Refinishing Project listed above.	\$7,000
MDF Improvements	Add a 100A 208/120V panel to the MDF to provide separate power for critical communications equipment. In addition this will address current lack of future expansion. Add a card reader for improved access and monitoring. Add cooling to room to increase longevity of equipment.	\$15,000
