DMPS FACILITY ASSESSMENT | PHILLIPS ELEMENTARY

10.25.2023

EXECUTIVE BUILDING SUMMARY

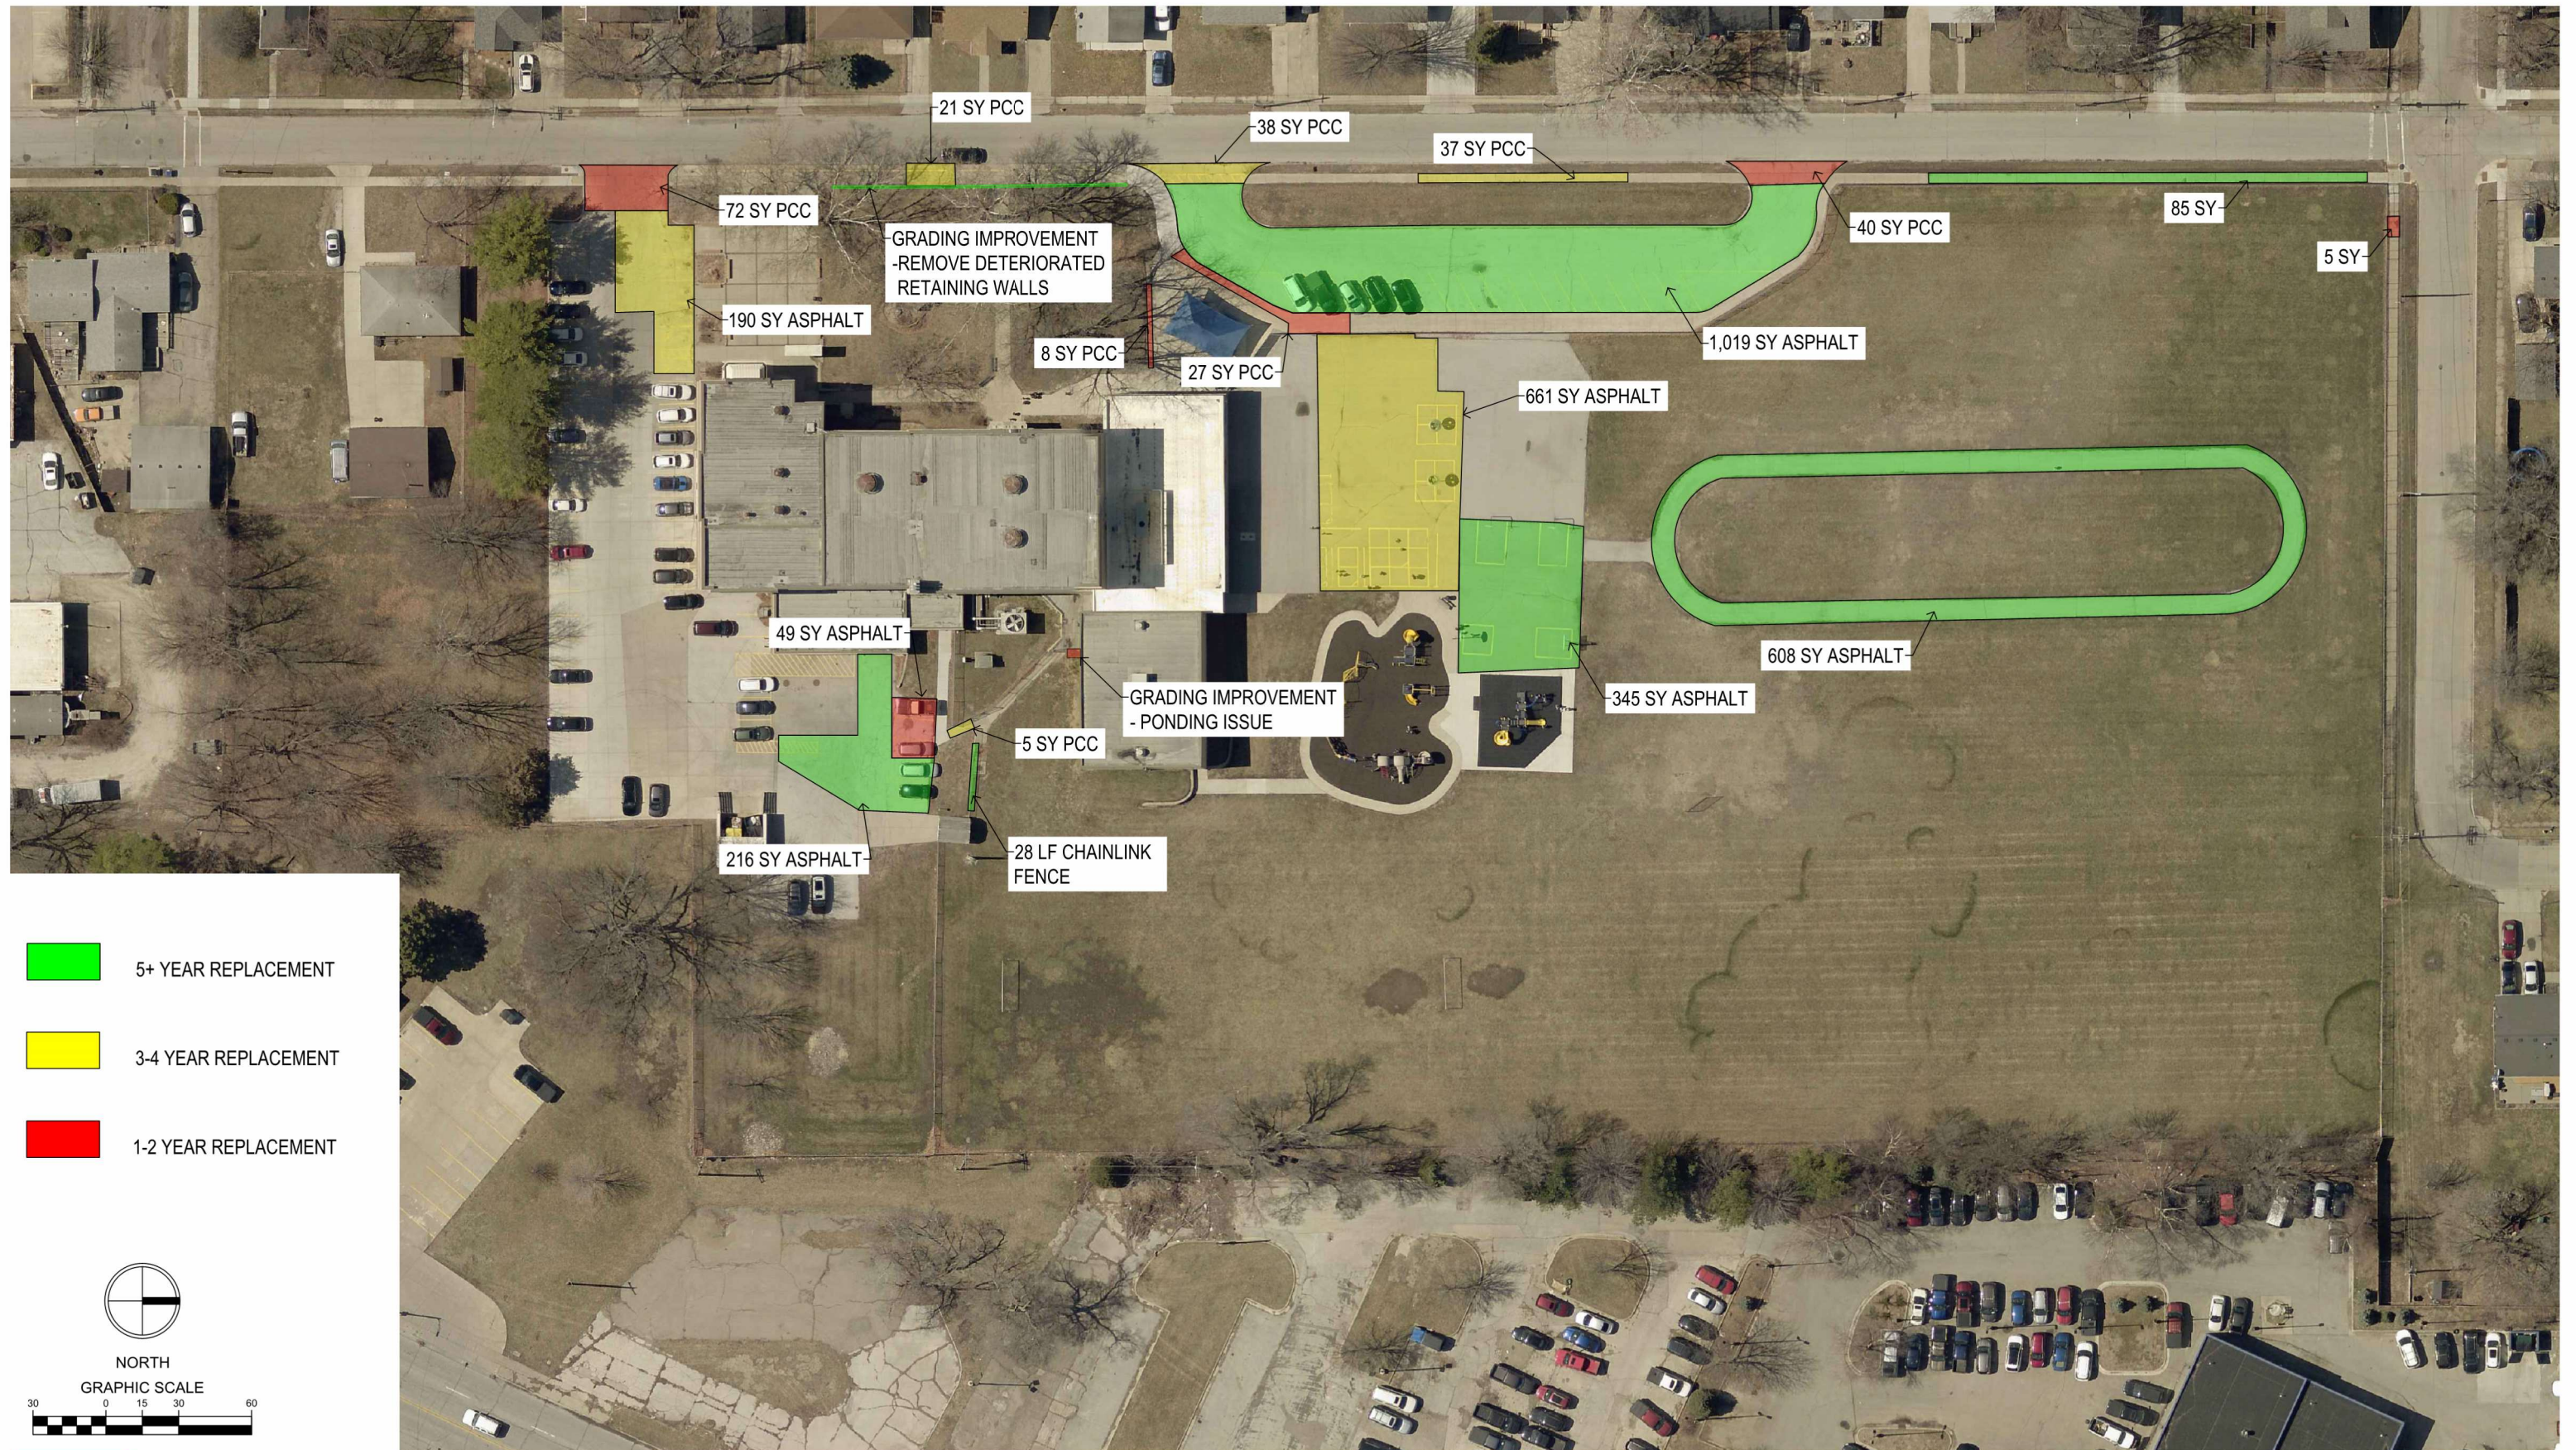
4.3 Drive areas are in good condition.	3	3	9	The north drive area contained a lot of spiderweb cracks and both accesses to the lot had considerable cracking, with the north access being the worse of the two. The drive access to the south lot was also not in good condition.

4.5 Sidewalks around the facility are in good condition .	1	3	3	Stairs in front of building missing handrails, couple of panels cracked on backside of building, curbing and adjacent pavement of southwest shaded picnic area of north lot in bad condition w/ tripping hazards (old bike rack), sidewalk to west of north lot will be due for repair within 3-4 years.

4.7 Hard surface playground surfaces are in good condition.	3	3	9	The reworked areas around basketball hoops were in good condition. Older areas were not in good condition with areas of sagging, cracks, and a few tripping hazards. Asphalt loop north of playground cracking but has potential to last another 10 years.

Curb Repair	Return damaged curbs to new condition. Approximately 40 LF of 6" curbs. For locations, refer to civil site plan exhibit found in the appendix of this report.	\$7,000.00
Regrading	Restore positive drainage on the south side of the building. For location, refer to civil site plan exhibit found in the appendix of this report.	\$8,000.00
Lightning Protection Repairs	Building Lightning Protection was not modified when mechanical systems were added. Mechanical vent stack extends higher than existing protection.	\$8,000.00
Domestic Hot Water Circulation and Mixing Valve	Replace and modify domestic hot water recirculation to reduce time lag. Install new digital mixing valves.	\$20,000.00

Sidewalk Repairs	Repair damaged sidewalks across the site. Approximately 63 SY. For locations, refer to civil site plan exhibit found in the appendix of this report.	\$14,000.00
Closed-Circuit Cooling Tower Replacement	Replace closed-circuit cooling tower or install new ground-coupled heat exchanger (geothermal) system. The geothermal system would be a separate price as noted depending on the outcome of the study described below. Confirm scope of B8892-Phillips-2024	\$370,000.00

Parking Pavement Replacement	Remove and replace 1235 SY of asphalt pavement. For location, refer to civil site plan exhibit found in the appendix of this report.	\$220,000.00
Playground Pavement Replacement	Take out and restore less deteriorated playground asphalt. Approximately 953 SY. For location, refer to civil site plan exhibit found in the appendix of this report.	\$170,000.00
Sidewalk Repairs	Repair damaged sidewalks across the site. Approximately 85 SY. For locations, refer to civil site plan exhibit found in the appendix of this report.	\$20,000.00
Fencing Replacement	Remove and replace 28 LF of chain link fence. For location, refer to civil site plan exhibit found in the appendix of this report.	\$9,000.00
Grading Repair	Remove deteriorated retaining walls and grade up to building. For location, refer to civil site plan exhibit found in the appendix of this report.	\$13,000.00
Boiler Replacement	Replace boilers if geothermal system is not being installed. Viability of this project is dependent on the study described described below. Confirm scope of B8892-Phillips--2024 HVAC Upgrades project to make sure replacement of boiler did not occur in this project.	\$90,000.00
