DMPS FACILITY ASSESSMENT | RIVER WOODS ELEMENTARY

10.31.2023

EXECUTIVE BUILDING SUMMARY

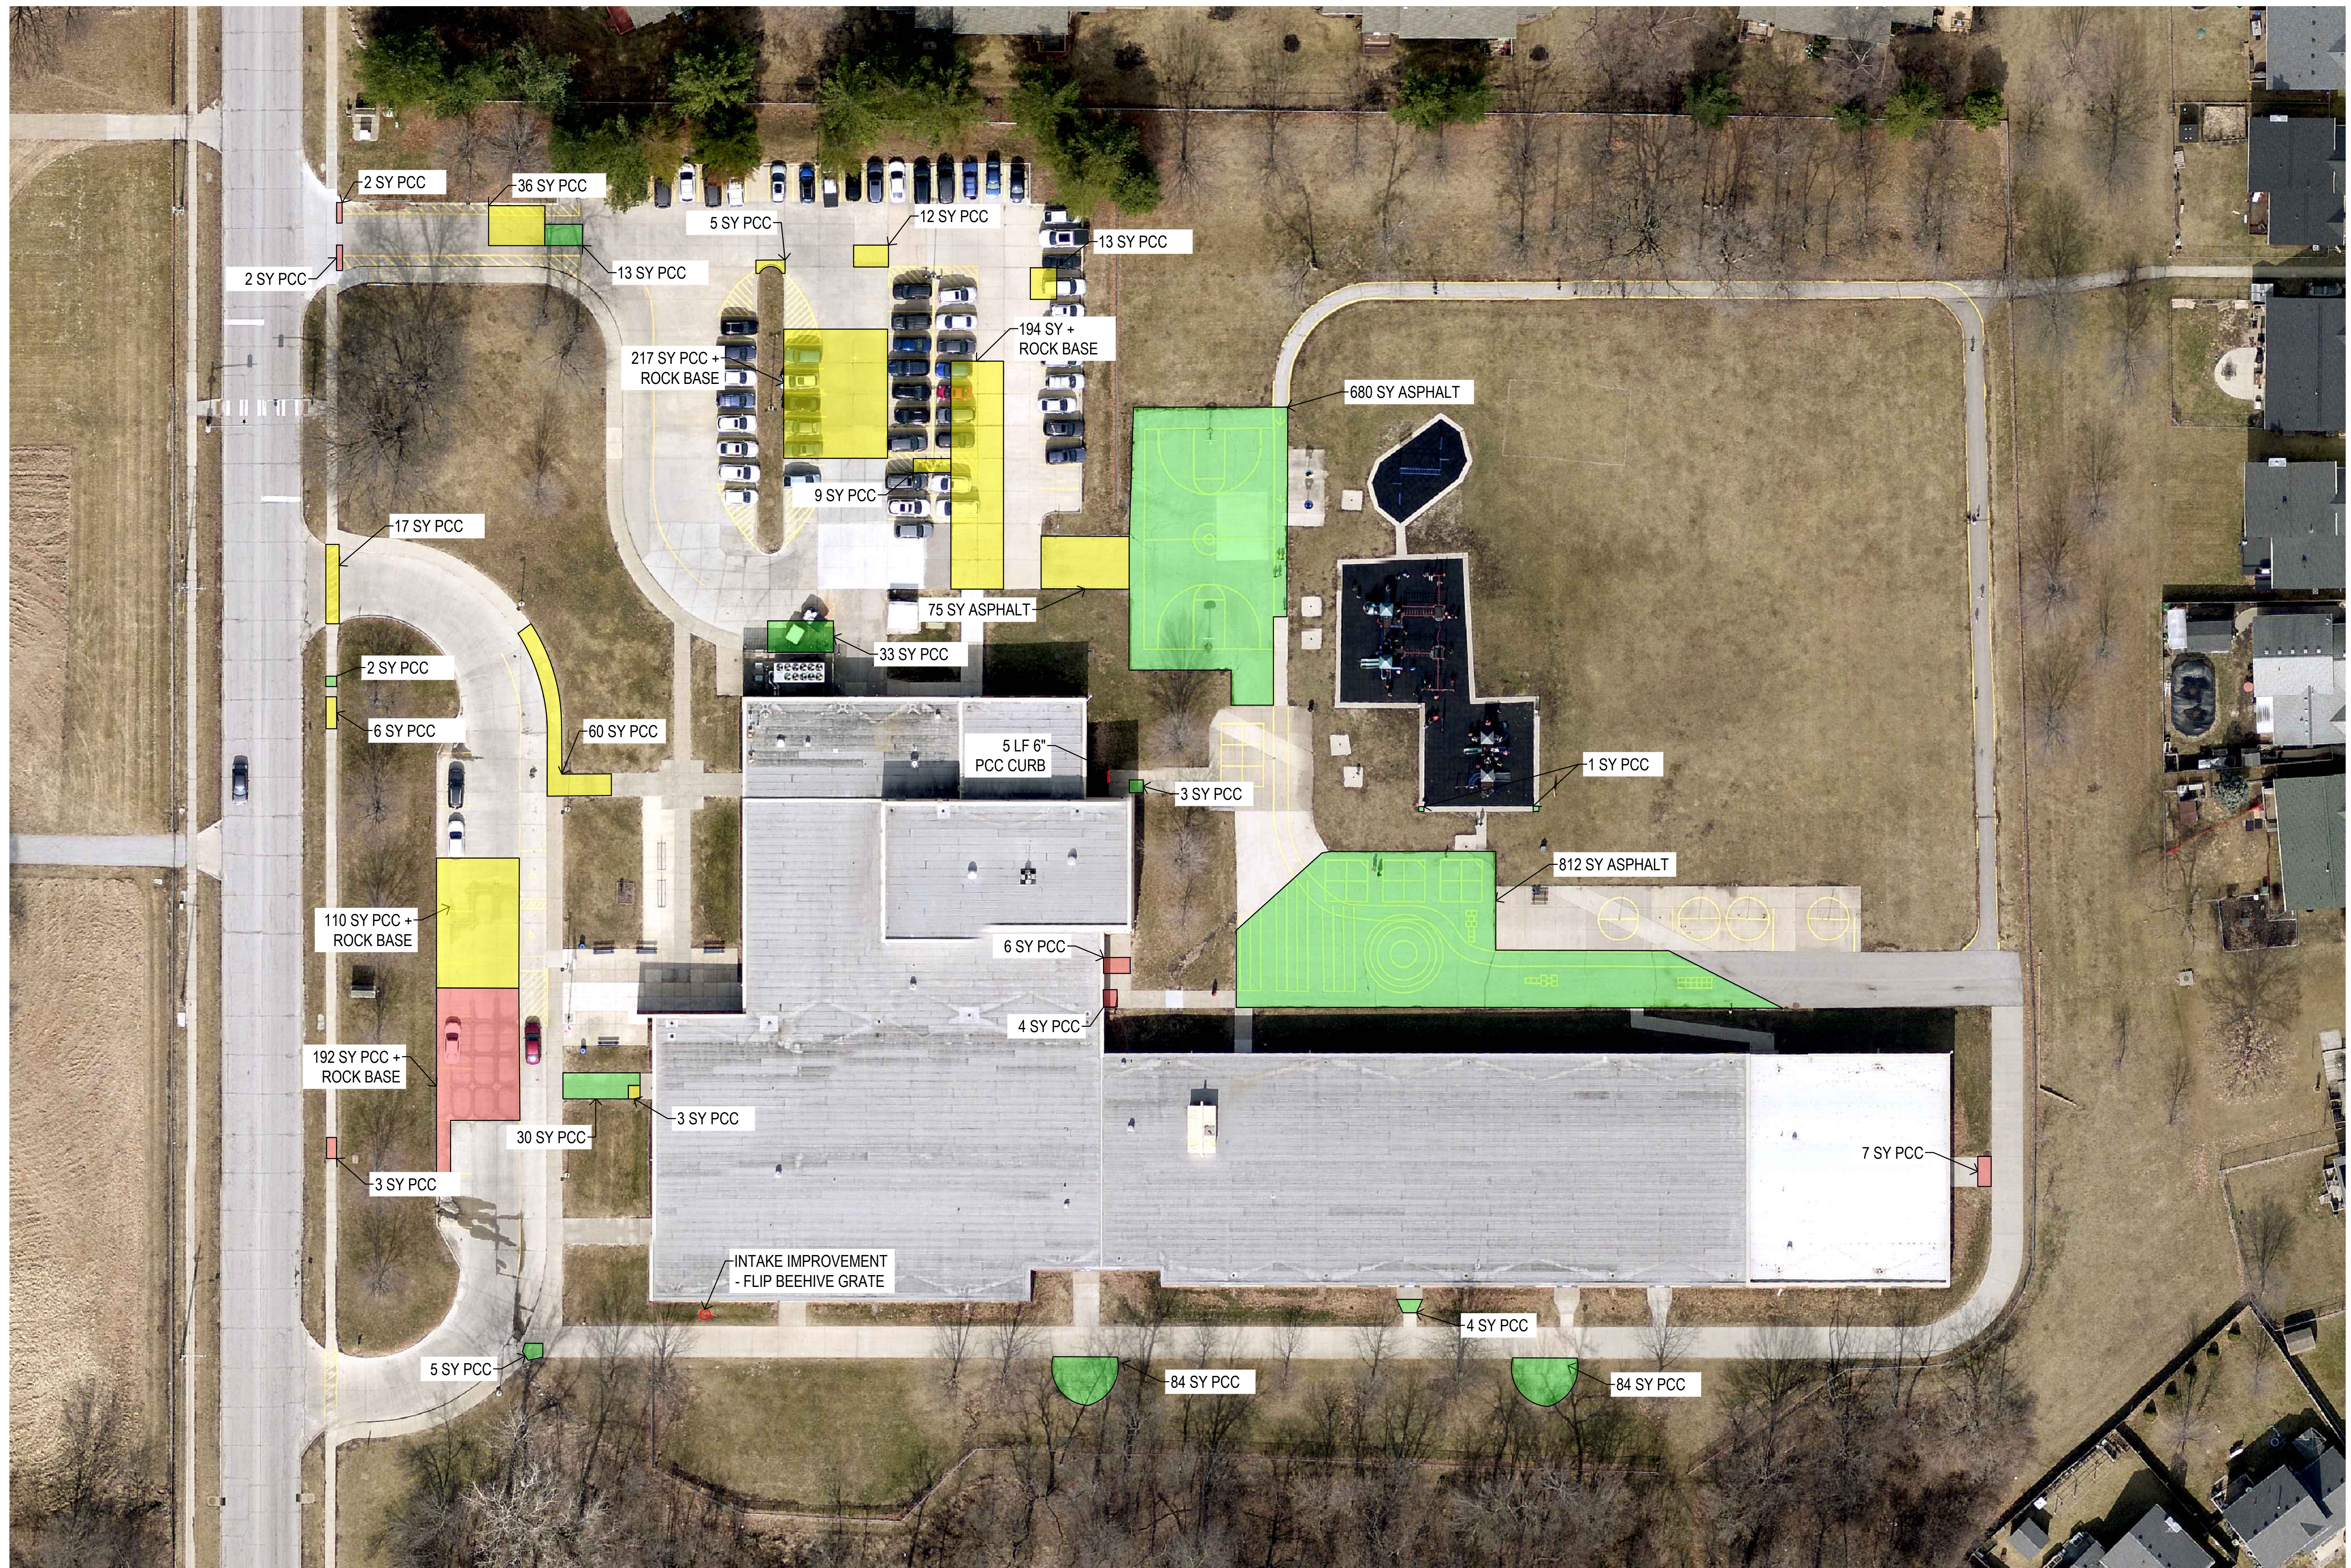
4.2 Parking areas are in good condition.	5	3	15	The north parking lot has poor subsurface drainage and the pavement joints are wearing out as a result. Areas in the west lot also are experiencing the same issue. Both areas would benefit from a rock base and subdrain.

4.3 Drive areas are in good condition.	3	3	9	The north drive aisles have sections with subsurface drainage issues. The west drop off lane has a considerable amount patch work done and there are many spiderweb cracks around these patches.

Intake Adjustment	Flip intake beehive grate to remove tripping hazard. For location, refer to civil site plan exhibit found in the appendix of this report.
MDF / IDF Grounding	Add #6 grounding connections for equipment racks in MDF and IDF room, and for CATV service entrance. Connect to TGB bars already located in rooms.
Exterior Door Adjustment	Adjust the following doors so that they latch from any closing position: door at kitchen and room 118.
Replace Boiler Flue	Replace boiler flue piping that is currently PVC with AL-294C stainless steel.
Carbon Monoxide Detection Installation	Install carbon monoxide detection in the mechanical room and connect to DDC.

Pavement Replacement	Remove and replace 192 SY of pavement in south drive and install a rock base. For location, refer to civil site plan exhibit found in the appendix of this report.	\$40,000
Sidewalk Repair	Repair 24 SY damaged sidewalks across the site. For locations, refer to civil site plan exhibit found in the appendix of this report.	\$9,000
Curb Repair	Return damaged curbs to new condition. Approximately 5 LF of 6" curbs. For locations, refer to civil site plan exhibit found in the appendix of this report.	\$6,000
Exterior Lighting Installation	Add exterior lighting near playground and east end of building, (3) fixtures estimated.	\$11,000
Heating Water Pumps Replacement	Install new heating water pumps. Confirm scope of B9074-Riverwoods-2024 HVAC Upgrades project to make sure replacement of pumps did not occur in this project.	\$100,000

Wall Base Replacement	Remove and replace rubber wall base in all corridors due to staining and damage (approximately 1,600 LF)	\$14,000
Pavement Replacement	Remove and replace 587 SY of pavement across site and install a rock base under the 521 SY experiencing subsurface moisture issues. For location, refer to civil site plan exhibit found in the appendix of this report.	\$120,000
Sidewalk Repair	Repair 83 SY damaged sidewalks across the site. For locations, refer to civil site plan exhibit found in the appendix of this report.	\$15,000
Playground Asphalt Replacement	Take out and restore deteriorated playground asphalt. Approximately 75 SY. For locations, refer to civil site plan exhibit found in the appendix of this report.	\$13,000

Roof Replacement	Remove 58,000 SF of modified bitumen roofing and insulation over roof areas A, B, C, D, and E. Install code compliant insulation and TPO roofing.	\$2,000,000
Pavement Replacement	Remove and replace 49 SY of pavement. For location, refer to civil site plan exhibit found in the appendix of this report.	\$12,000
Sidewalk Repair	Repair 212 SY damaged sidewalks across the site. For locations, refer to civil site plan exhibit found in the appendix of this report.	\$50,000
Playground Asphalt Replacement	Take out and restore deteriorated playground asphalt. Approximately 1,492 SY. For locations, refer to civil site plan exhibit found in the appendix of this report.	\$270,000
Fire Smoke Damper Actuator Replacement	Replace fire smoke damper actuators. Include position switch on all fire smoke damper actuators to be monitored by DDC or include monitoring with LED for position identification.	\$220,000
