DMPS FACILITY ASSESSMENT | SOUTH UNION ELEMENTARY

11.14.2023

Building Data Record

Building Name: South Union Elementary

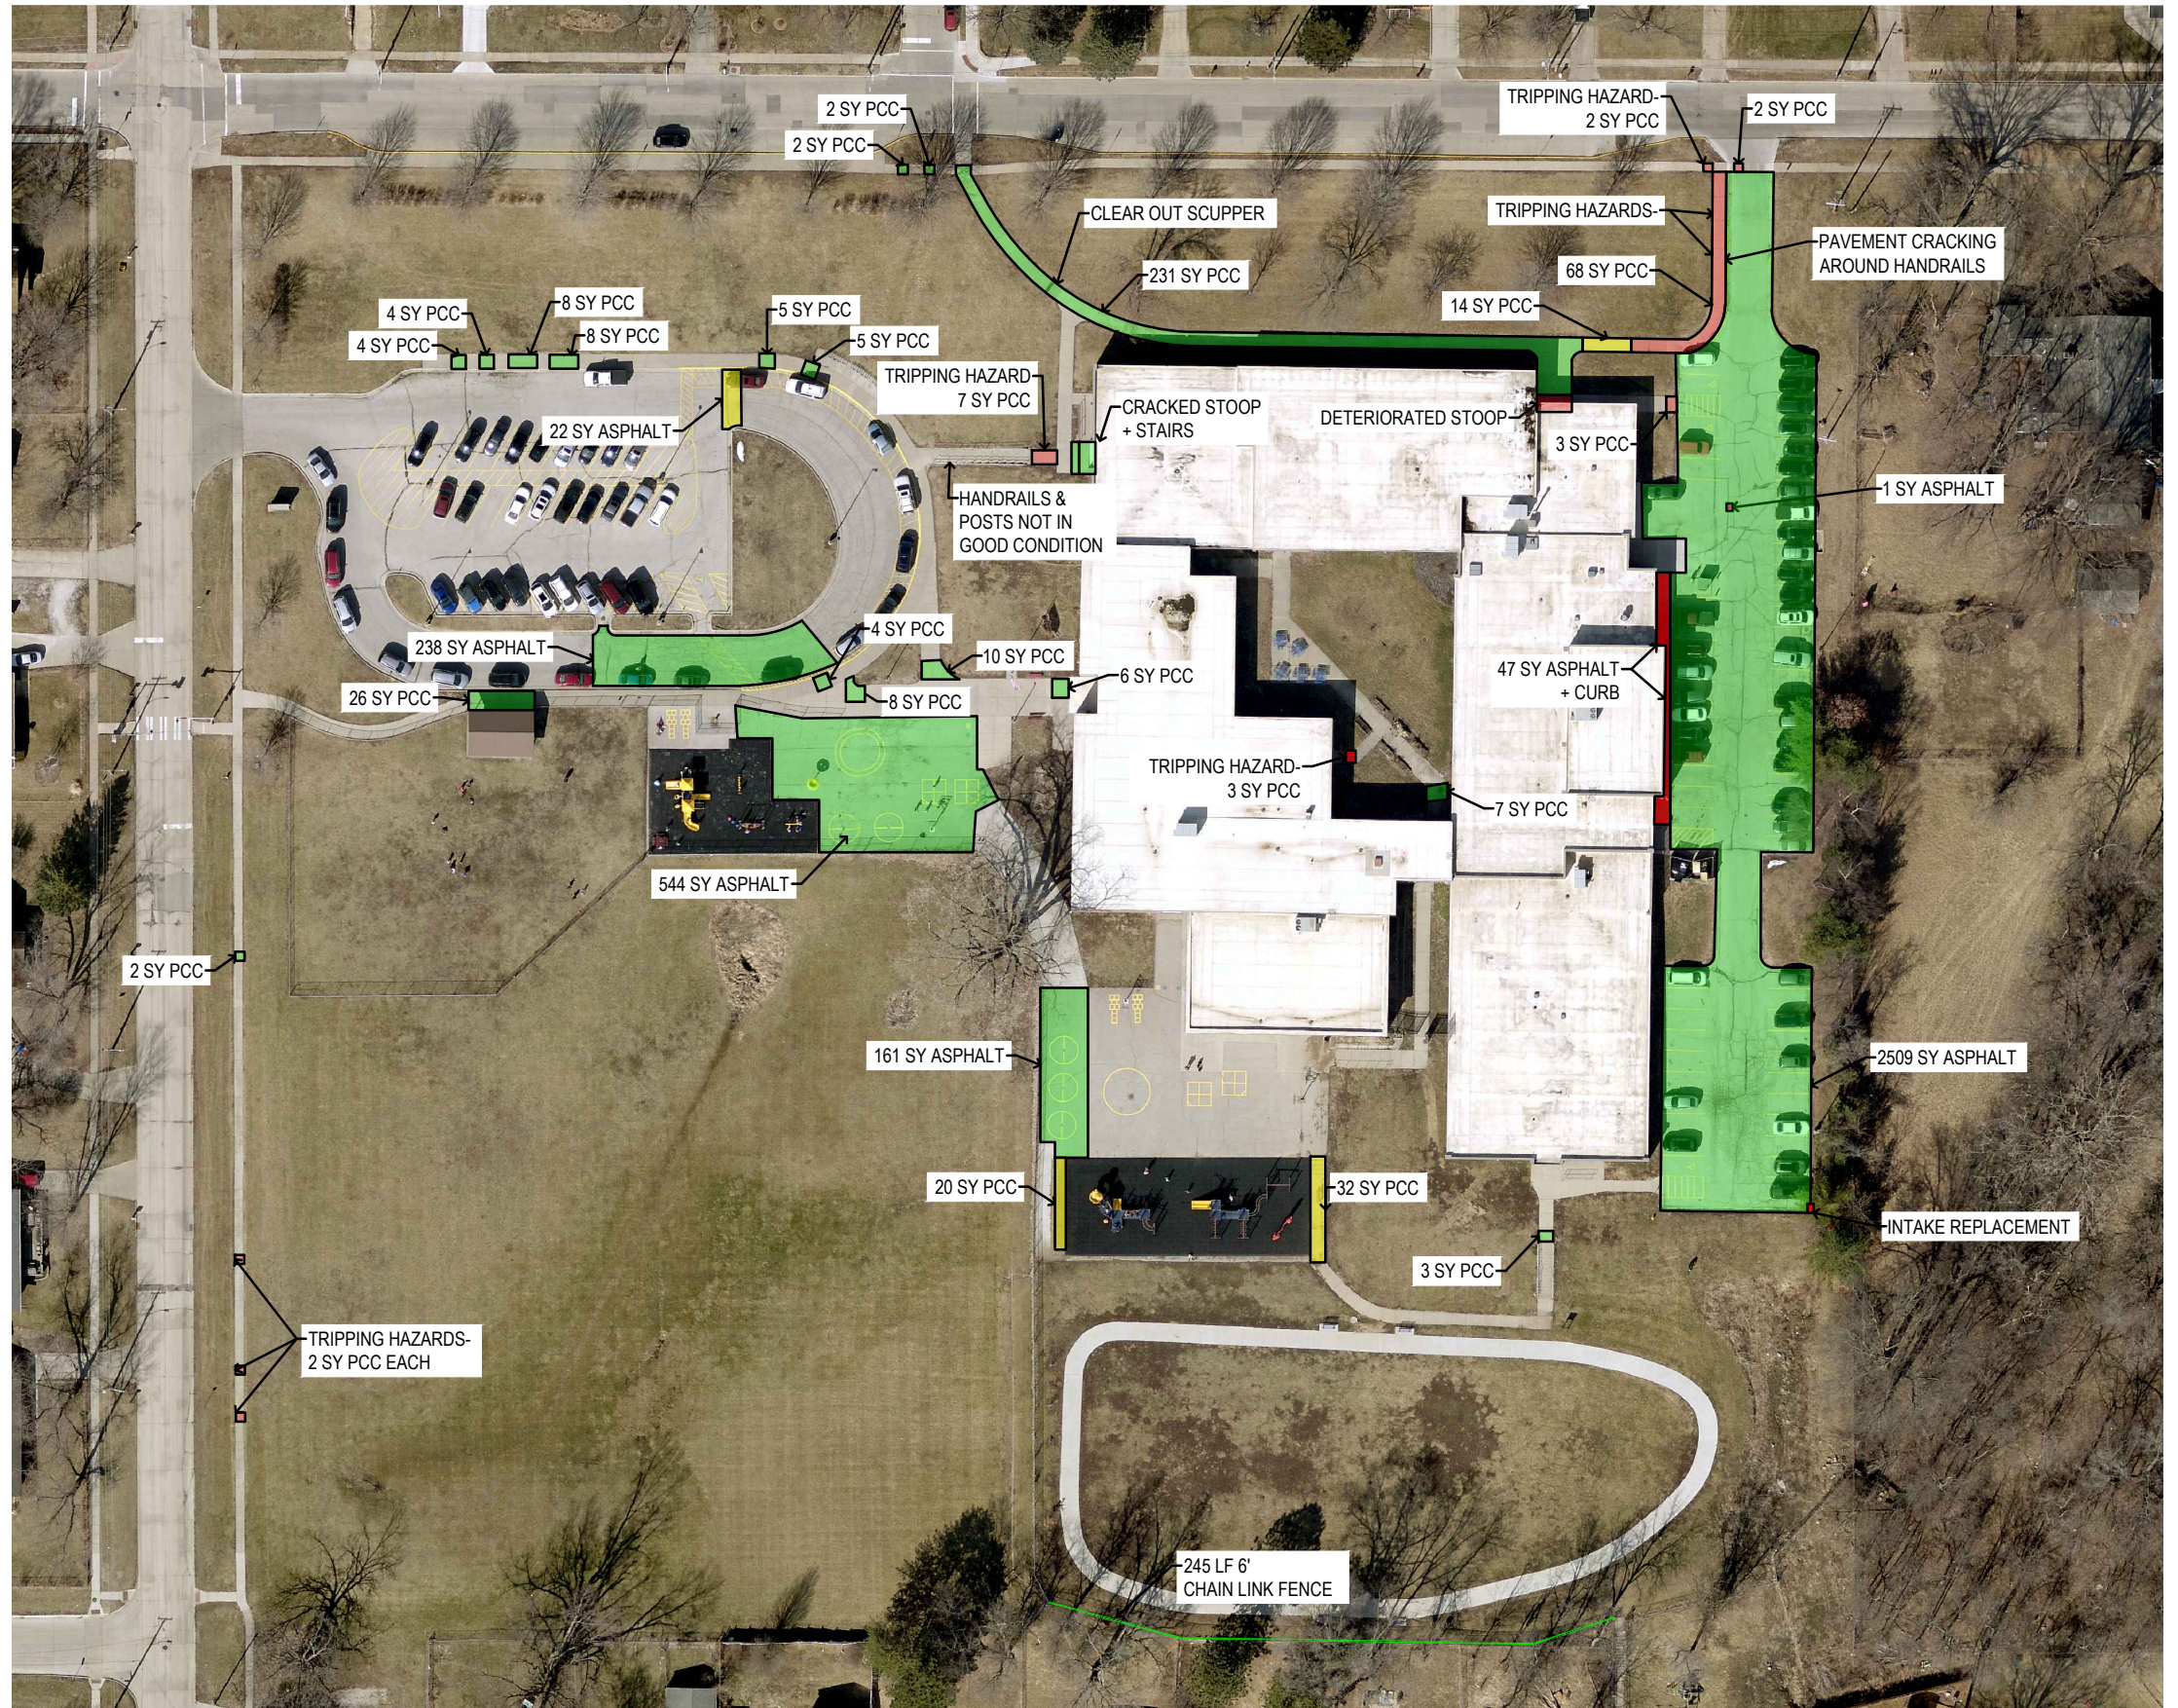
Sidewalk Replacement	Remove and replace 91 SY of damaged sidewalk and tripping hazards. See attached civil exhibit.	\$15,000
Parking Pavement Replacement	Remove and replace 47 SY of asphalt sidewalk in the east parking lot and rebuild curb. See attached civil exhibit.	\$12,000
Intake Replacement	Remove and replace the stormwater intake in the southeast corner of the east parking lot. See attached civil exhibit.	\$20,000
Exterior Stairs and Railings Replacement	Remove and replace exterior stairs and railings on grade near northwest corner of the building (45 LF, 11 risers) and near the southeast corner of the gymnasium	\$25,000

Playground Pavement Removal	Remove old concrete paving on the edges of the new south playground equipment. See attached civil exhibit.	\$12,000
Parking Pavement Replacement	Remove and replace 22 SY of asphalt paving in the west parking lot. See attached civil exhibit.	\$9,000
Sidewalk Replacement	Remove and replace 14 SY of sidewalk paving. See attached civil exhibit.	\$8,000
Stoop Replacement	Remove and replace concrete stoop at the northeast entrance (15 ft x 10 ft area).	\$20,000
Hand Wash Stations Replacement	Install new hand washing stations at restrooms with sensor operated faucets.	\$11,000
Grease Interceptor	Install new grease interceptor sized to meet WRA requirements	\$530,000
Power Panel Replacement	Replace antiquated 480V, 125A distribution panel in electrical room 277 with a new panel.	\$25,000
Combi-Oven Disconnect Relocation	Relocate disconnect switch for combi-oven to provide adequate working clearances around the equipment.	\$7,000

Playground Pavement Replacement	Remove and replace 705 SY of asphalt paving at the playground. See attached civil exhibit.	\$190,000
Fencing Replacement	Remove and replace 245 LF of chain link fence on the south side of the site. See attached civil exhibit.	\$50,000
Parking Pavement Replacement	Remove and replace 2,747 SY of asphalt pavement in the east and west parking lots. See attached civil exhibit.	\$730,000
Sidewalk Replacement	Remove and replace 325 SY of sidewalk pavement. See attached civil exhibit.	\$110,000
Stoop Replacement	Remove and replace concrete stoop at the northwest entrance (15 ft x 10 ft area).	\$25,000
Loop Well Pumps and VFDs Replacement	Install new geothermal loop water pumps including VFDs. Confirm scope of B9701 South Union HVAC Upgrades to make sure this work did not occur in that project	\$190,000
Domestic Hot Water Mixing Valve Installation	Install digital mixing valve in place of existing thermostatic mixing valve. . Rebalance hot water recirculation system.	\$15,000
