# DMPS FACILITY ASSESSMENT | STOWE ELEMENTARY

10.25.2023

# EXECUTIVE BUILDING SUMMARY

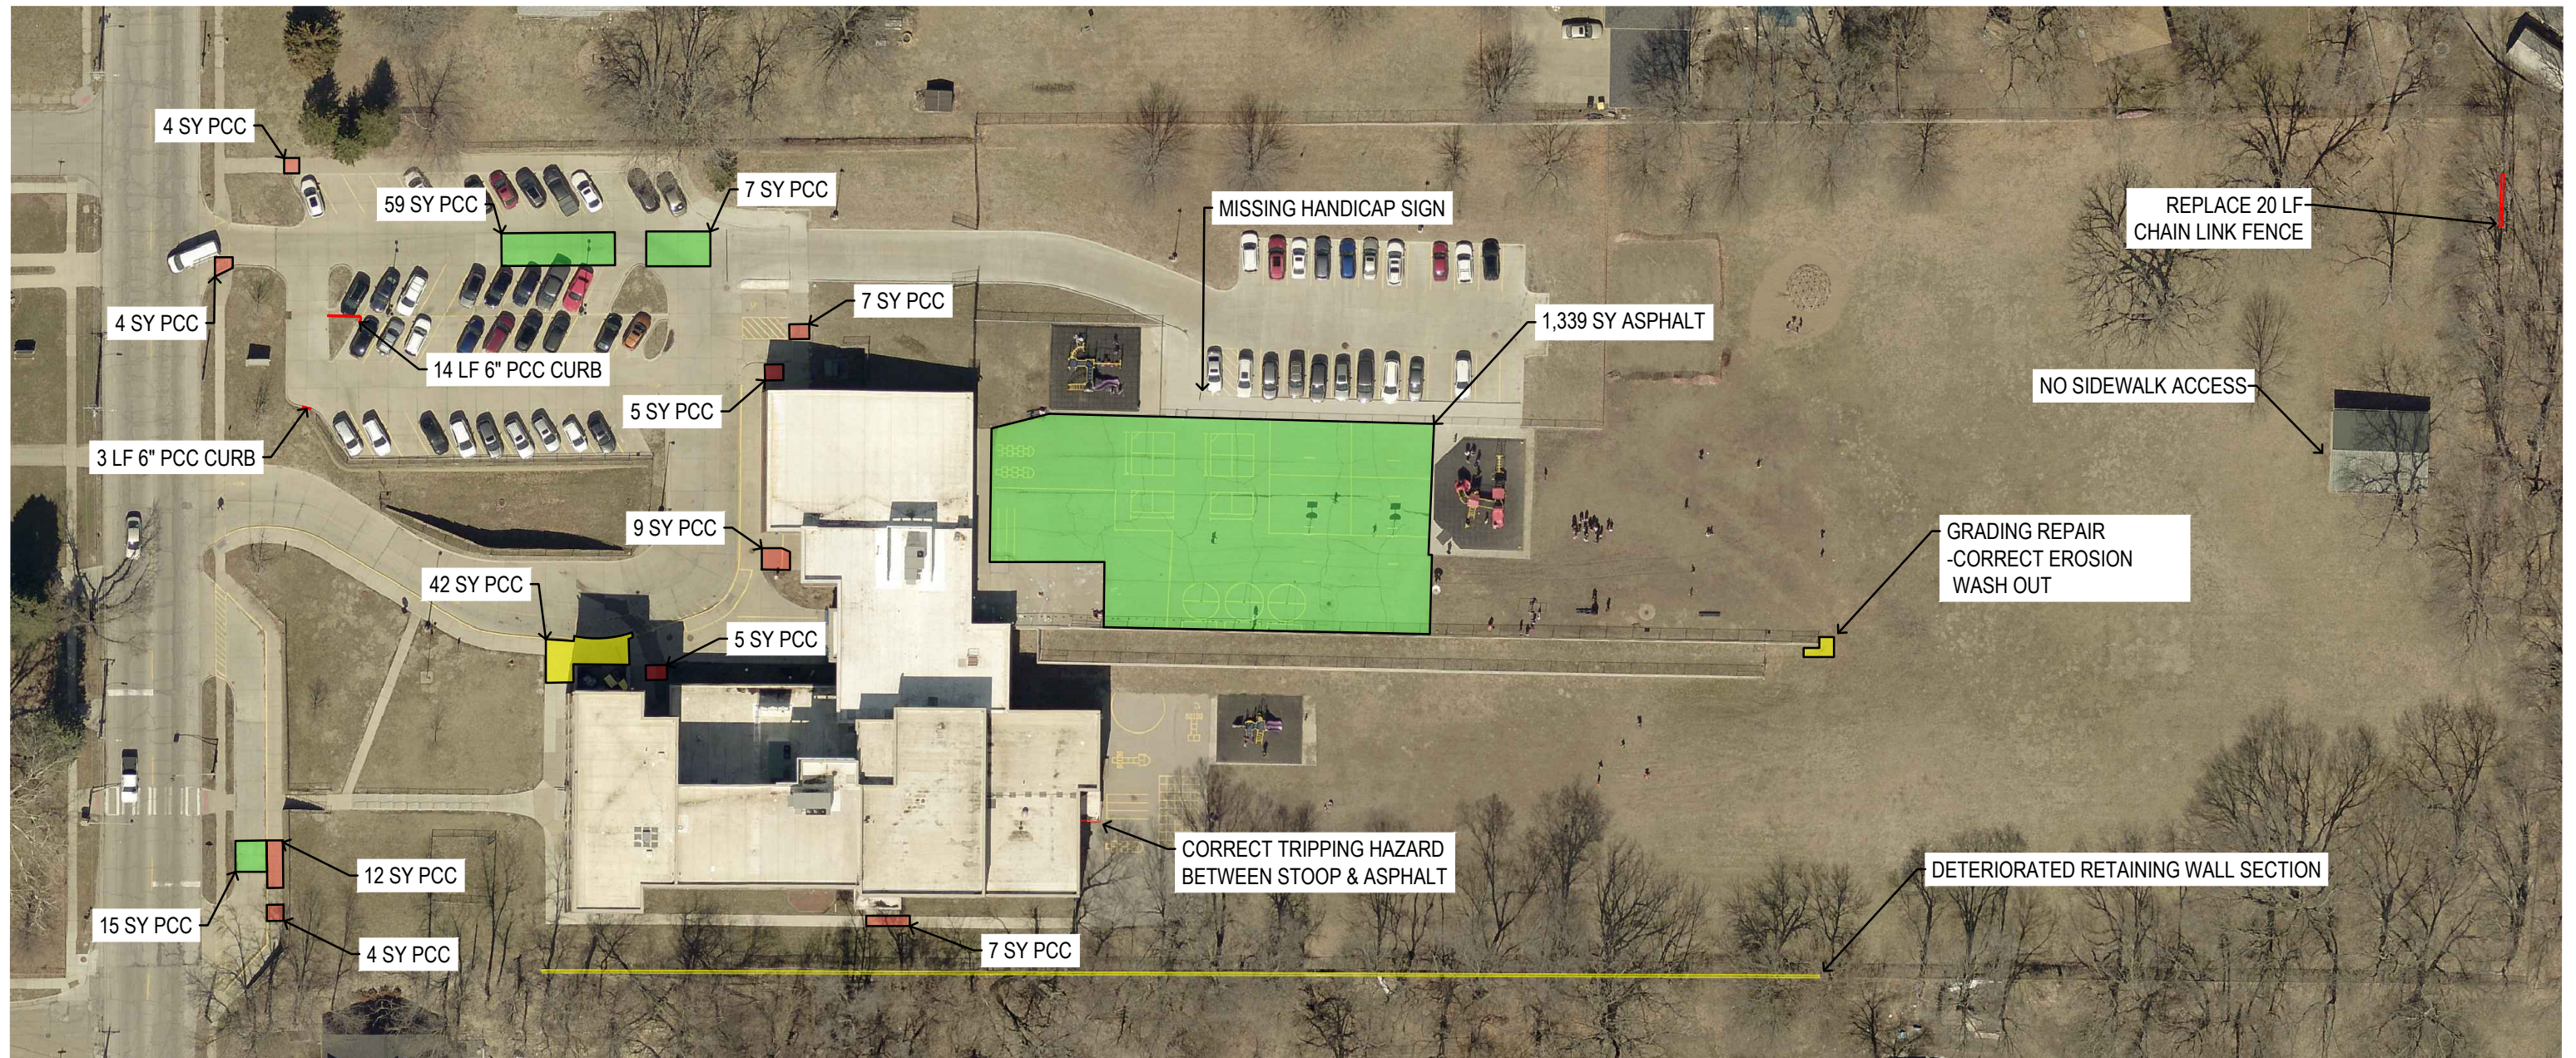
Weight Factor	Rating	Points	Comments
4.1 <b>Site topography</b> and grading drains water away from the building and retaining walls.	1	3	3	Drainage away from building is adequate. Eastern portion of site is rather steep with some erosion observed during visit, minor grading work may be necessary around retaining walls.

4.7 <b>Hard surface</b> playground surfaces are in good condition.	3	3	9	Cracks were throughout asphalt pavement with sealer on most of them. Although the asphalt was cracking, it was still in decent shape and didn't appear to be at risk of failing. Asphalt on the lower level to the south was in good condition.

Retaining Wall Investigation	Retaining wall to the south of the site should be replaced. Civil and structural concerns with existing conditions. Approximately 500 LF for replacement. See civil exhibit for location.	\$5,000.00
Ventilation and Exhaust System Improvements	The level of ventilation to classrooms is below what is required. Current system is only 50 to 60% of recommended airflow. The DOAS unit that provides this ventilation was recently replaced, but the amount of ventilation provided was not increased at that time. Investigate options to provide the required amount of ventilation to the Classrooms.	\$7,500.00
	Anticipated Capital Investment:	\$1,700,000
<b>Anticipated Capital Investment Costs</b>		<b>\$3,300,000</b>
<b>Total Study Design Service Fees</b>		<b>\$35,000</b>

Drainage Repair	Repair the wash out by the middle retaining walls. For location, refer to civil site plan exhibit found in the appendix of this report.	\$9,000.00
Pavement Replacement	Install reinforced PCC in front of trash enclosure. For location, refer to civil site plan exhibit found in the appendix of this report.	\$12,000.00
Stair Guardrail Replacement	Remove particle board guardrail top-extensions. Replace guardrails with a code compliant fully engineered system - 80 LF. Recommendations based on expected life of particle board extension, unknown current structural performance to meet safety codes, and aesthetics	\$50,000.00

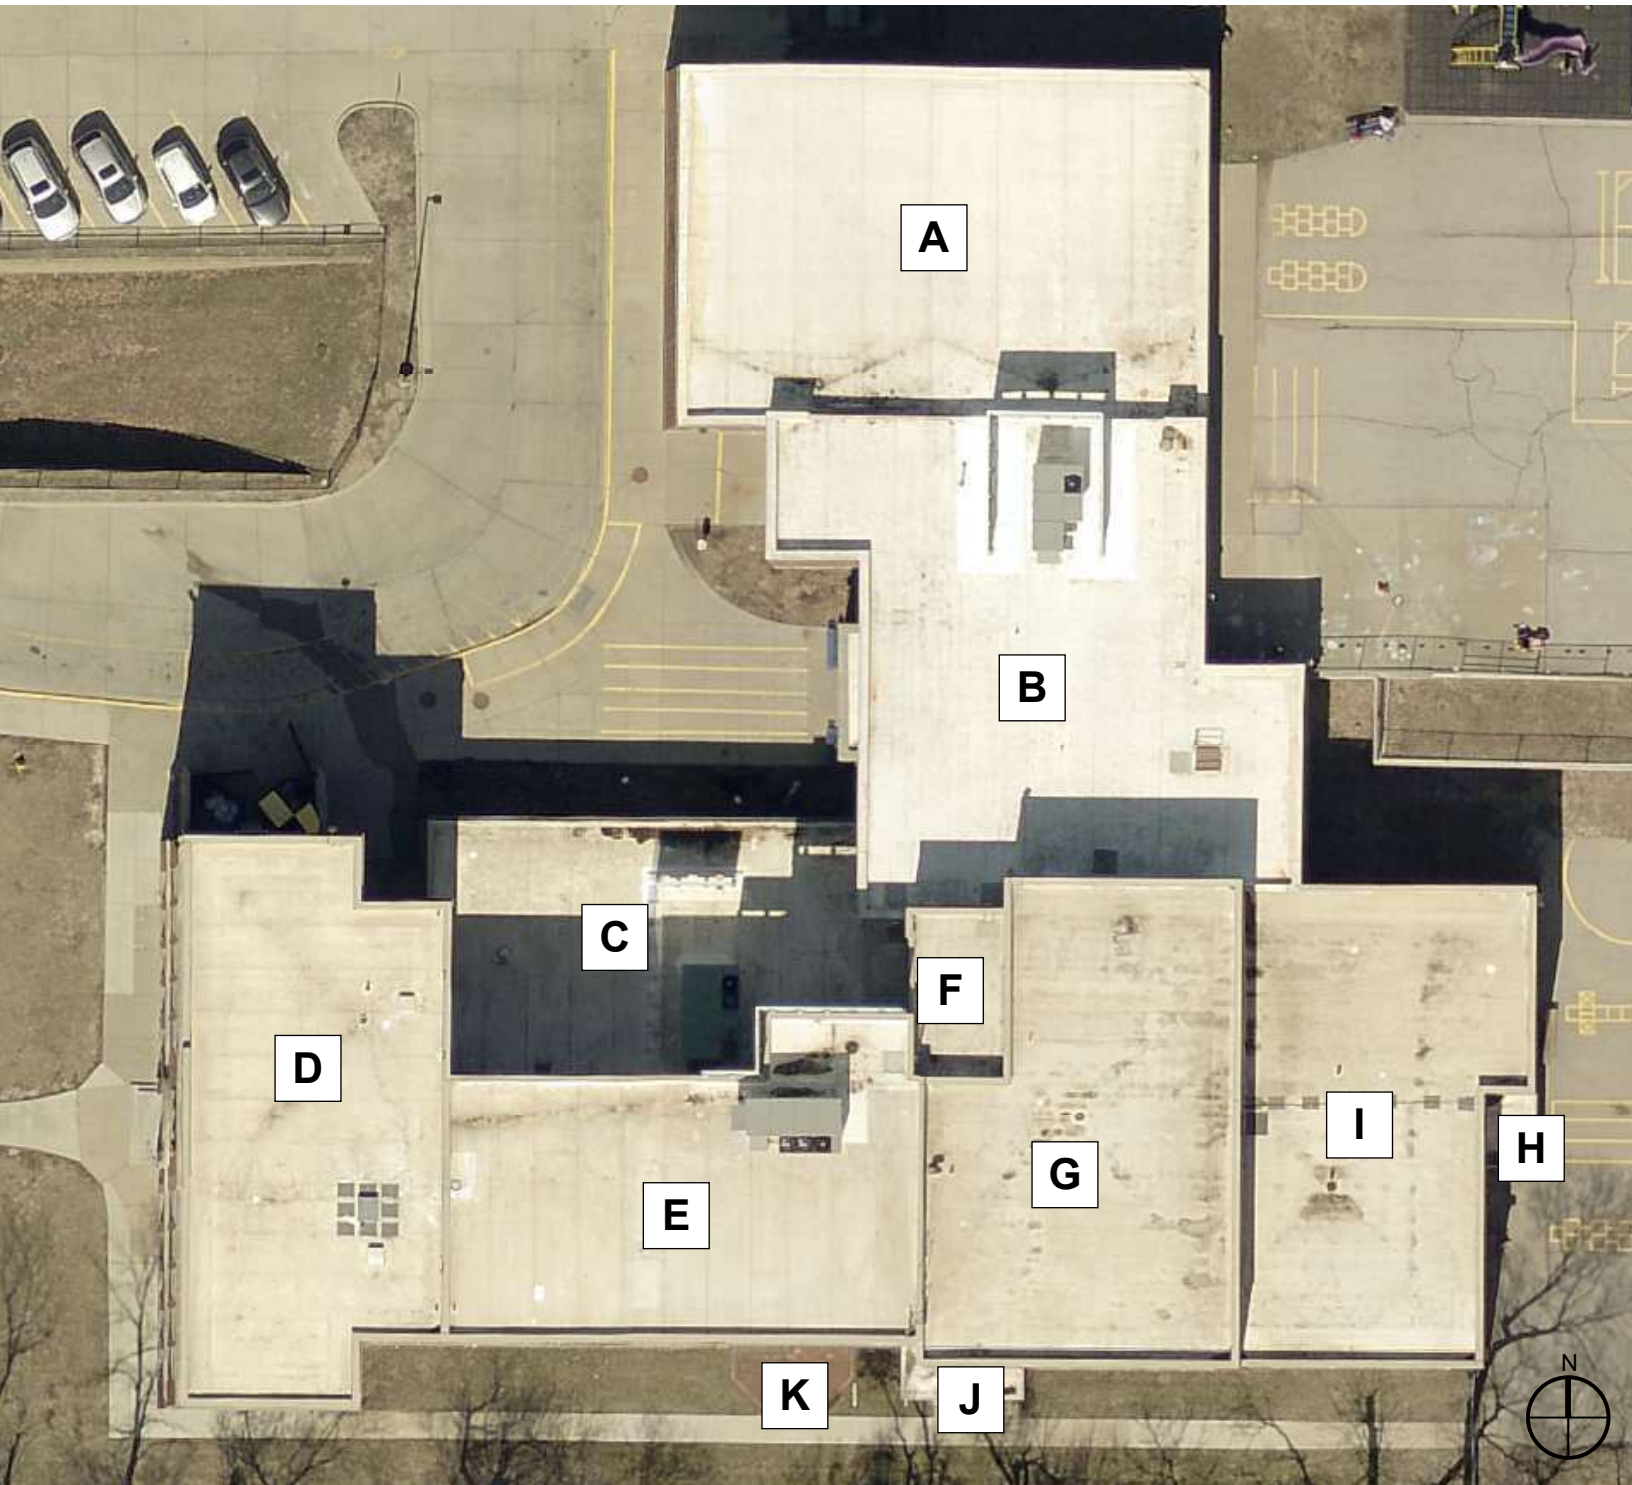
PVC roofs are nearing end of service life and should be replaced in 5-10 years. Reseal top edge of termination bar along Roofs B and C.

Roof Replacement	Full roof replacement recommended, 23,200 SF. Replace PVC with TPO.	\$740,000.00
Playground Pavement Replacement	Restore playground asphalt pavement. For location, refer to civil site plan exhibit found in the appendix of this report.	\$240,000.00
Parking Pavement Replacement	Remove and replace degenerated sections of parking pavement. For location, refer to civil site plan exhibit found in the appendix of this report.	\$15,000.00
Exterior Wall Repair	Remove and replace sealant in exterior masonry joints. Approximately 450 LF. Clean exterior walls, window sills, and roof parapets to remove any stains, mildew, or other biological growth. Approximately 24,000SF of exterior wall cleaning.	\$250,000.00
Hydronic Pumps	Install new geothermal loop pumps. Install new circulation pump on backup electric boiler.	\$170,000.00
Water Heater Replacement	Replace two electric hot water heaters, EWH-1 - 50 gallon and EWH-2 30 gallon	\$90,000.00
