DMPS FACILITY ASSESSMENT | STUDEBAKER ELEMENTARY

11.08.2023

EXECUTIVE BUILDING SUMMARY

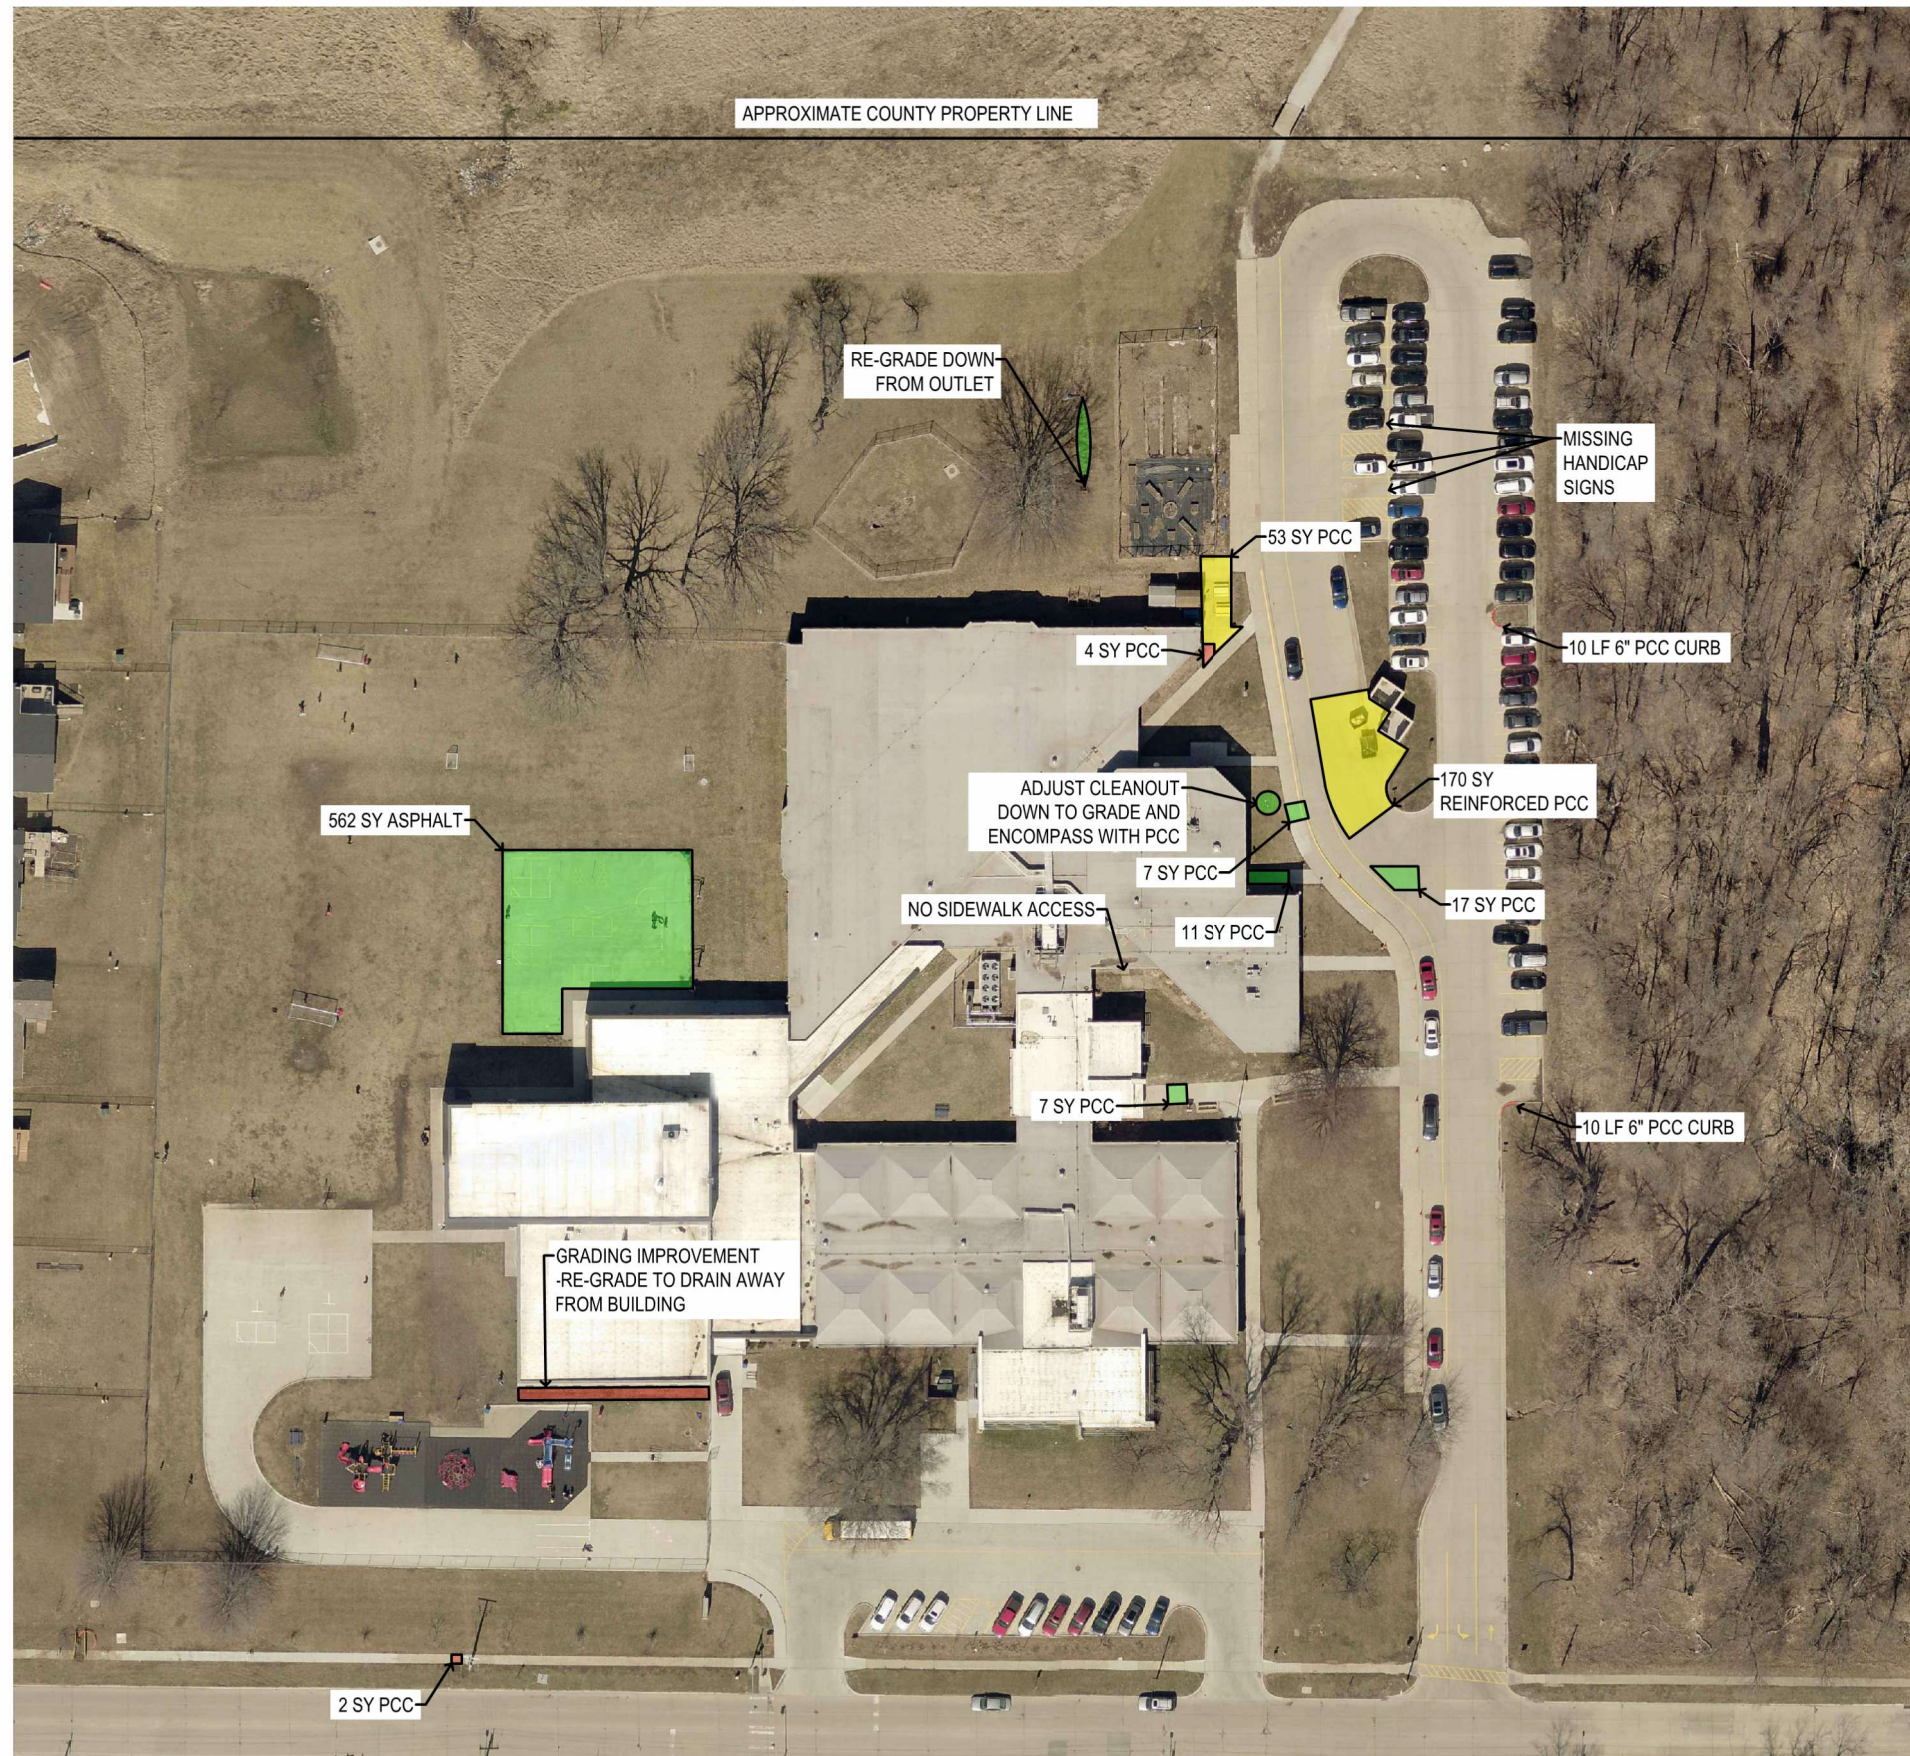
STUDEBAKER ELEMENTARY

Sidewalk Repair	Repair damaged sidewalks across the site. Approximately 53 SY. For locations, refer to civil site plan exhibit found in the appendix of this report.	\$13,000

- 5+ YEAR REPLACEMENT
- 3-4 YEAR REPLACEMENT
- 1-2 YEAR REPLACEMENT
