DMPS FACILITY ASSESSMENT |

EXECUTIVE BUILDING SUMMARY

Building Name: **Weeks Middle**

Date: **2.14.2024**

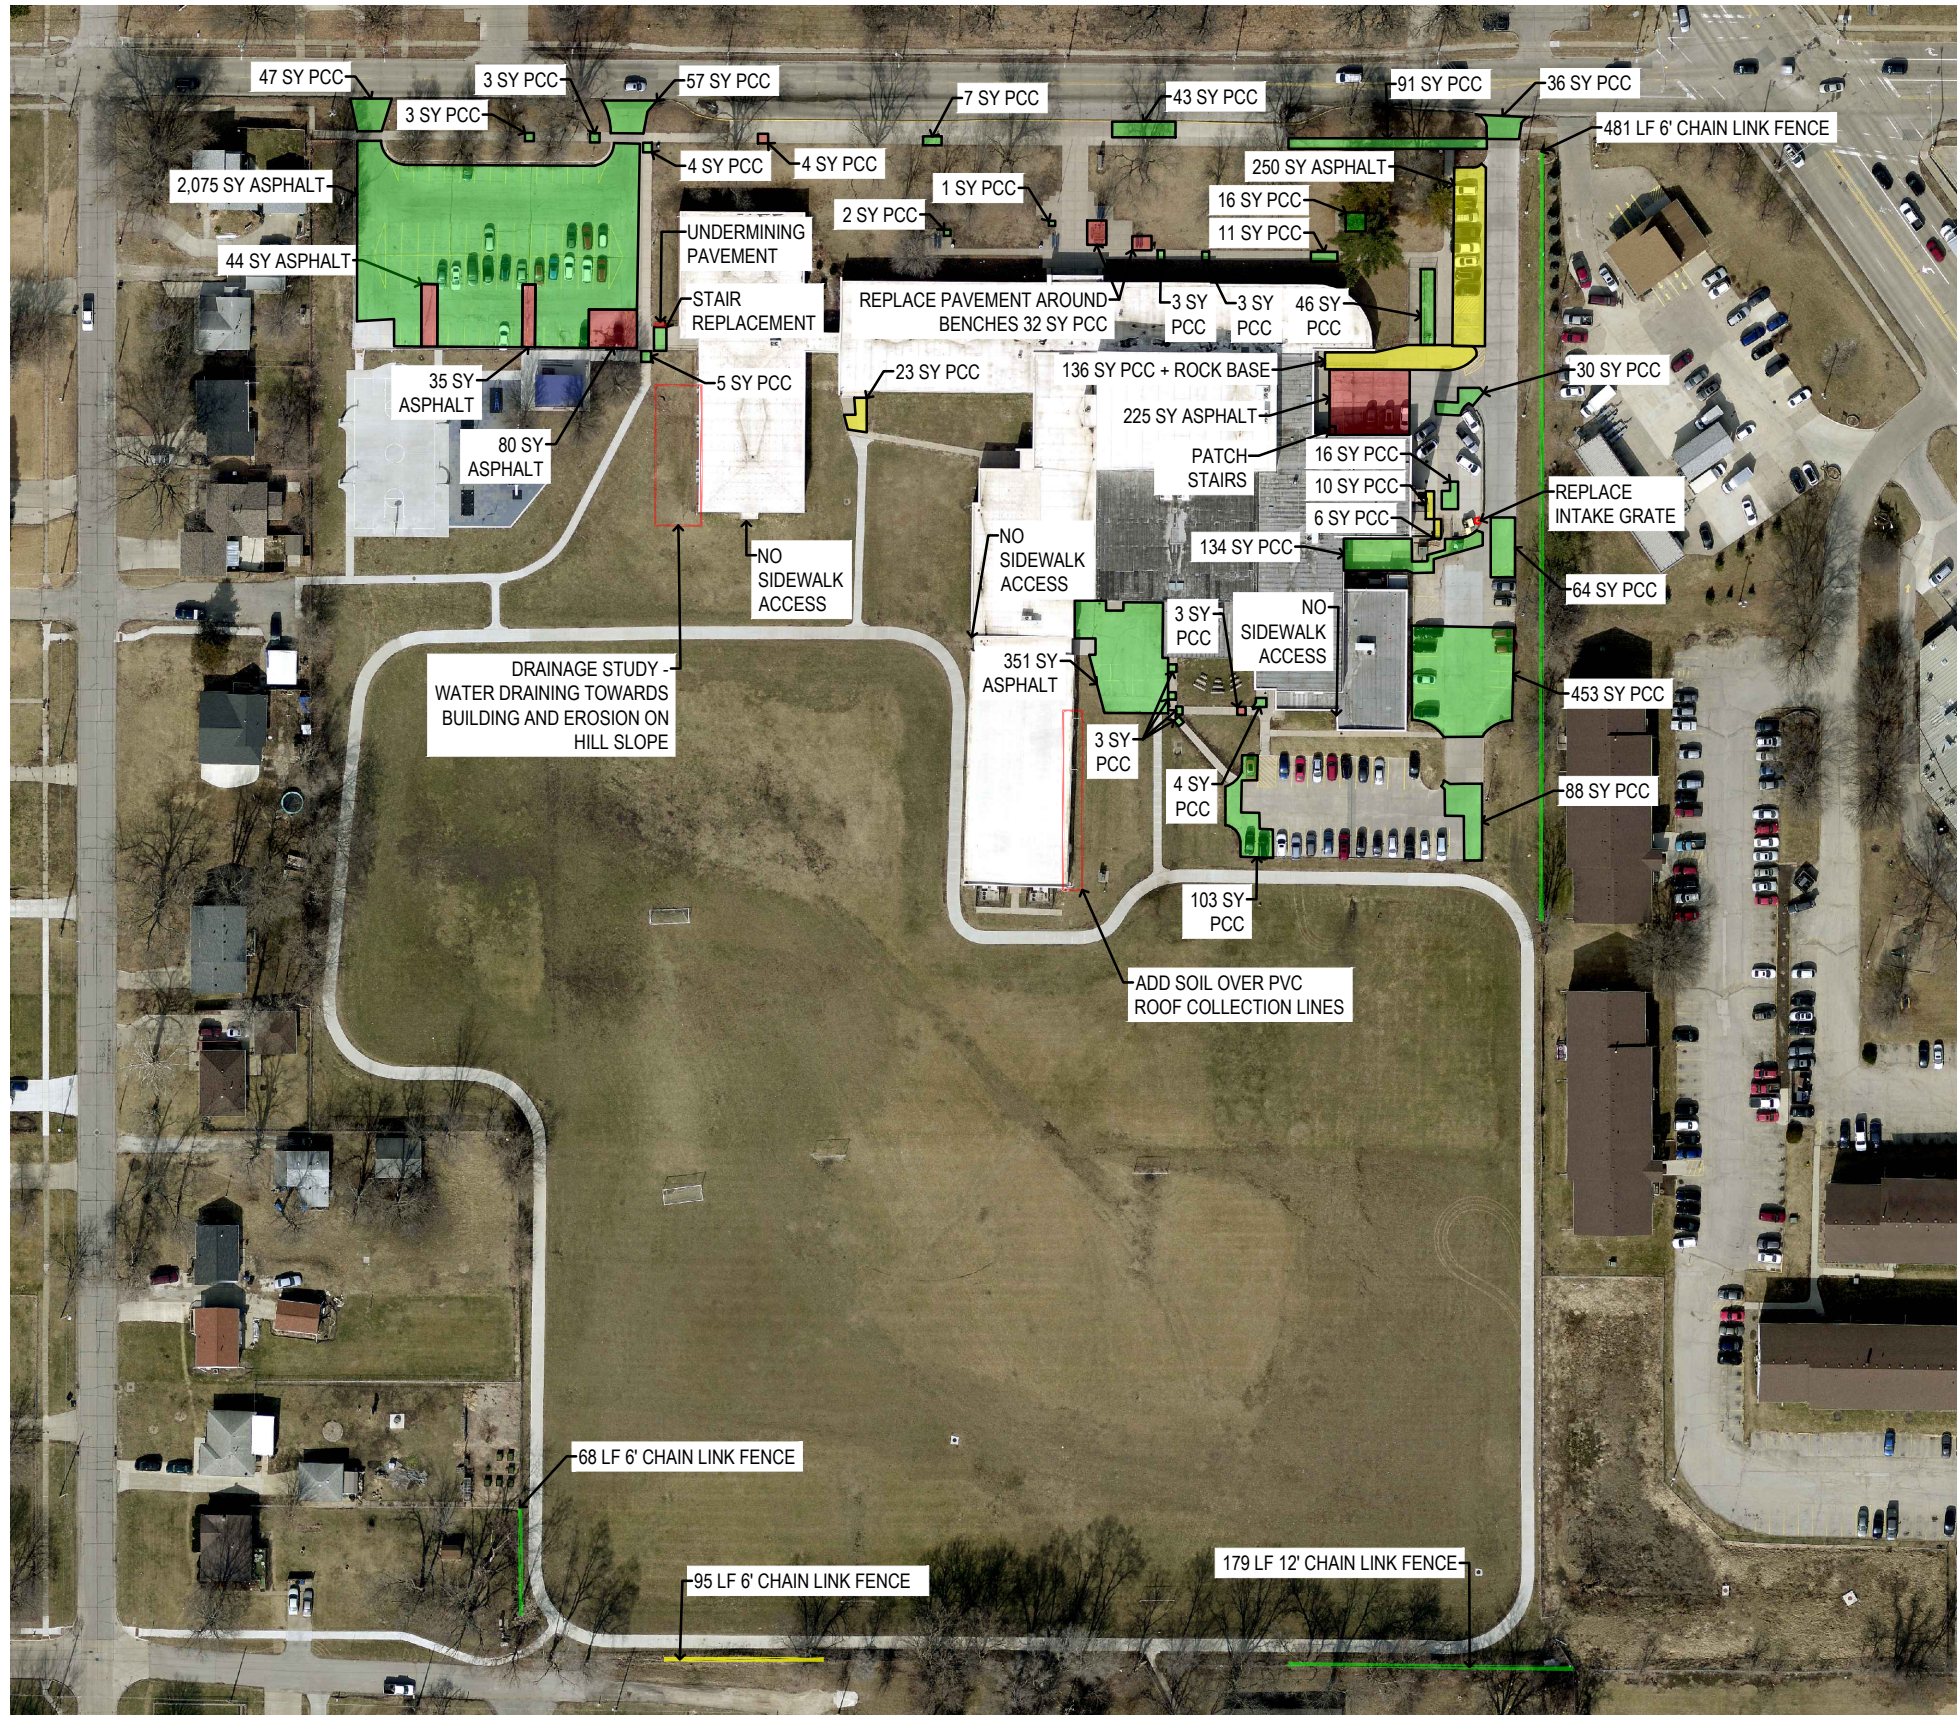
EXHIBIT
 PROJECT # 230286-48
 DATE 2/16/2024

4.2 Parking areas are in good condition.	5	3	15	The west parking lot asphalt is cracking and has sections cracking throughout pavement. The east side parking lot has sections of asphalt and PCC both needing replacement.

4.5 Sidewalks around the facility are in good condition .	1	3	3	Sections of the east side sidewalk has failed from what appears to be subsurface moisture issues, areas north side sidewalk will need replacement in the future. The stairs on the west side of the school are being undermined, adding soil and sod would help alleviate issue.

4.7 Hard surface playground surfaces are in good condition.	3	4	12	The walk track and basketball court pavement both appeared new and in good condition. The asphalt pad on the south side of school is cracking and will need replacement in the future.

4.8 Fencing around the site is in good condition.	1	3	3	The east and south fencing of the site have sections of needing replacement.
4.9 Trash enclosure is in good condition.	1	N/A	0	The dumpsters were out in the east drive at the time of visit.

4.10 Utilities are in newly constructed conditions and placed in suitable locations.	1	4	4	An intake on the east side needs replacement and the roof drain collection lines are exposed, recommending to add soil on top of the PVC pipe.

- 5+ YEAR REPLACEMENT
- 3-4 YEAR REPLACEMENT
- 1-2 YEAR REPLACEMENT
