DMPS FACILITY ASSESSMENT | WILLARD ELEMENTARY

01.09.2024

EXECUTIVE BUILDING SUMMARY

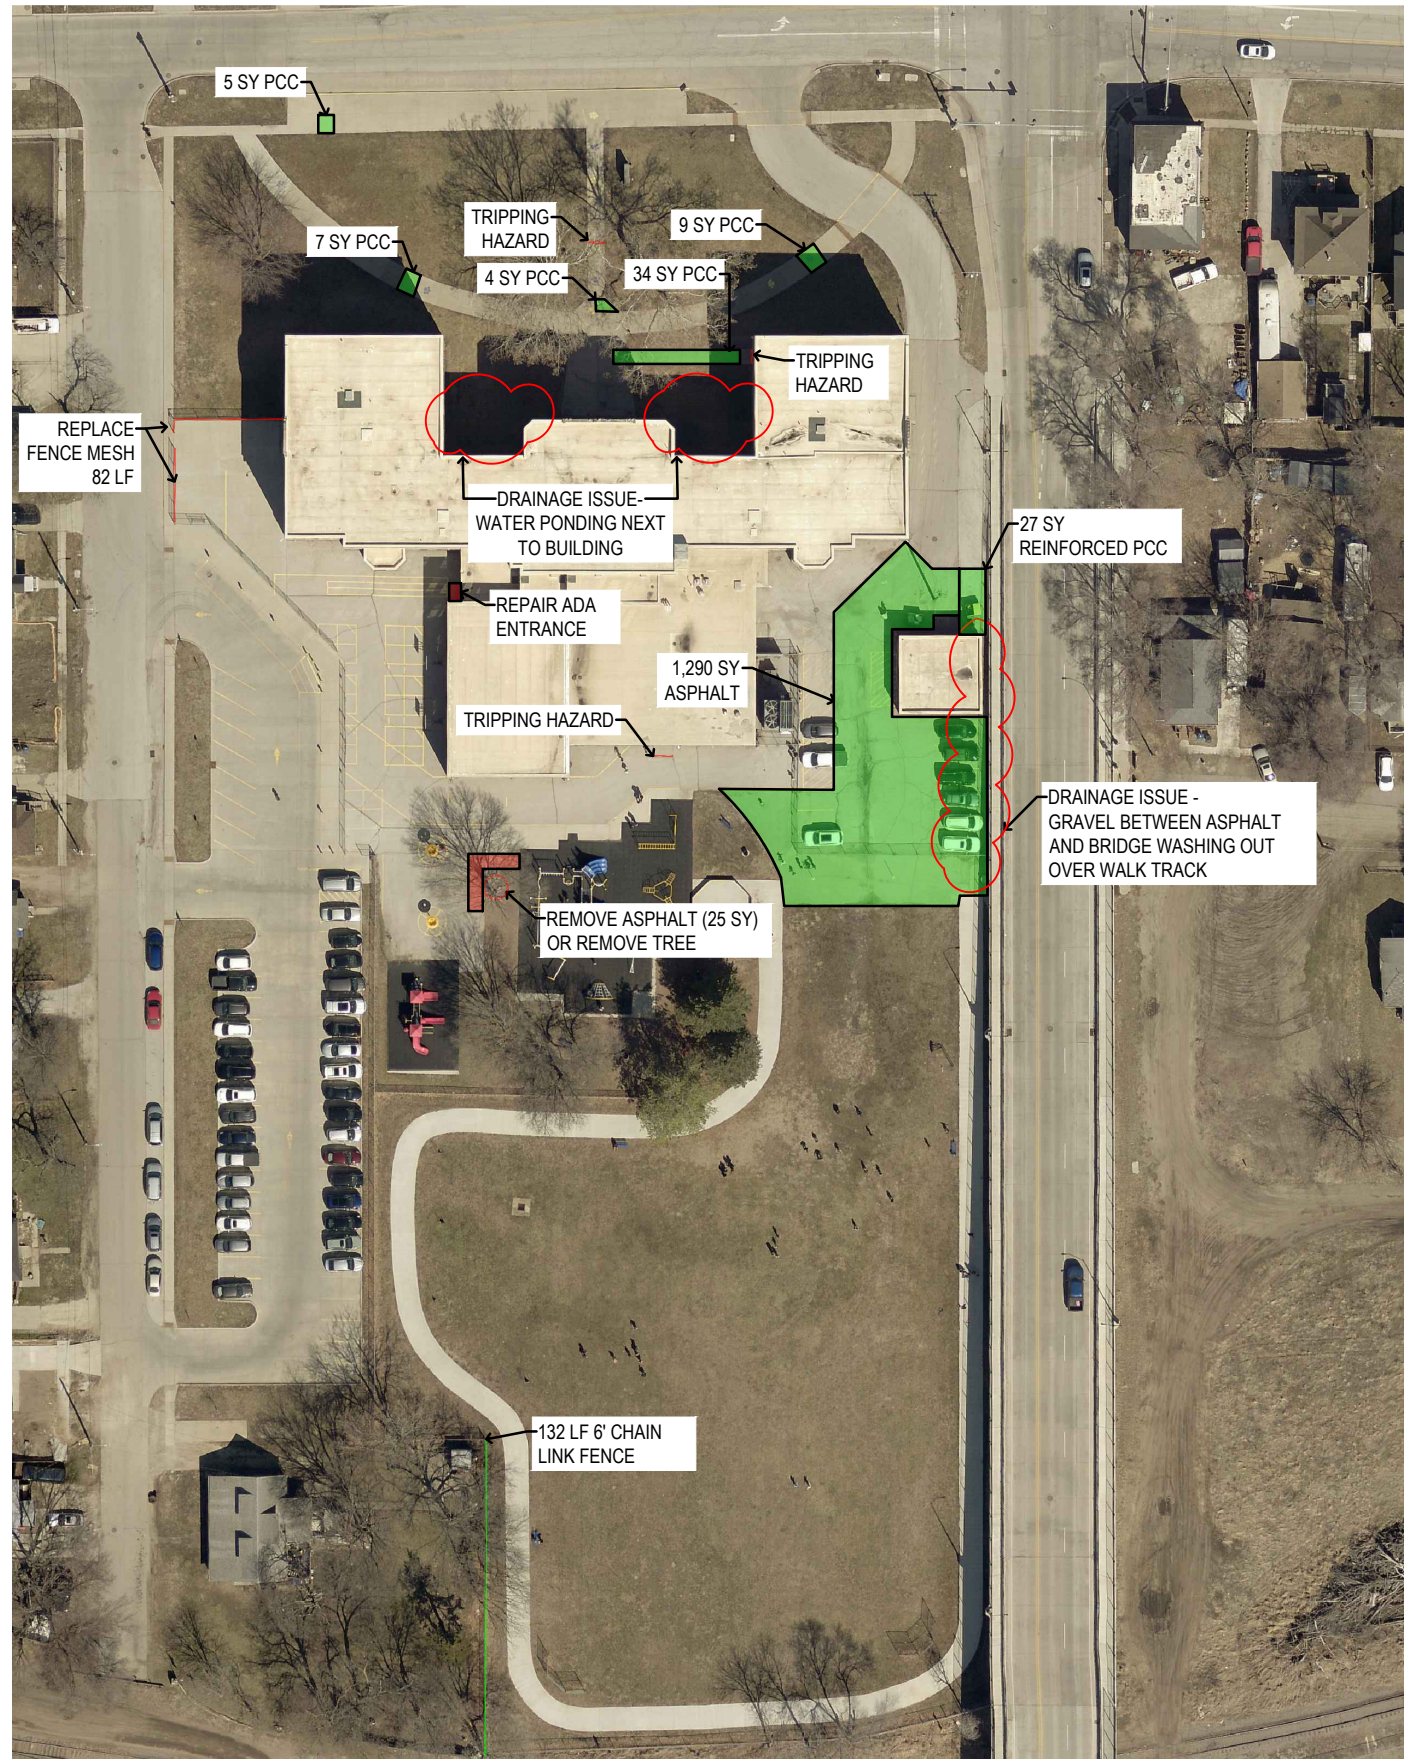
WILLARD ELEMENTARY

4.2 Parking areas are in good condition.	5	4	20	West parking new is newer concrete and good condition, east side asphalt has sections due for replacement.

4.3 Drive areas are in good condition.	3	3	9	Southeast asphalt sagging and cracking in the drive aisle. Remainder of drive aisles are in good condition.

4.5 Sidewalks around the facility are in good condition.	1	4	4	Sections of the north side need repairs but sidewalk conditions mostly good
4.6 Sidewalks are located in appropriate areas with adequate building access.	1	4	4	Only 1 ADA entrance and there is a lip between the building stoop and pavement that would be hard to roll a wheelchair over

4.8 Fencing around the site is in good condition.	1	4	4	The SW area by the walk track needs replacement, All other areas good.
4.9 Trash enclosure is in good condition.	1	N/A	0	Dumpsters currently out in east parking lot and no enclosure is located on site.

Exterior Masonry Cleaning	Clean stonework at main entry and entries near room 107 and 108; approx. 600 SF.	\$10,000
Replace Fence Mesh	Replace 82 LF of chain link fence mesh. For locations, refer to the civil site plan exhibit found in the appendix of this report.	\$7,000
Repair ADA Entrance	Remove the lip between the building stoop and asphalt of the ADA entrance on the west side of the school. For location, refer to the civil site plan exhibit found in the appendix of this report.	\$7,000
Playground Pavement or Tree Removal	Remove 25 SY of asphalt to provide more space for tree roots or remove tree. For location, refer to the civil site plan exhibit found in the appendix of this report.	\$10,000
Exterior Brick Lintel Rust Repairs	Rusted steel lintels need to be cleaned and loose material removed down to sound metal. New high performance coating and sealant shall be applied. This was typical at the majority of window lintels on the exterior of the building on each level that were able to be observed. Approximately 350 linear feet of lintel per level.	\$15,000
