DMPS FACILITY ASSESSMENT | WINDSOR ELEMENTARY

11.28.2023

EXECUTIVE BUILDING SUMMARY

Building Name: Windsor Elementary

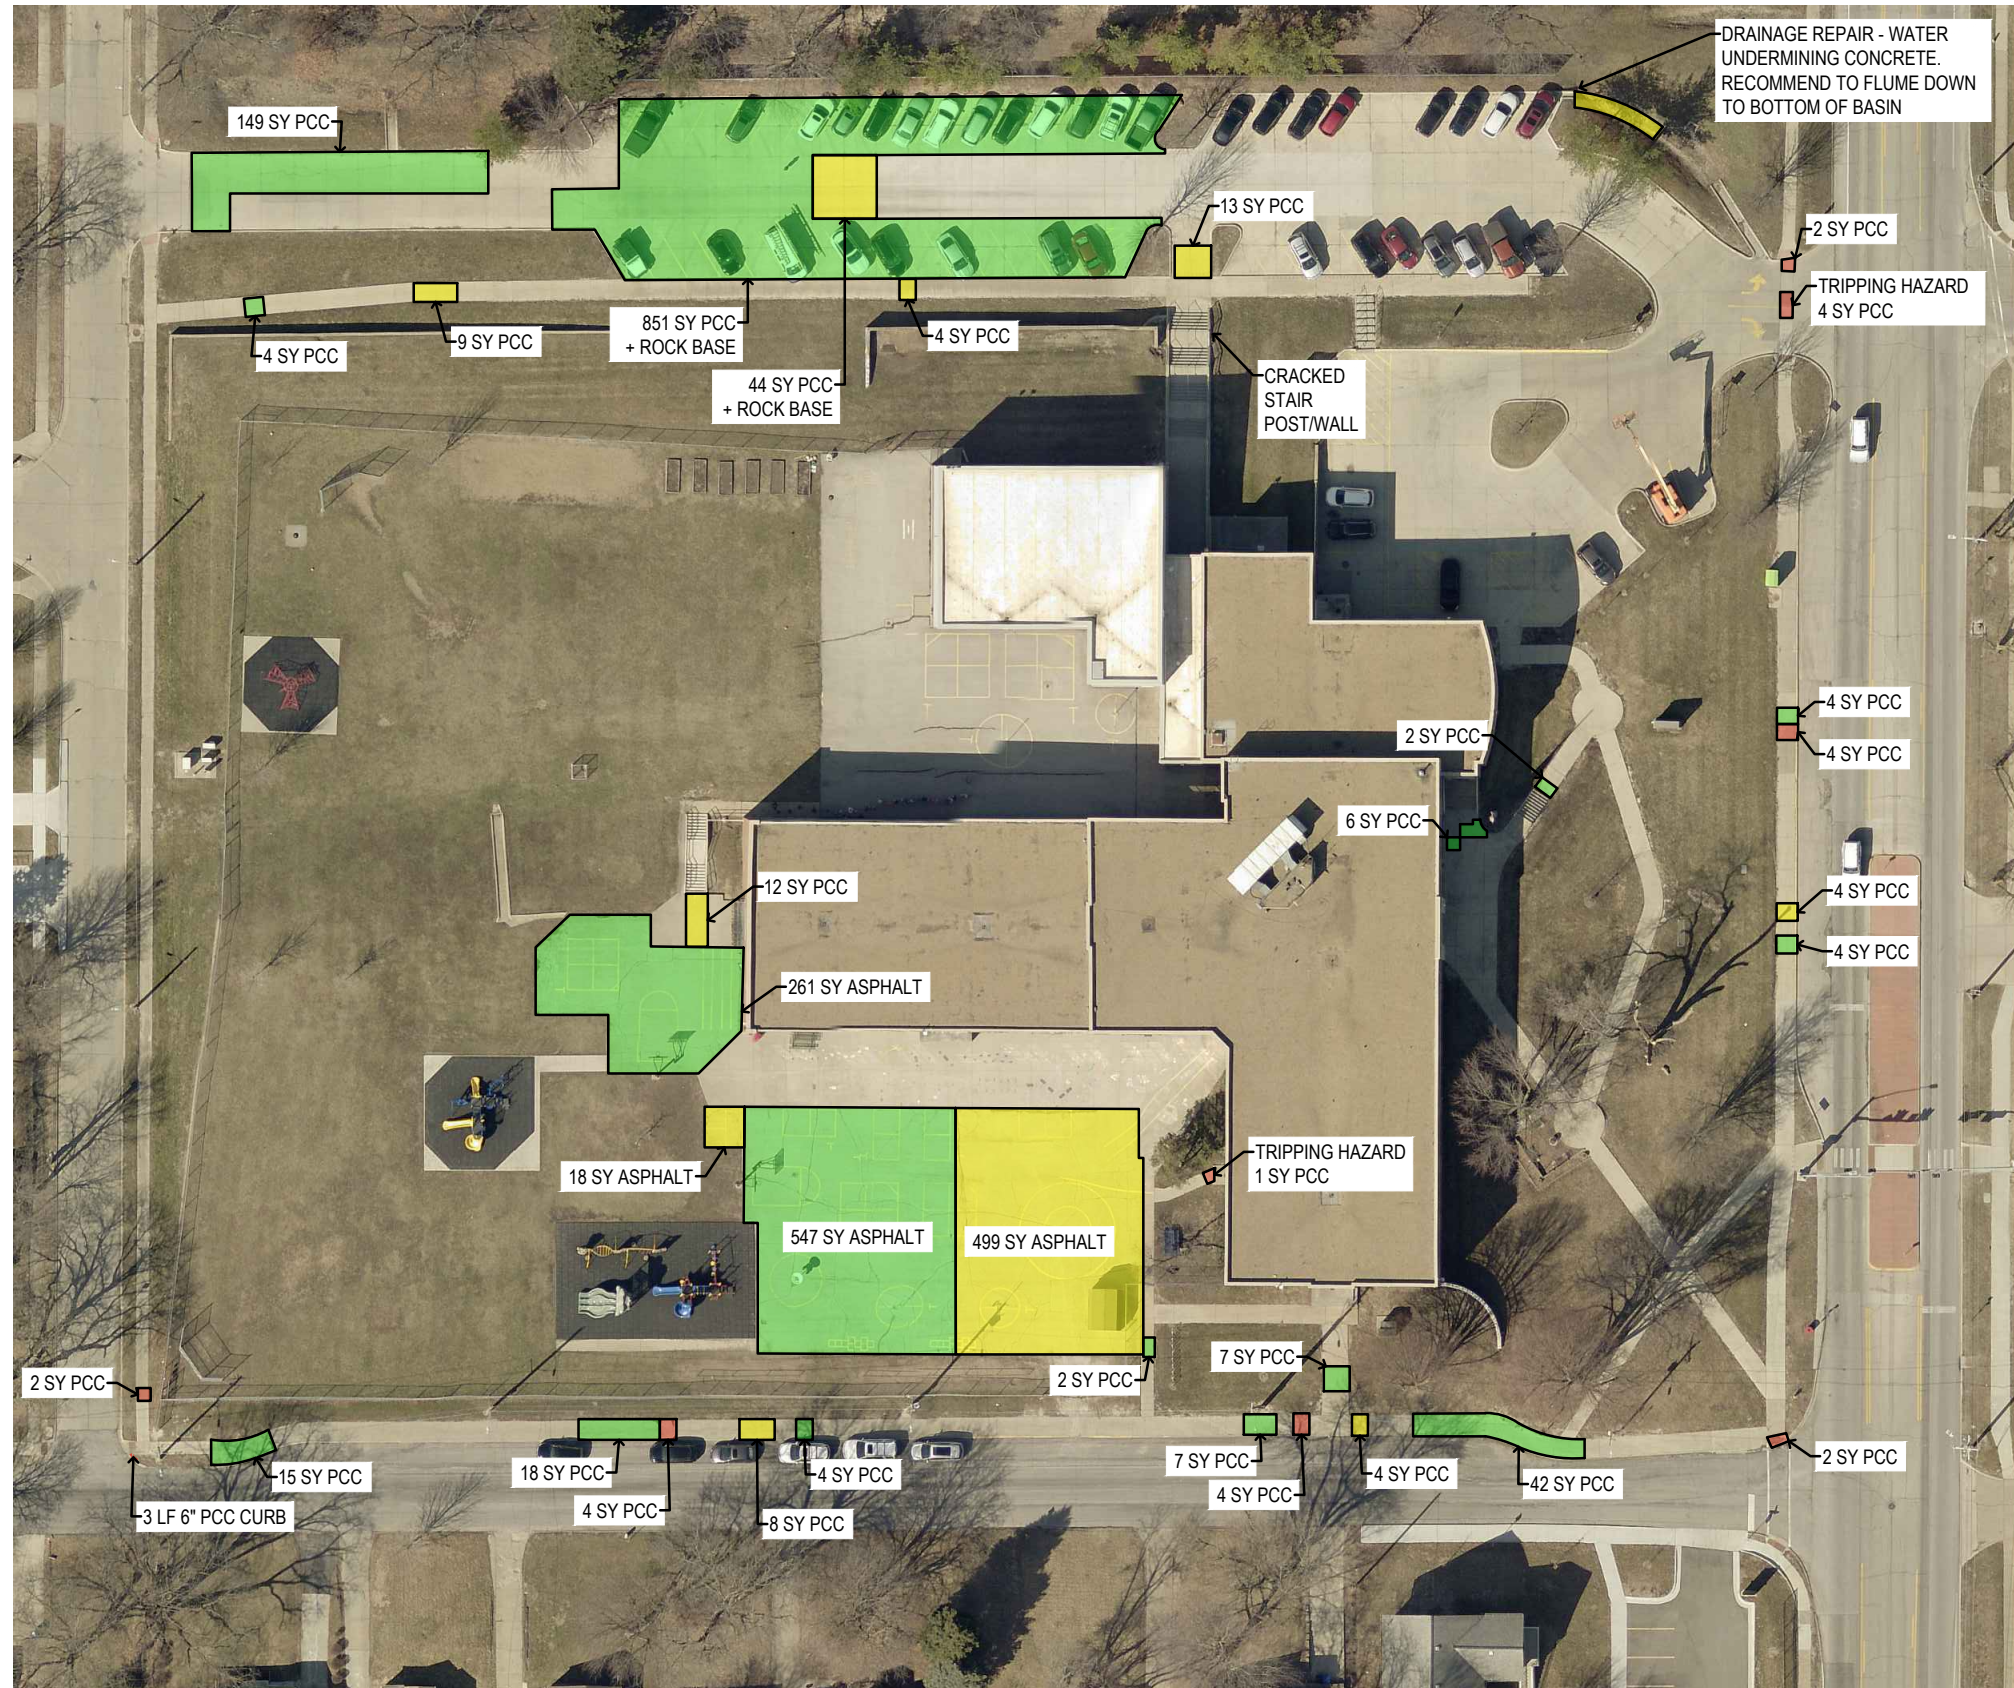
EXHIBIT
PROJECT # 230286-37
DATE 11/1/2023

Weight Factor	Rating	Points	Comments
4.1 Site topography and grading drains water away from the building and retaining walls.	1	4	4	Good drainage away from building, one erosion issue around parking pavement on NW side of site

4.2 Parking areas are in good condition.	5	4	20	Appears to be subsurface moisture issues on site, pavement cracking at joints in a few locations in the west parking area

4.3 Drive areas are in good condition.	3	3	9	Sizable section of the western drive cracking due to surface moisture issues. Recommend a rock base for any new pavement.

4.5 Sidewalks around the facility are in good condition .	1	4	4	Sections of sidewalk across site in need of repair, a tripping hazard in the NW walk through the north exit is in need of immediate repair

4.6 Sidewalks are located in appropriate areas with adequate building access.	1	5	5	Sidewalks were easy to navigate and all doors had sidewalk access
4.7 Hard surface playground surfaces are in good condition.	3	3	9	A substantial section of the upper level asphalt is cracking and sagging, the lower level asphalt was better and appeared to be able to last another 10 years

Roof Replacement	Remove 25,800 SF of ballasted modified bitumen roofing and insulation over roof areas A, B, C, and D. Install code compliant insulation and TPO roofing.	\$720,000
Roof Access Repair	Install handrail extensions on ladder from roof F to G. Remove embedded rungs from roof D to A, 8 total. Install guardrails around and a permanent 12 VLF ladder below roof hatch on roof D.	\$13,000
Insulated Metal Panel Replacement	Replace three insulated metal panels in hollow metal window at east end of hallway to gymnasium, 45 SF.	\$10,000
Sidewalk Repair	Repair damaged sidewalks across the site. Approximately 23 SY. For locations, refer to civil site plan exhibit found in the appendix of this report.	\$11,000

Curb Repair	Return damaged curbs to new condition. Approximately 3 LF of 6" curbs. For locations, refer to civil site plan exhibit found in the appendix of this report.	\$6,000
Heat Pump Replacement	Replace all of the older 2005 heat pumps in the building with extended range. Include two stage compressor to more closely match load and provide dehumidification.	\$1,700,000
Domestic Water Heater Replacement	Replace electric hot water heater.	\$40,000
Exterior Lighting Installation	Add exterior lighting at west side, especially to cover stairs to lower parking lot.	\$11,000
CCTV Camera Installation	Add cameras at northeast corner of building.	\$9,000
Elevator Cab Interior Finishes	Replace the laminate panels and car door. Panels need metal edges for increased durability	\$25,000

Exterior Sealant Replacement	Replace sealant at the following: around perimeter of windows on east, south, and west facades, 1560 LF; at wide masonry soft joints around gym addition, west façade of south wing, and south façade of east wing, 180 LF; concrete cap at west façade 1/4 inch wide, 12 LF.	\$25,000
Playground Pavement Replacement	Take out and restore deteriorated playground asphalt. Approximately 517 SY. For locations, refer to civil site plan exhibit found in the appendix of this report.	\$75,000
Pavement Replacement	Remove and replace 40 SY of PCC and install a rock base. For locations, refer to civil site plan exhibit found in the appendix of this report.	\$12,000
Sidewalk Repair	Repair damaged sidewalks across the site. Approximately 54 SY. For locations, refer to civil site plan exhibit found in the appendix of this report.	\$13,000
Drainage Repair	Flume down to basin to stop water undermining concrete. For location, refer to civil site plan exhibit found in the appendix of this report.	\$9,000

Playground Pavement Replacement	Take out and restore deteriorated playground asphalt. Approximately 808 SY. For locations, refer to civil site plan exhibit found in the appendix of this report.	\$150,000
Pavement Replacement	Remove and replace 1000 SY of PCC and install a rock base under the 851 SY experiencing subsurface moisture issues. For locations, refer to civil site plan exhibit found in the appendix of this report.	\$250,000
Sidewalk Repair	Repair damaged sidewalks across the site. Approximately 133 SY. For locations, refer to civil site plan exhibit found in the appendix of this report.	\$30,000
Thermostatic Mixing Valve Installation	Replace central thermostatic mixing valve with digital style.	\$15,000
