DMPS FACILITY ASSESSMENT |

EXECUTIVE BUILDING SUMMARY

Building Name: Woodlawn Early Childhood Center

Date: 01.24.2024

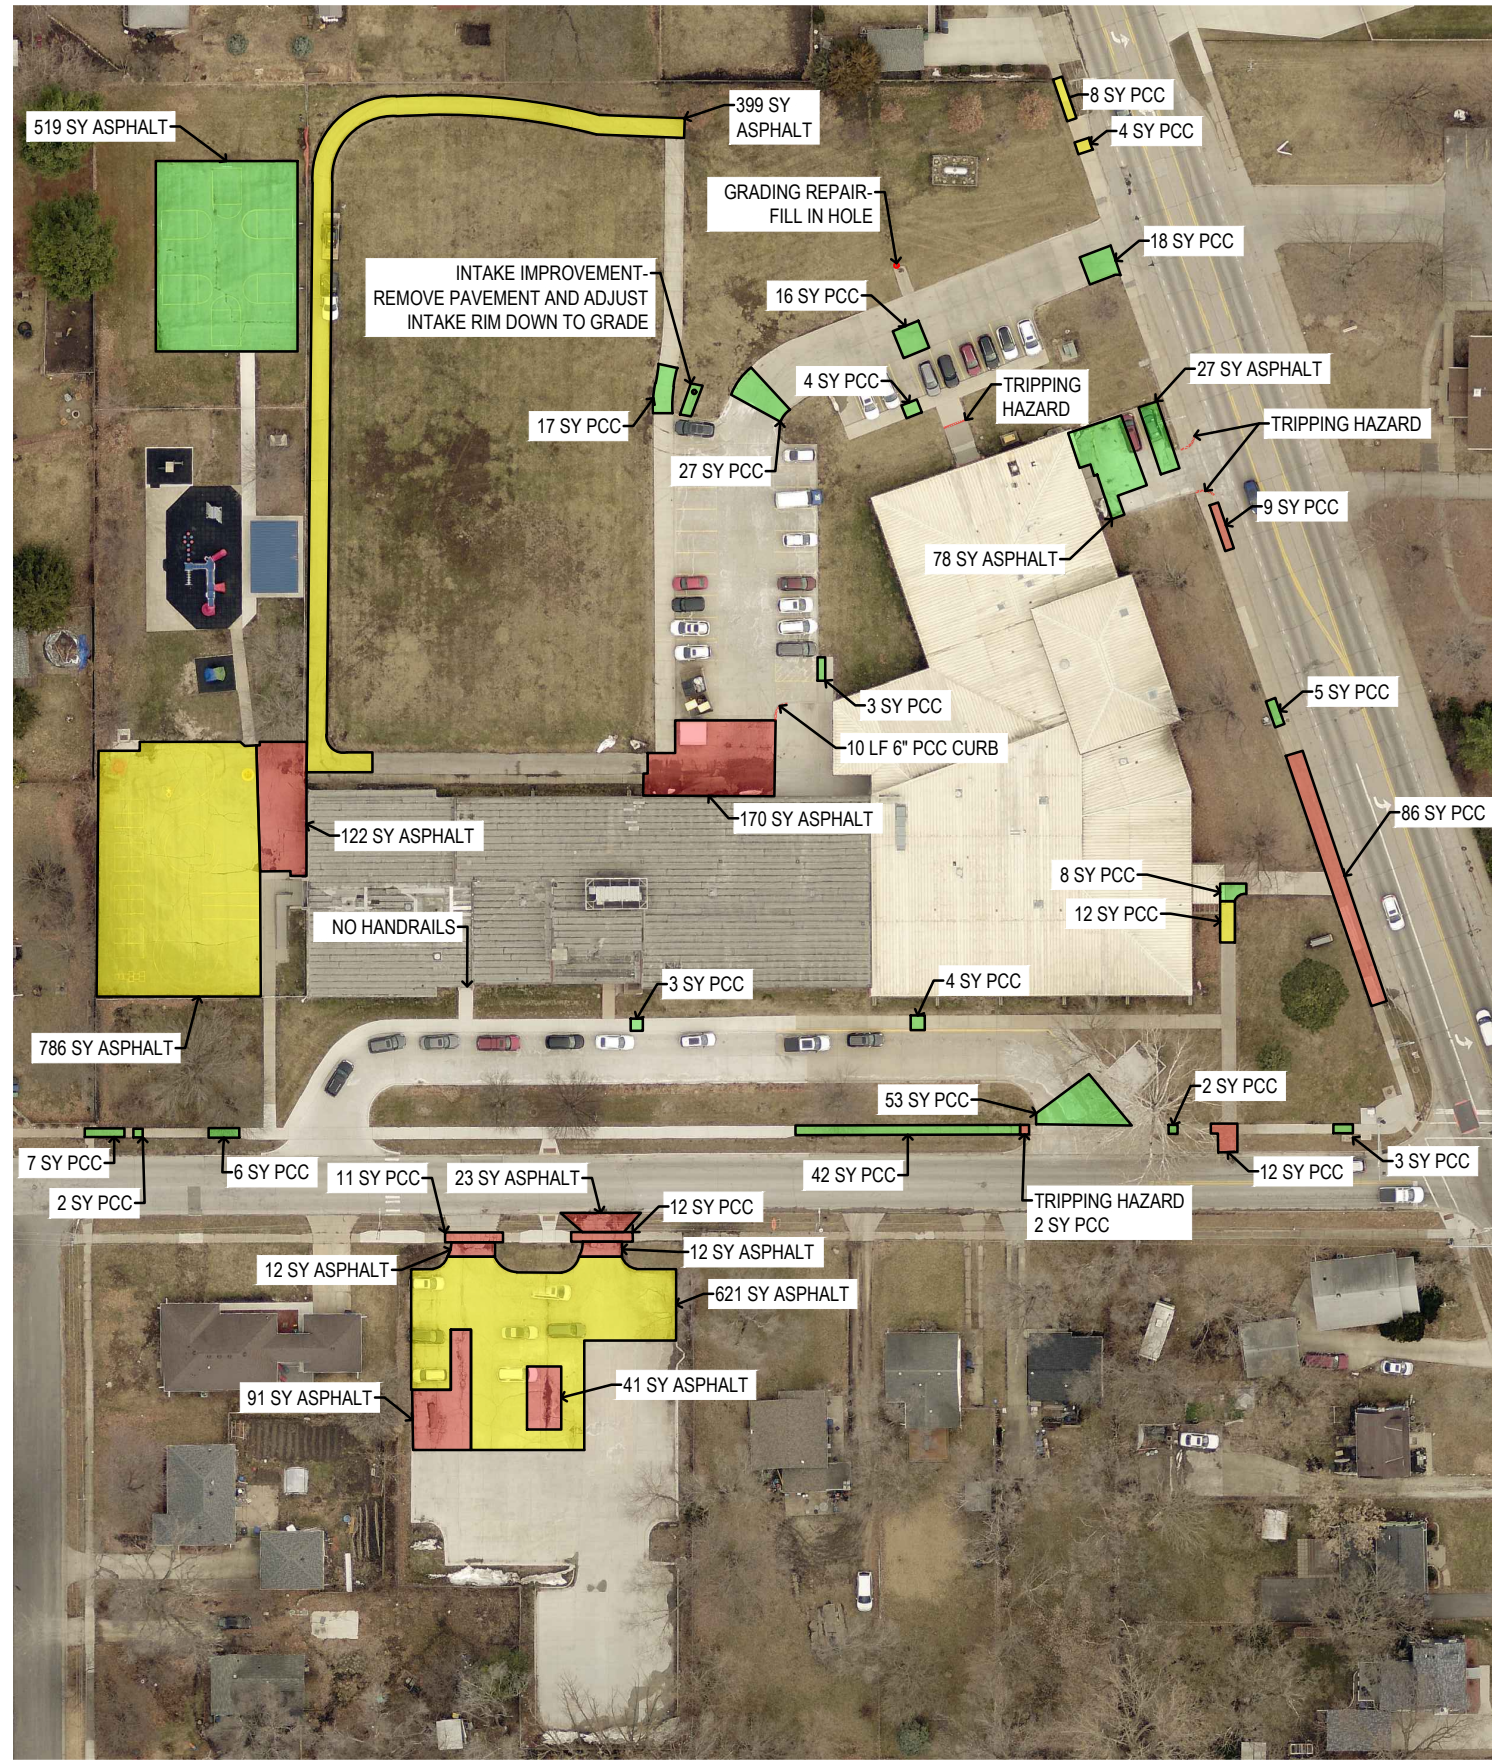
WOODLAWN EDUCATION CENTER

- 5+ YEAR REPLACEMENT
- 3-4 YEAR REPLACEMENT
- 1-2 YEAR REPLACEMENT

Fill in the hole with soil to prevent any undermining of the flume concrete. For location, refer to the civil site plan exhibit found in the appendix of this report.

Pavement Replacement	Remove and replace 326 SY of asphalt and 23 SY of PCC. For locations, refer to the civil site plan exhibit found in the appendix of this report.	\$45,000
Sidewalk Repair	Repair damaged sidewalks across the site. Approximately 132 SY. For locations, refer to civil site plan exhibit found in the appendix of this report.	\$25,000
Playground Pavement Replacement	Take out and restore deteriorated playground asphalt. Approximately 122 SY. For locations, refer to civil site plan exhibit found in the appendix of this report.	\$20,000
Loading Dock Concrete Repairs	The leading edge of the loading dock needs to be replaced. Cut back existing concrete slab approximately 16" from the face and extend the full length of the dock approximately 11'-0". Drill and epoxy new epoxy coated #4 x 4'-0 (24" x 24") bent dowels @ 12" o.c. into the cut face of the slab. Provide (4) - #4 x 11'-0" horizontal bars (2 top face & 2 side face). Remove old patch repair and grid down concrete to a minimum depth of 1 1/2", edges shall be vertical and not flared. Replace patch with new concrete grout patch and install per manufactures instructions. Assume 5 cubic feet of patch repair.	\$11,000

Roof Replacement	Remove and replace roofing on Roof D, modified bitumen to be replaced with TPO (13,500 SF).	\$360,000
Pavement Replacement	Remove and replace 621 SY of asphalt. For location, refer to the civil site plan exhibit found in the appendix of this report.	\$90,000
Sidewalk Repair	Repair damaged sidewalks across the site. Approximately 24 SY. For locations, refer to civil site plan exhibit found in the appendix of this report.	\$10,000

Playground Pavement Replacement	Take out and restore deteriorated playground asphalt. Approximately 1185 SY. For locations, refer to civil site plan exhibit found in the appendix of this report.	\$170,000
Master Clock System Installation	Install Primex master clock system throughout building.	\$40,000

Intake Improvement	Remove pavement and adjust intake rim down to grade for better drainage into the intake. For location, refer to civil site plan exhibit found in the appendix of this report.	\$11,000
Heat Pump Replacement	Replace heat pumps throughout building. Consider two speed type to more closely match load and provide dehumidification.	\$2,600,000
