DMPS FACILITY ASSESSMENT | WRIGHT ELEMENTARY

11.07.2023

EXECUTIVE BUILDING SUMMARY

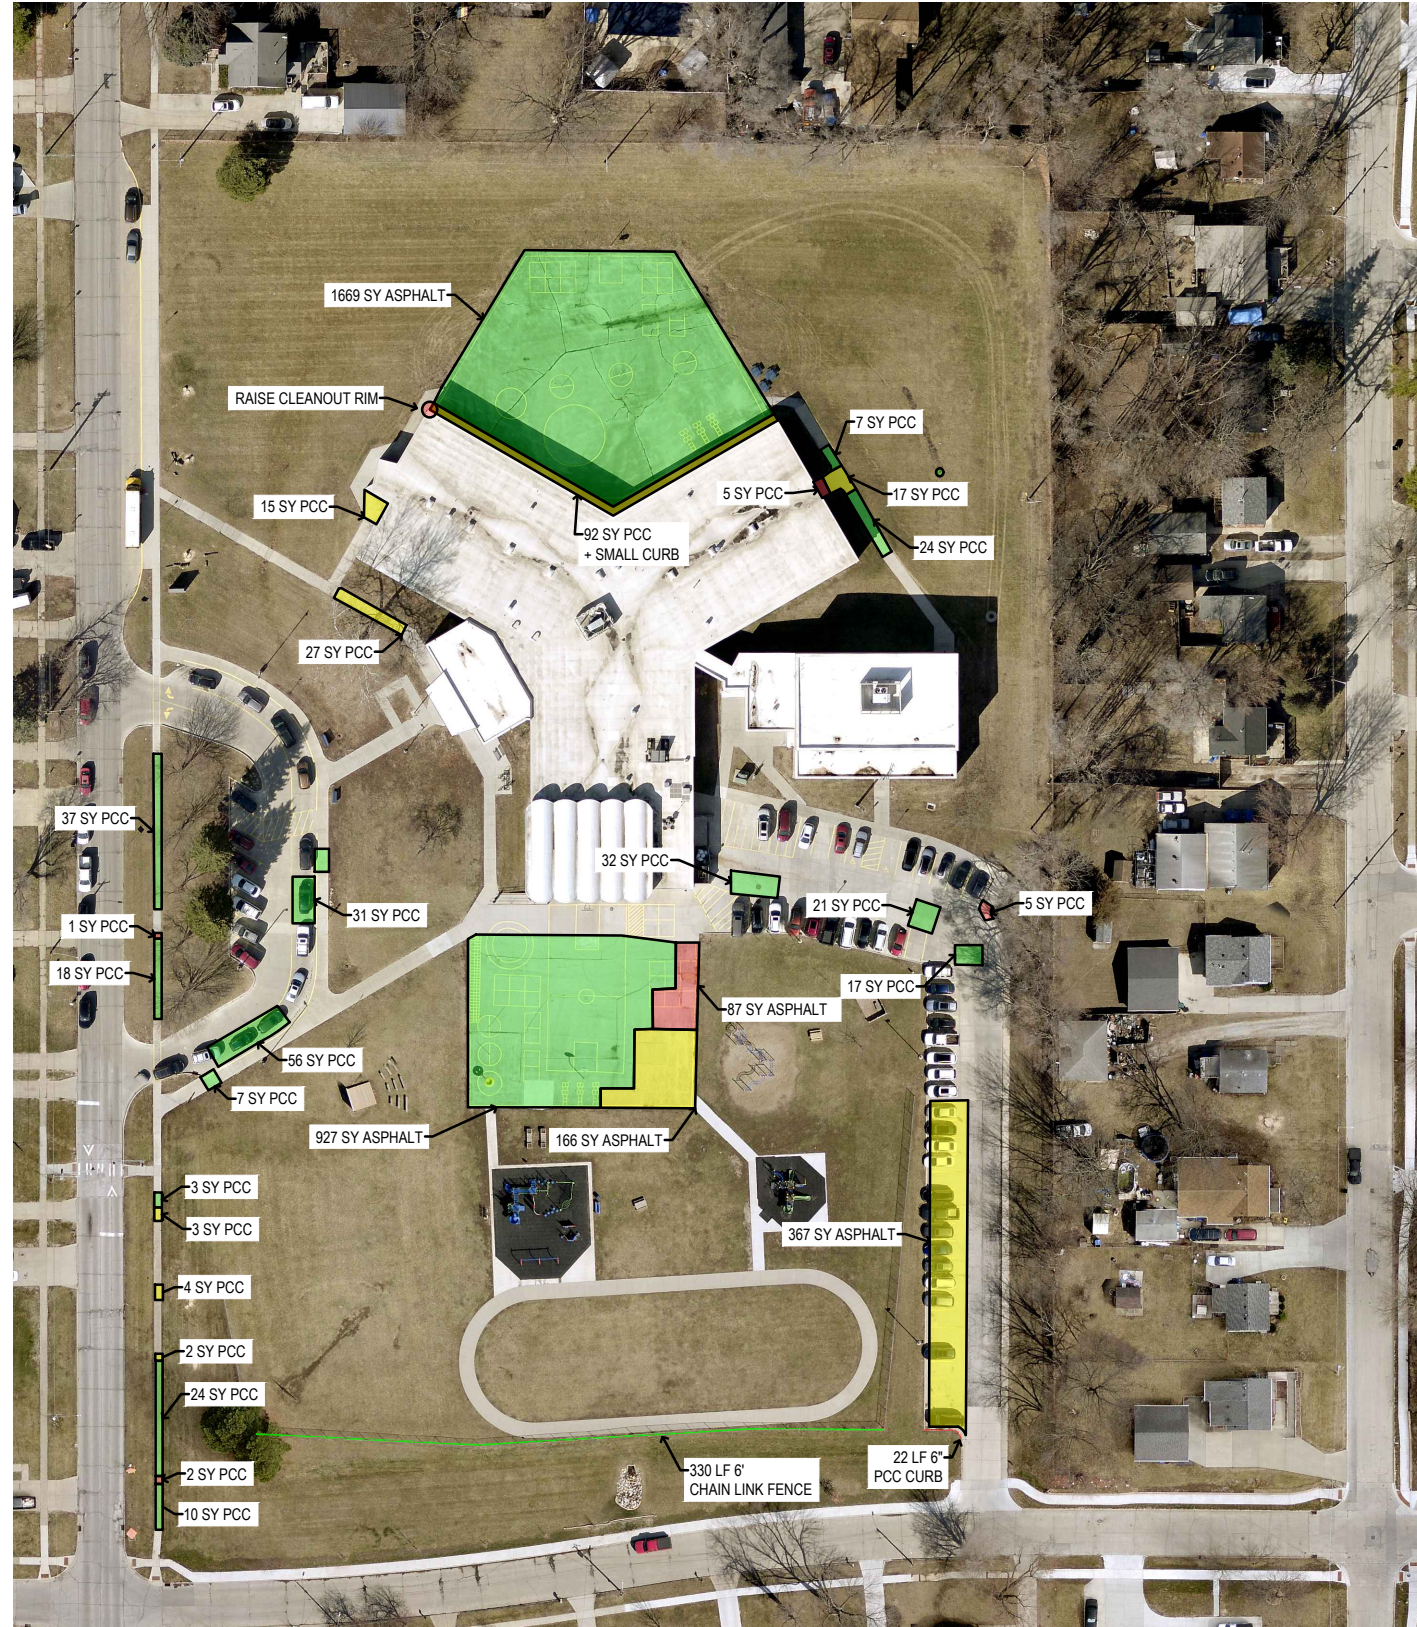
WRIGHT ELEMENTARY

Weight Factor	Rating	Points	Comments
4.1 Site topography and grading drains water away from the building and retaining walls.	1	4	4	There is good drainage away from the building, the north side of the site is quite steep but walkable. The north asphalt area is flat by the building

4.2 Parking areas are in good condition.	5	3	15	The parking pavement in the west lot is in good condition. The east lot parking pavement is cracking throughout and will need replacement in areas.

4.5 Sidewalks around the facility are in good condition .	1	3	3	Most of the interior walk on site were in good condition. The perimeter walk was patched throughout the west side with some older sections requiring repair.

4.7 Hard surface playground surfaces are in good condition.	3	2	6	The concrete areas in the south looked new and in good condition, including the walk track. The north asphalt was cracking badly in areas and had moved away from the building by ~ 6".

4.8 Fencing around the site is in good condition.	1	4	4	The fence along northeast of the site looked a little rusty/old but was without any major issues. The fence along the south looked worn out and will need replacement in the future.

Replace Exterior Sealant at Control Joints	Replace sealant in building control joints (10 LF in each of six locations).	\$6,000
Replace Exterior Sealant at Door	Replace sealant around one door frame and sidelight at the south side of the cafeteria (20 LF).	\$6,000
Replace Exterior Sealant at Fascia Panels	Replace sealant at enamel fascia panels around entire building (250 LF).	\$6,000
Replace Playground Paving	Remove and replace a portion of the asphalt paving at the playground. See attached civil exhibit.	\$8,000
Replace Sidewalk Paving	Remove and replace portions of heavily degraded sidewalk paving at various locations on site. See attached civil exhibit.	\$7,000

Replace Concrete Curb	Replace concrete curb at the south end of the east parking area. See attached civil exhibit.	\$14,000
Replace DOAS units with Air-Cooled DOAS/ERV	Replace existing DOAS unit installed in 2010, labeled AHU-1, with new DOAS with energy recovery, DX cooling, hot-gas reheat for dehumidification and electric heat. Duct restroom exhaust currently going to EF-1 to new DOAS unit.	\$280,000
Data Closet Cooling System	Install new mini-split to serve data closet.	\$20,000
Install Second Backflow Preventer	Add a second parallel back-flow preventer to water service.	\$12,000
Upgrade Electrical Distribution System	Design and replacement of outdated/original electrical components. A full evaluation of the building's electrical distribution system will be required for most accurate costing. Costs based on replacement of 6 branch panels.	\$50,000
MDP Meter Repair	Repair or replace power meter at the main breaker.	\$13,000

Replace Playground Paving	Remove and replace a portion of the asphalt paving at the playground. See attached civil exhibit.	\$14,000
Replace Sidewalk Paving	Remove and replace portions of degraded sidewalk paving at various locations on site. See attached civil exhibit.	\$25,000
Replace Vestibule Heatpumps	Replace vestibule heat-pumps with electric heating only cabinet unit heater.	\$20,000
Install Digital Mixing Valve	Replace existing domestic hot water mixing valve with a new digital mixing valve and monitor through DDC.	\$13,000

Replace Southern Fence	Remove and replace the south section of chain link fence. See attached civil exhibit.	\$45,000
Add Dedicated Outdoor Air for Gymnasium	Replace rooftop HVAC equipment with packaged unit with ERV (DOAS with recirc). Employ demand based ventilation.	\$510,000
Replace Heatpumps in Classrooms	Replace classroom heat-pumps units (BARD). Include 2-speed compressor for reduced load on well-field and match classroom load. Include demand control ventilation	\$730,000
