DMPS FACILITY ASSESSMENT |

EXECUTIVE BUILDING SUMMARY

Building Name: East High

Date: 2.27.2024

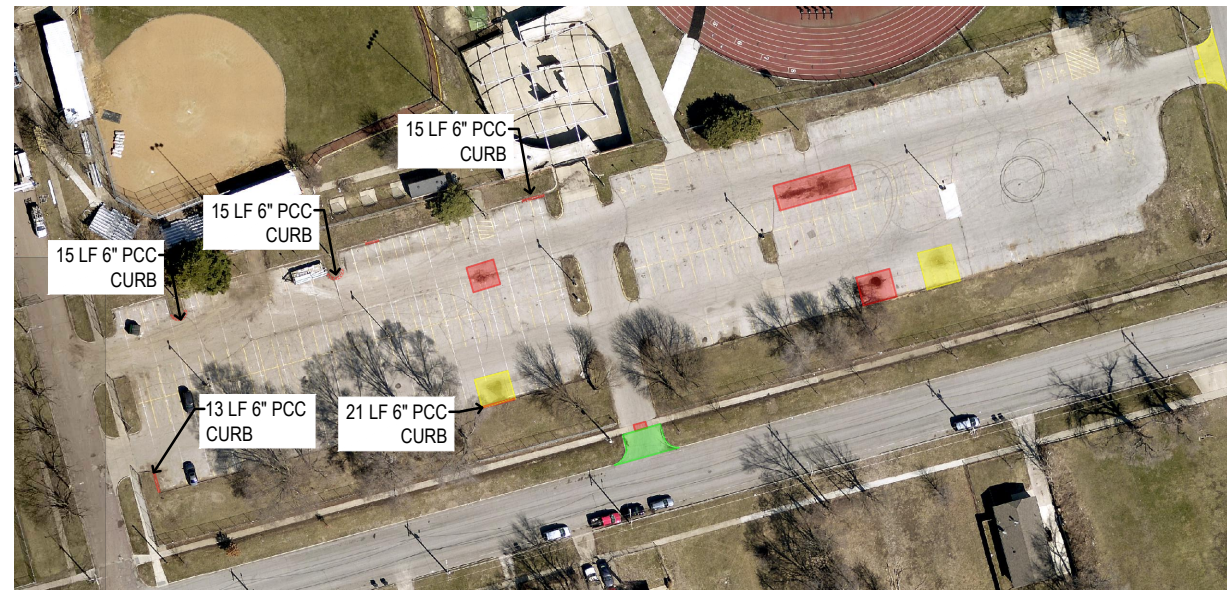
STADIUM PARKING LOT

PAVEMENT QUANTITIES (SY)			
	SIDEWALK	PCC	ASPHALT
■	646	850	9177
■	60	578	2624
■	115	166	1869

- 5+ YEAR REPLACEMENT
- 3-4 YEAR REPLACEMENT
- 1-2 YEAR REPLACEMENT
