DMPS FACILITY ASSESSMENT |

EXECUTIVE BUILDING SUMMARY

Lovejoy Elementary's on-site facility conditions assessment was conducted on November 8, 2023 and included visual conditions assessment from professionals covering interior architecture, exterior building envelope, the property's grounds (site), structural condition, mechanical (HVAC/Plumbing) systems, electrical systems (power, exterior lighting, interior lighting, fire alarm, and general IT), and the elevator conditions.

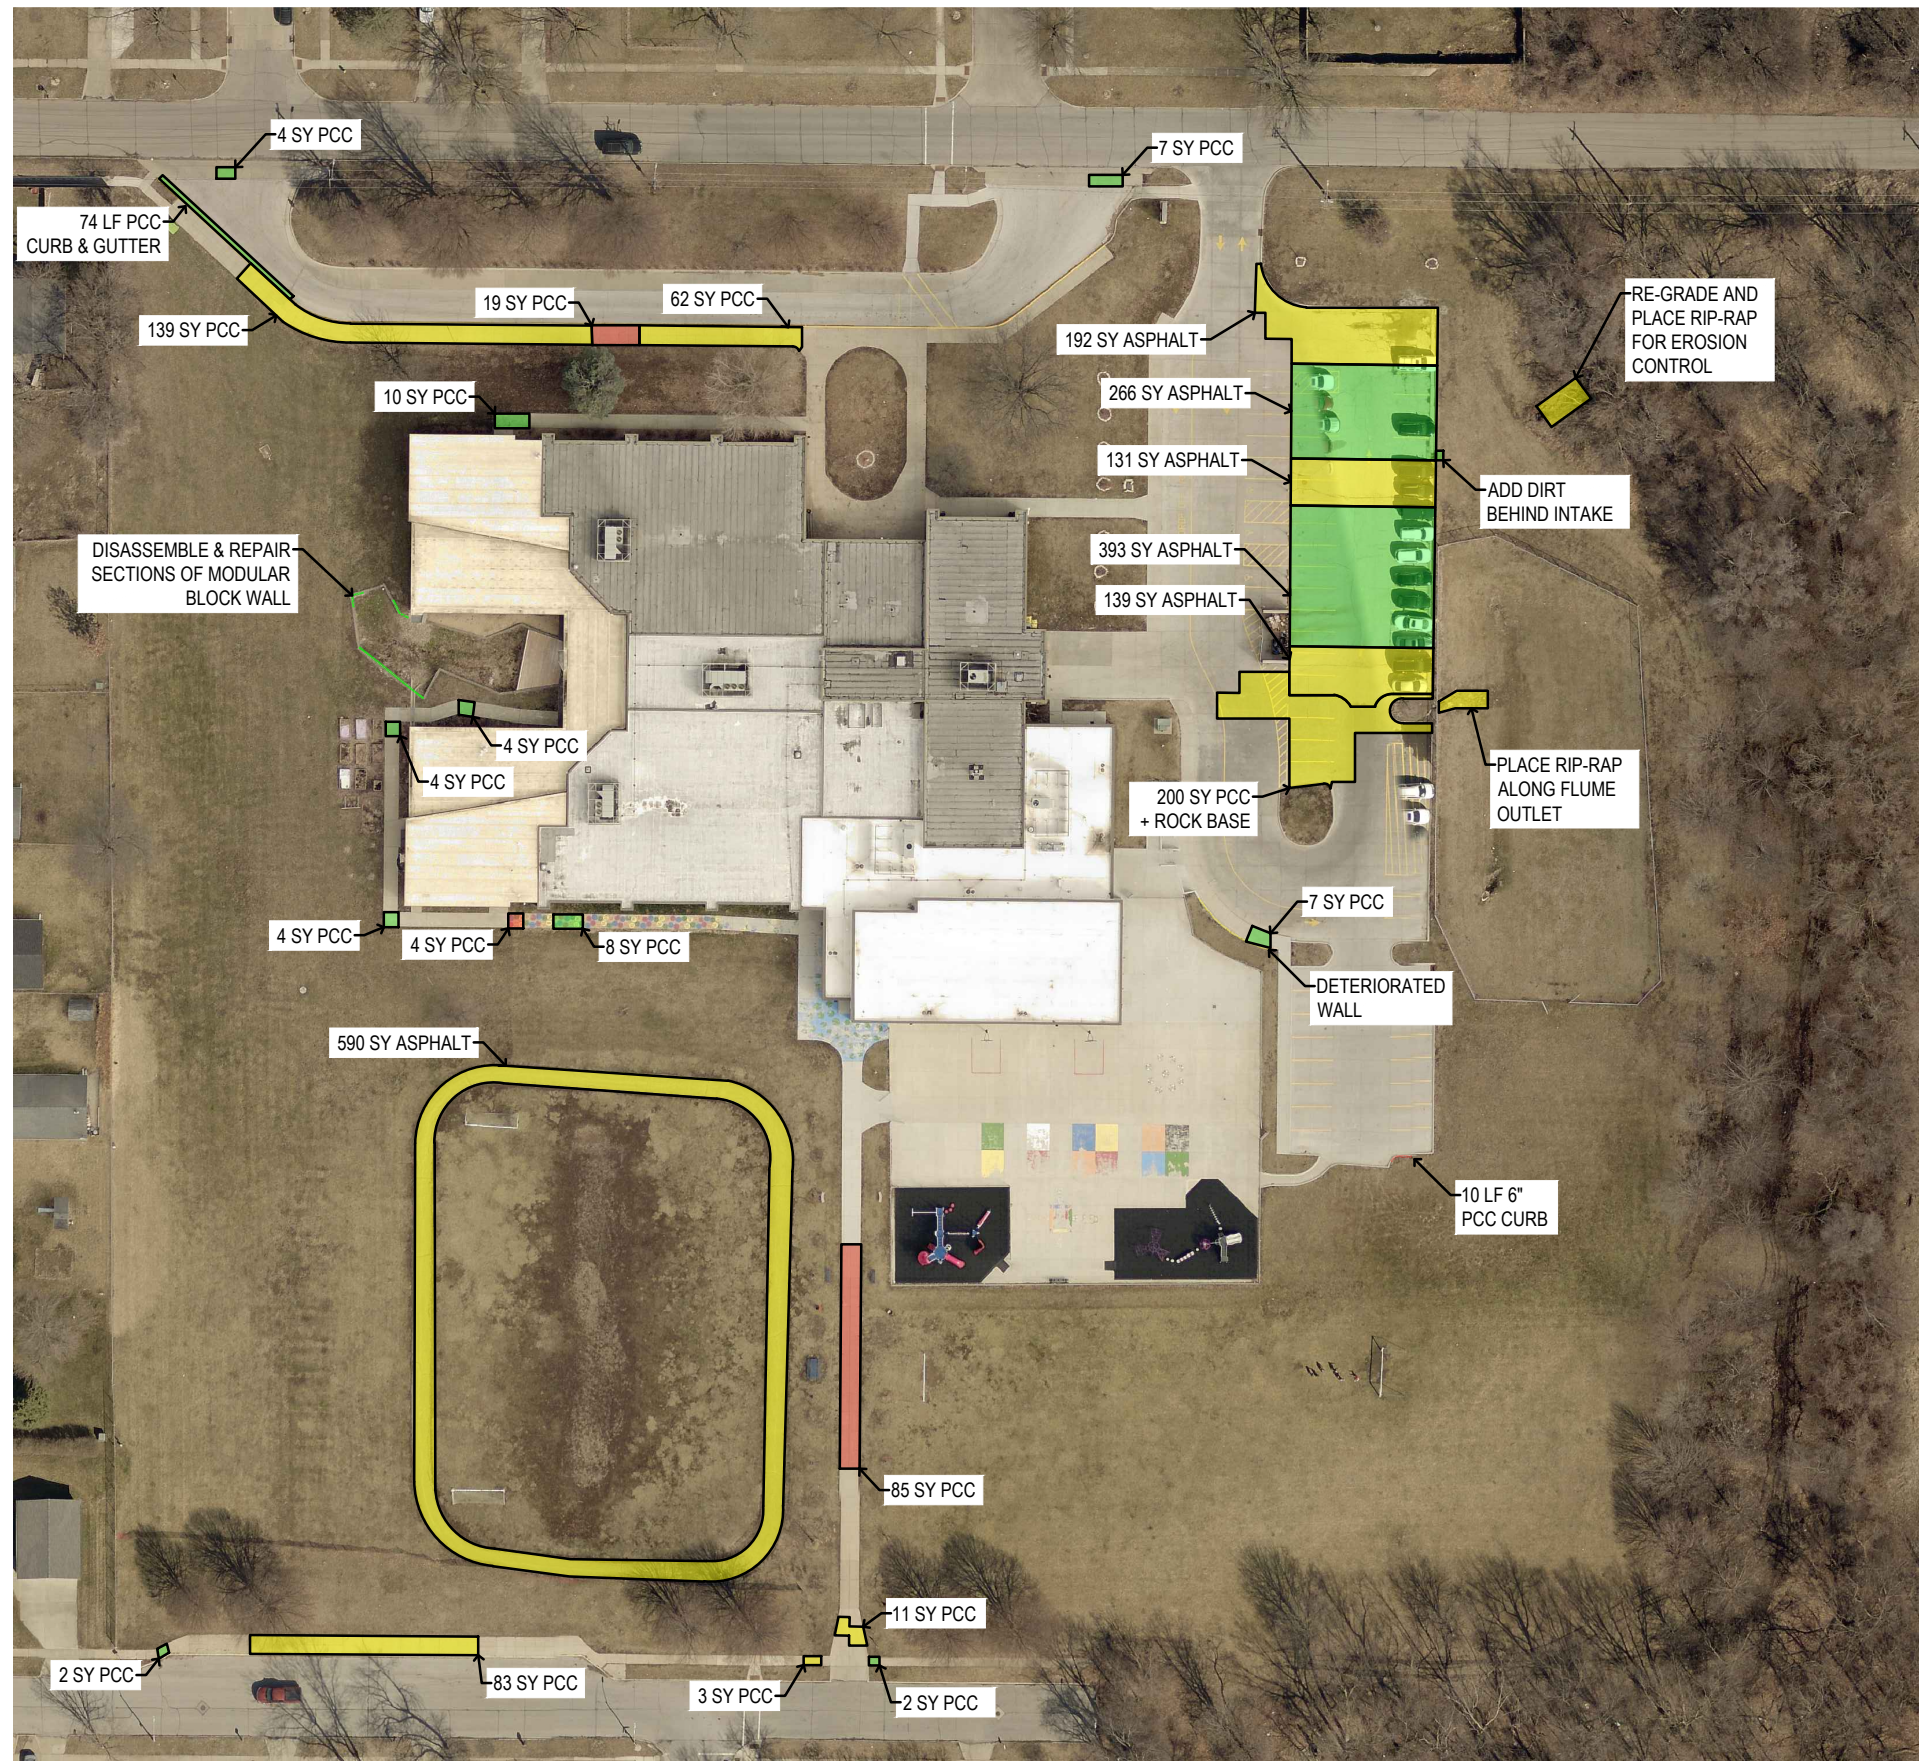
- 5+ YEAR REPLACEMENT
- 3-4 YEAR REPLACEMENT
- 1-2 YEAR REPLACEMENT

- Civil Site Plan
- Roof Identification Image
