DMPS FACILITY ASSESSMENT |

EXECUTIVE BUILDING SUMMARY

Moore Elementary's on-site facility conditions assessment was conducted on December 13, 2023 and included visual conditions assessment from professionals covering interior architecture, exterior building envelope, the property's grounds (site), structural condition, mechanical (HVAC/Plumbing) systems, electrical systems (power, exterior lighting, interior lighting, fire alarm, and general IT), and the elevator conditions.

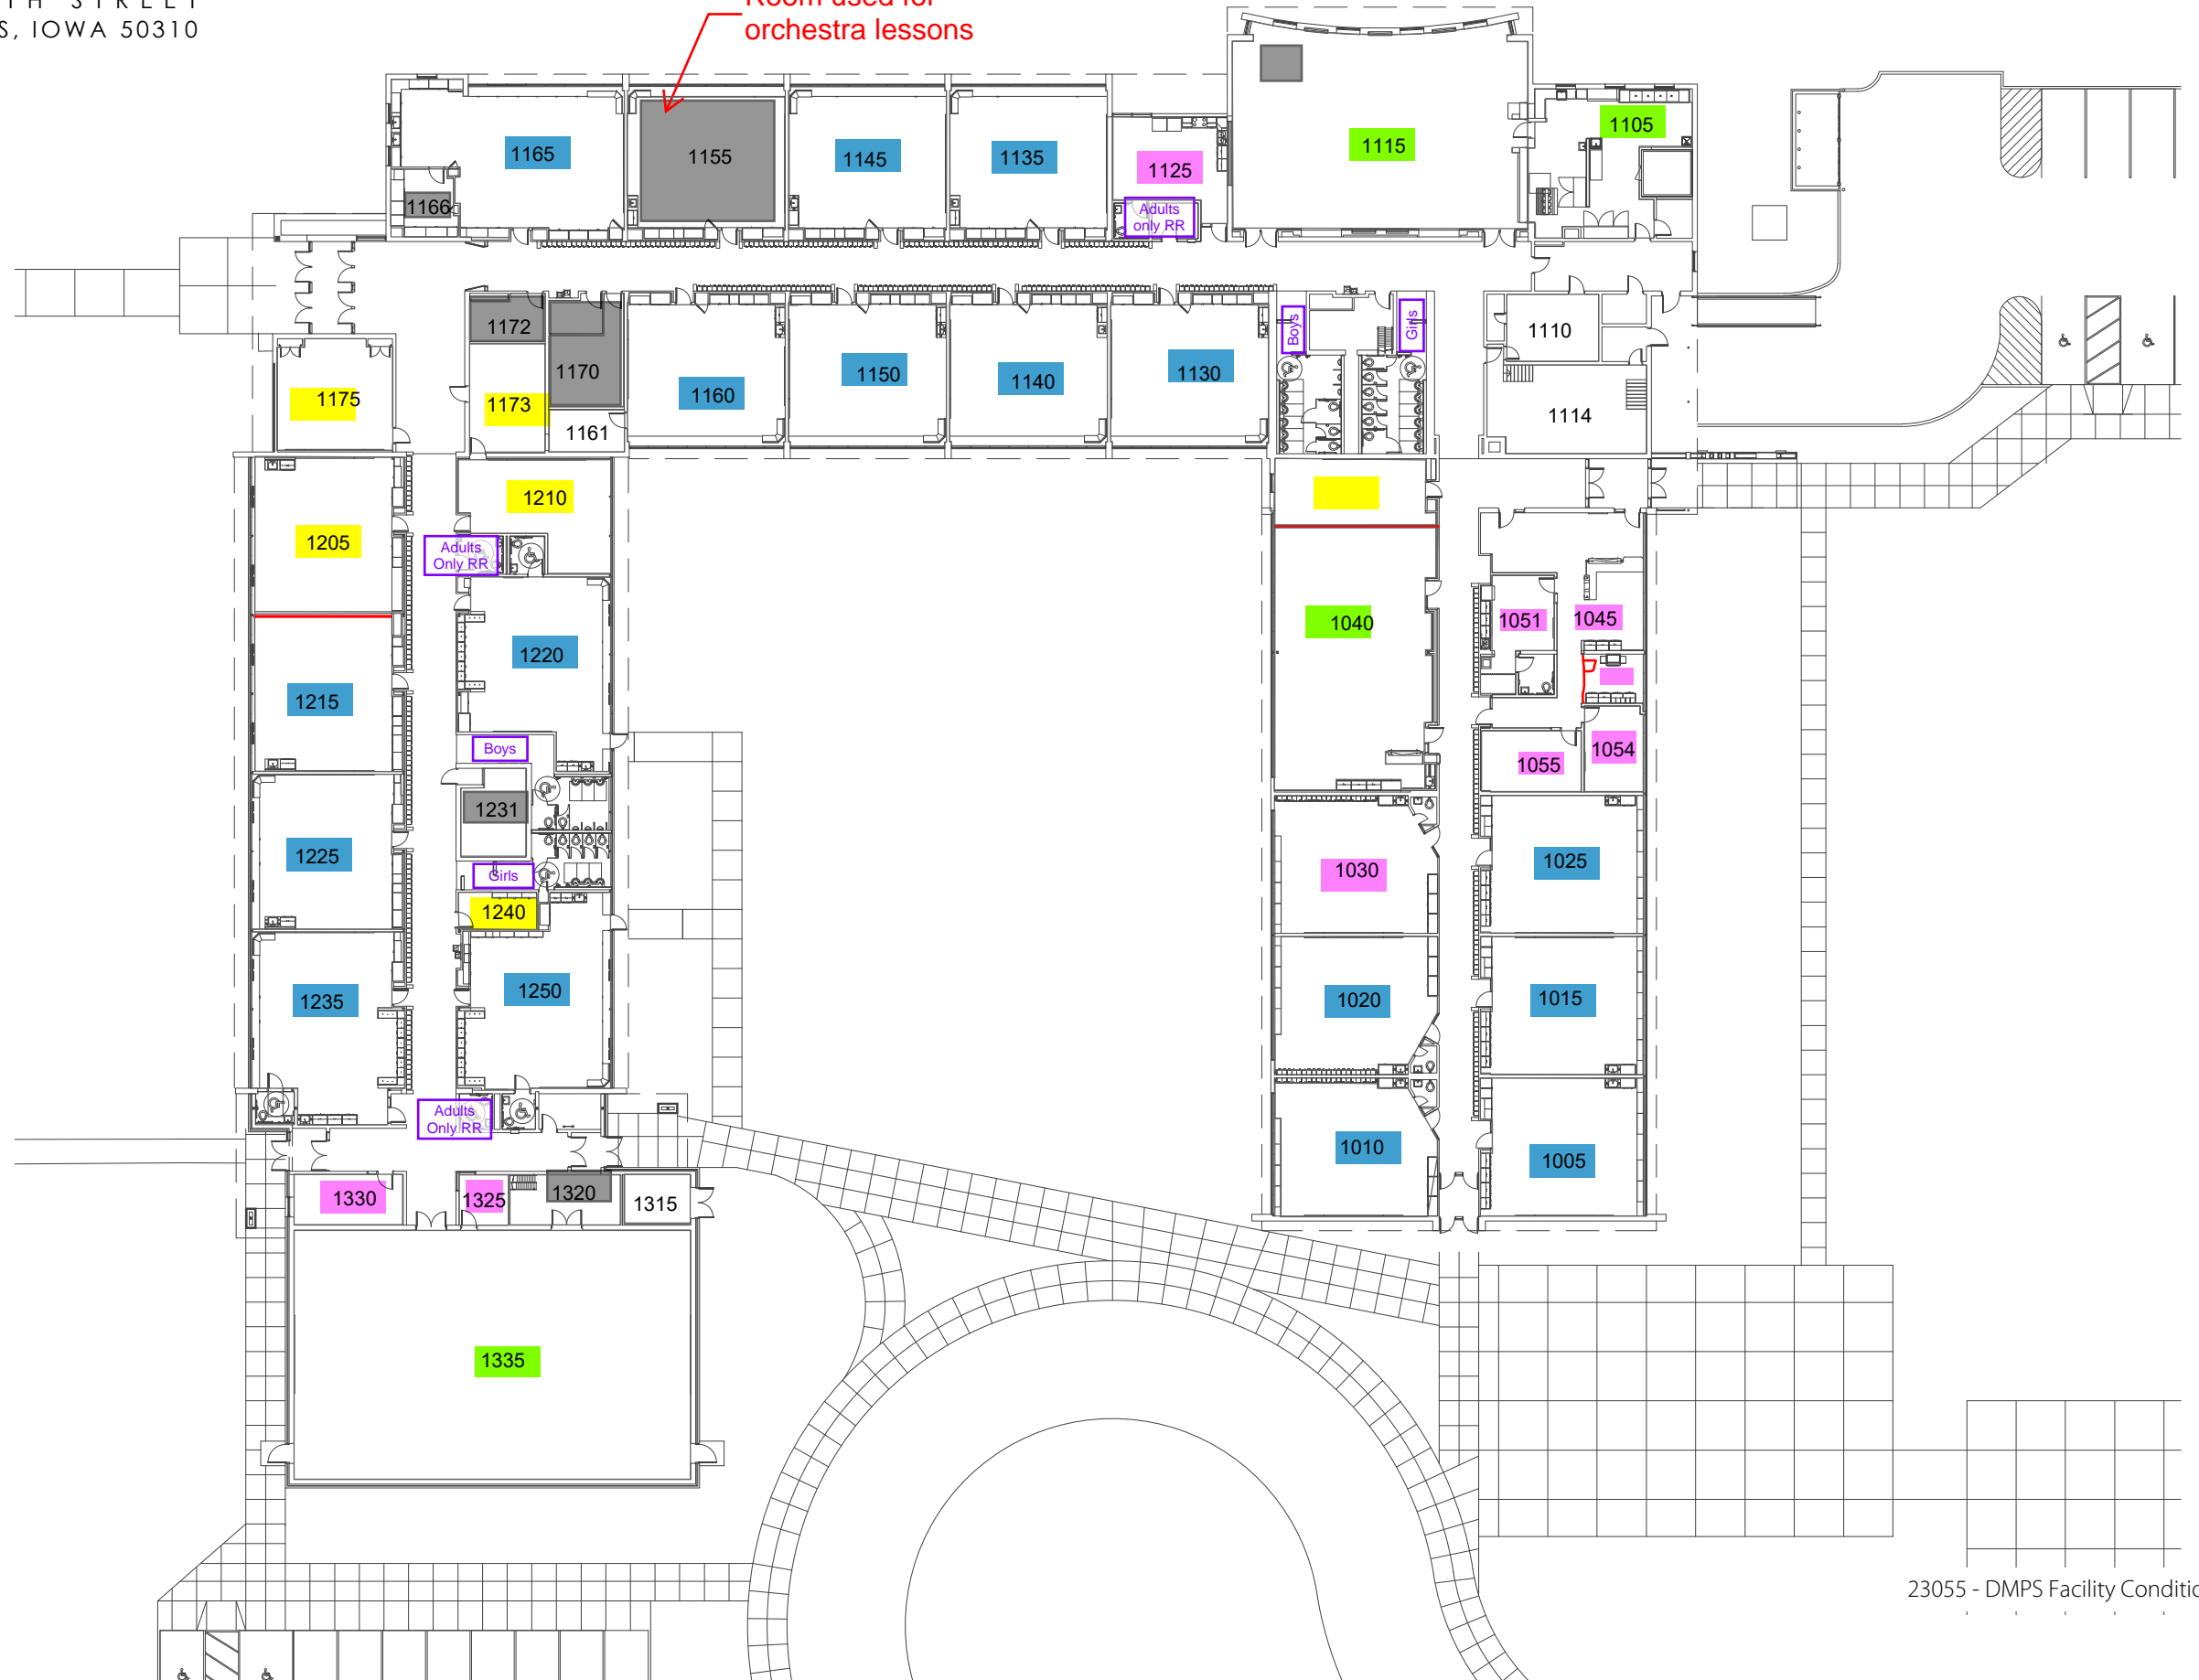
- Core Classroom
- Student Support
- Administration
- Large Shared Space
- Other
