DMPS FACILITY ASSESSMENT | ROOSEVELT HIGH SCHOOL

03.06.2024

EXECUTIVE BUILDING SUMMARY

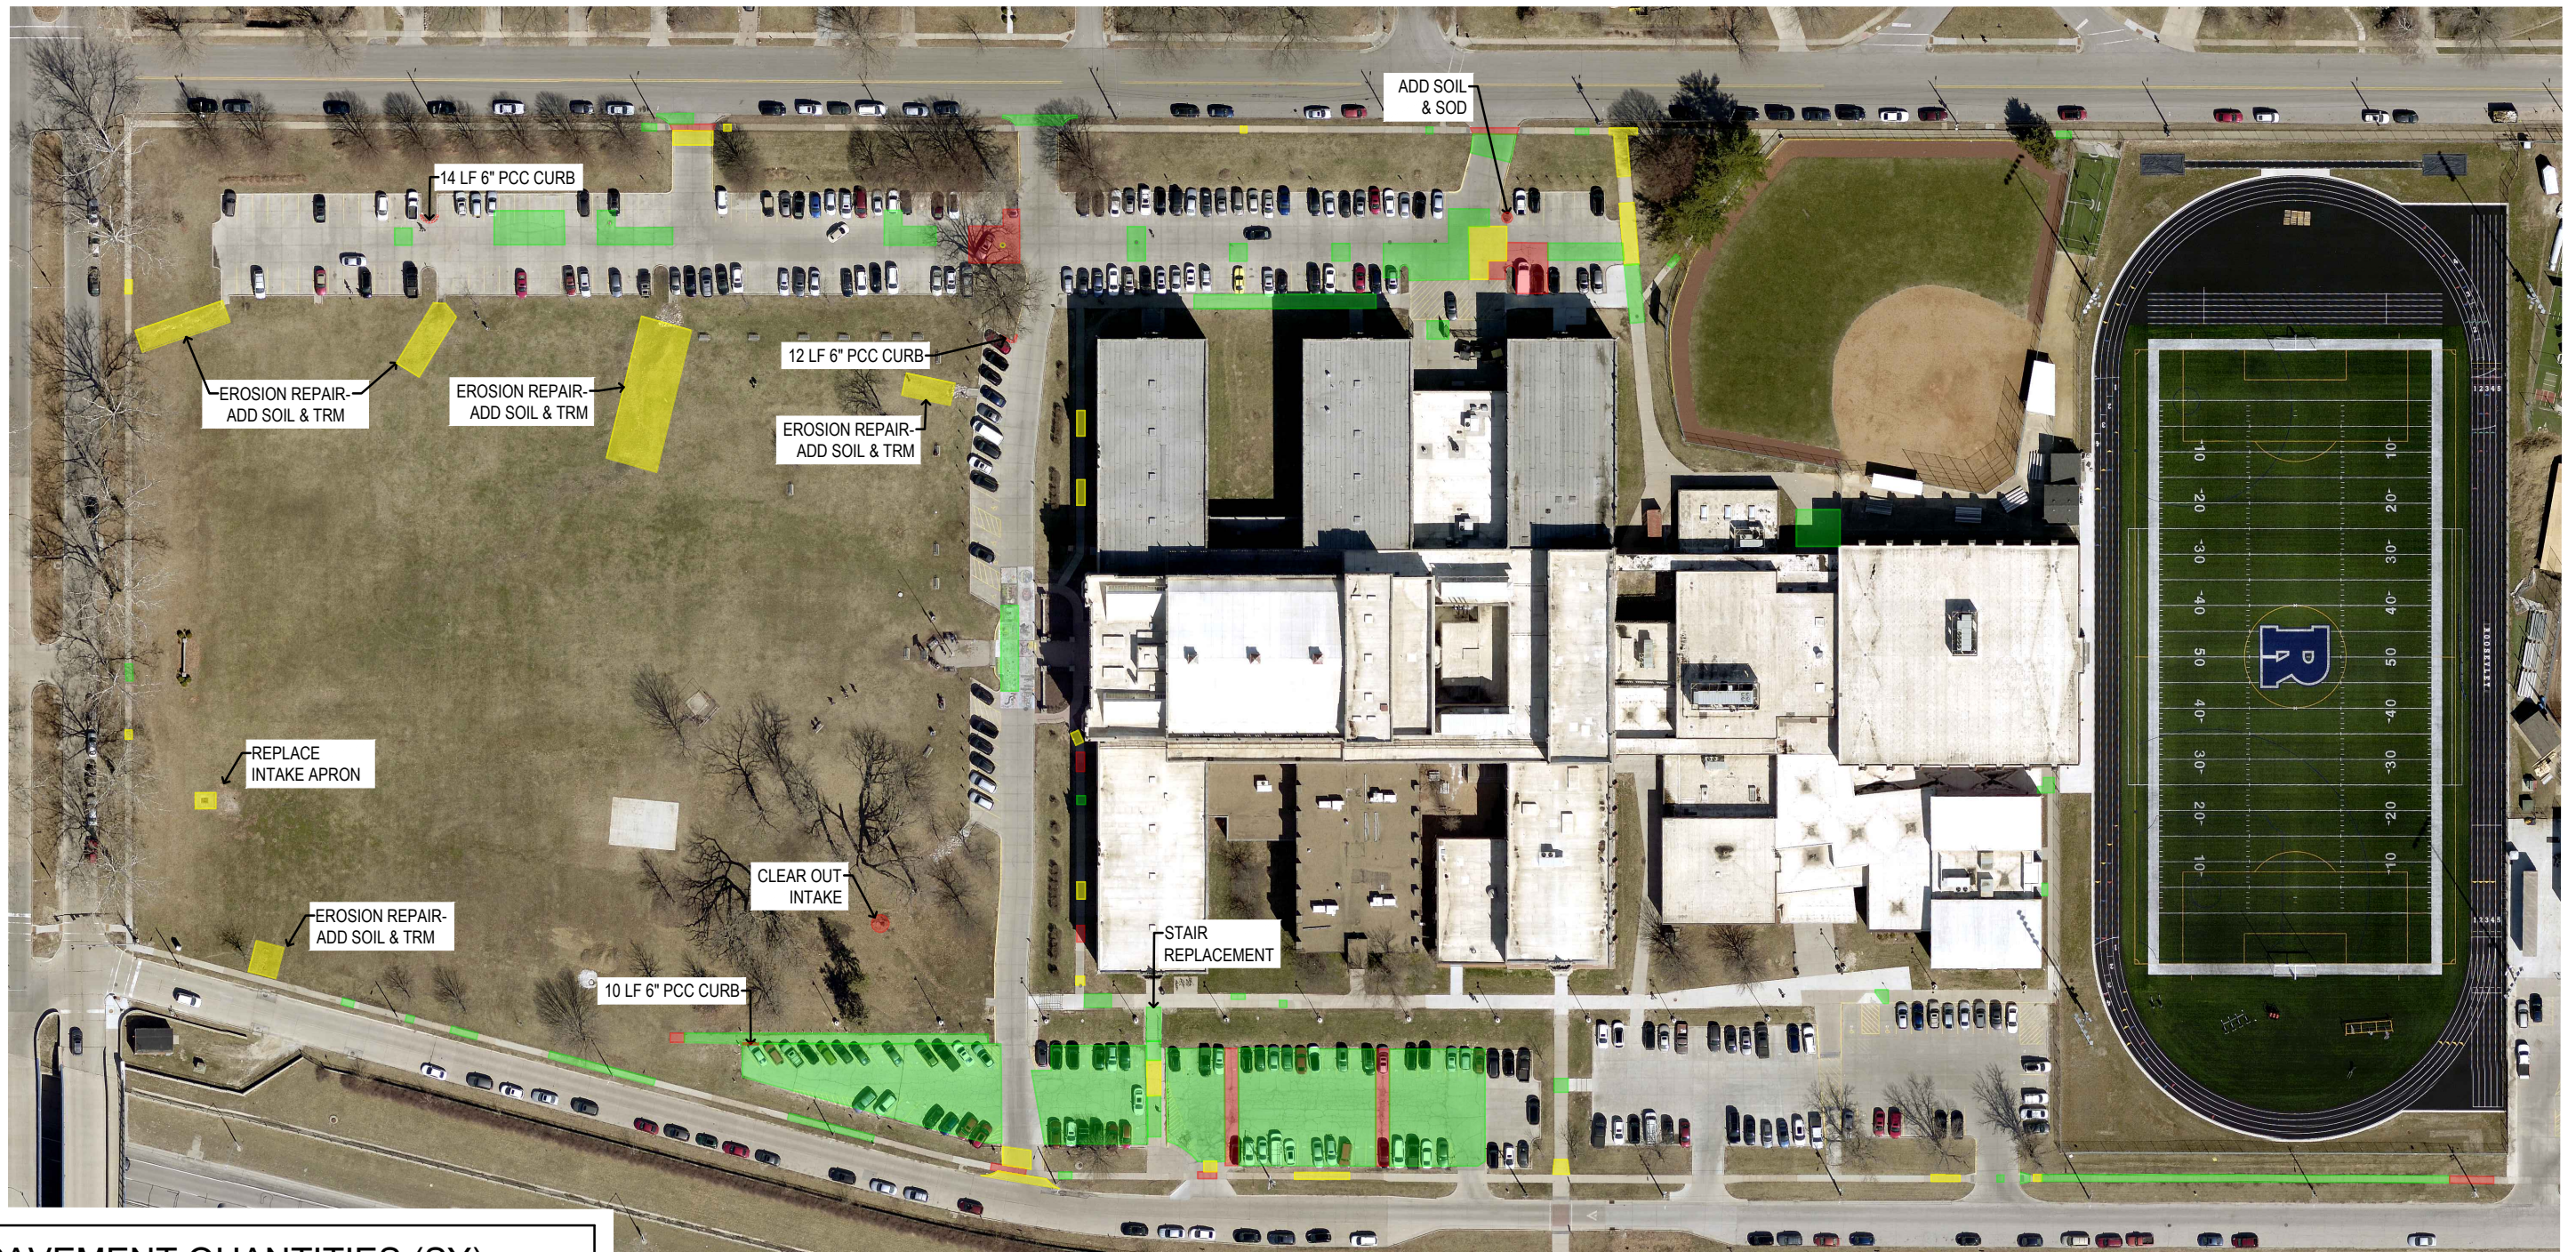
PAVEMENT QUANTITIES (SY)

SIDEWALK	PCC	ASPHALT

- Civil Site Plan
 - Roof Identification Image
 - Roosevelt Boiler Building Assessment Report
-
